**Heritage Report for the Old St James Anglican Church**

**2 Kent Street, Minto**

**Report undertaken by Heritage 21**

# *Heritage Data Form*

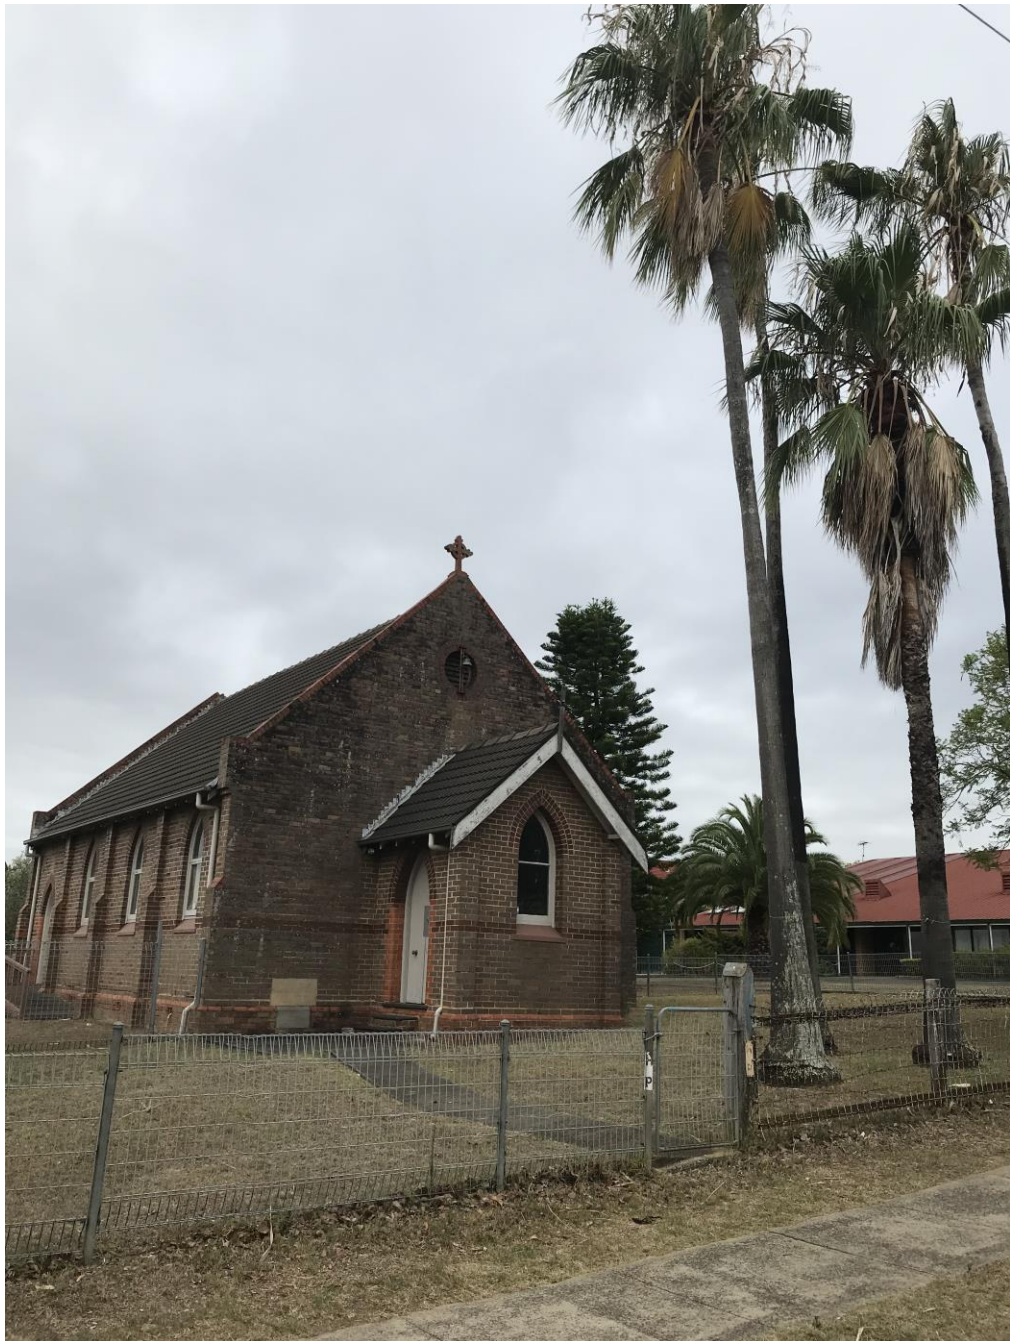
<b>Image caption</b>	Primary (western) elevation and front landscape elements (front fence, palm trees).				
<b>Image year</b>	2018	<b>Image by</b>	Heritage 21	<b>Image copyright holder</b>	Heritage 21

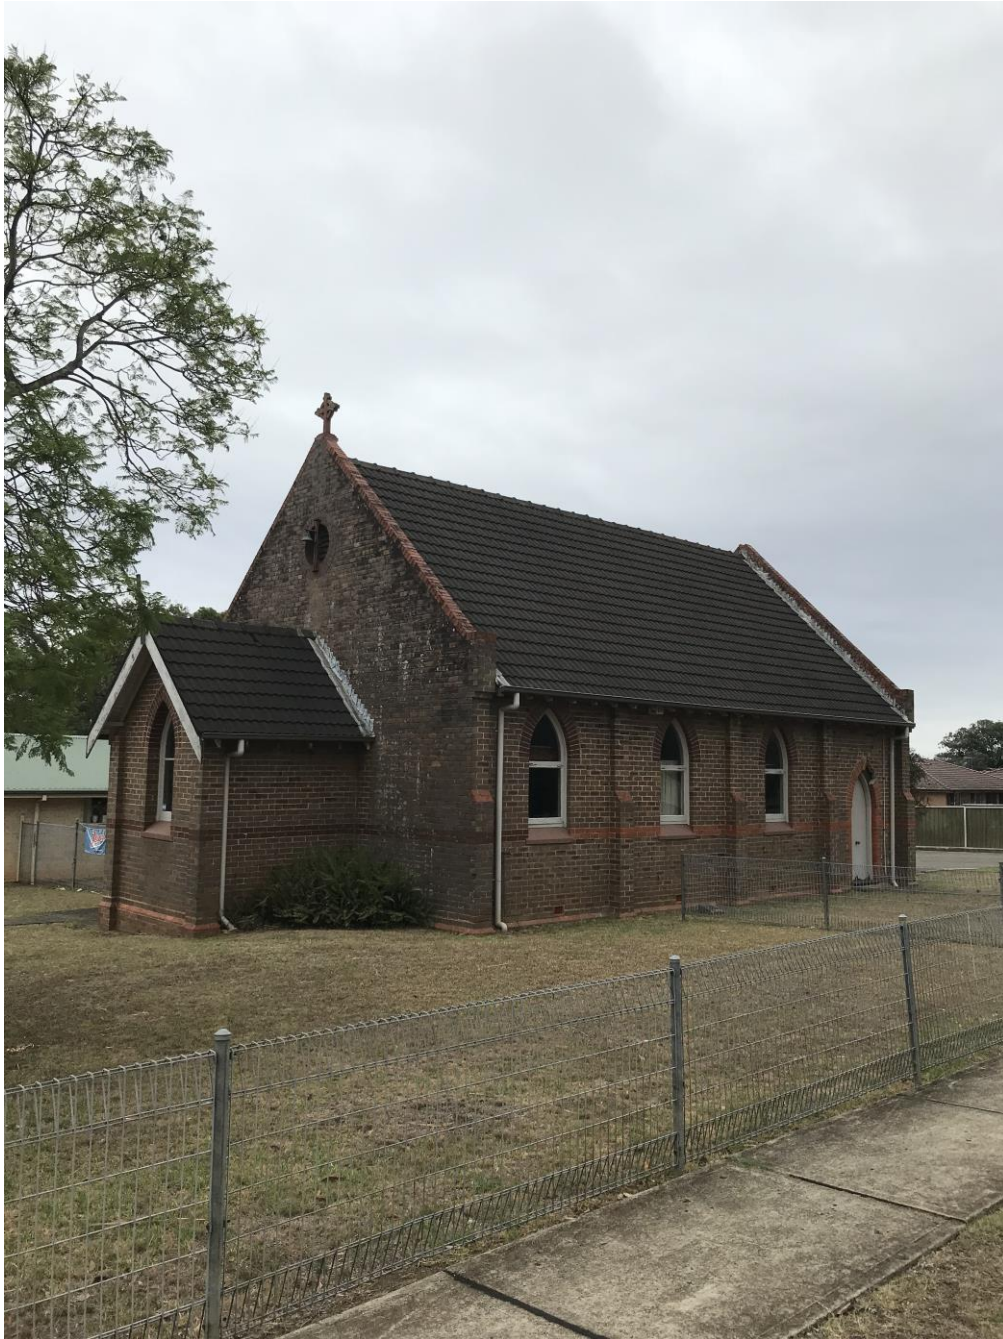
<b>Image caption</b>	Southern elevation.				
<b>Image year</b>	2018	<b>Image by</b>	Heritage 21	<b>Image copyright holder</b>	Heritage 21

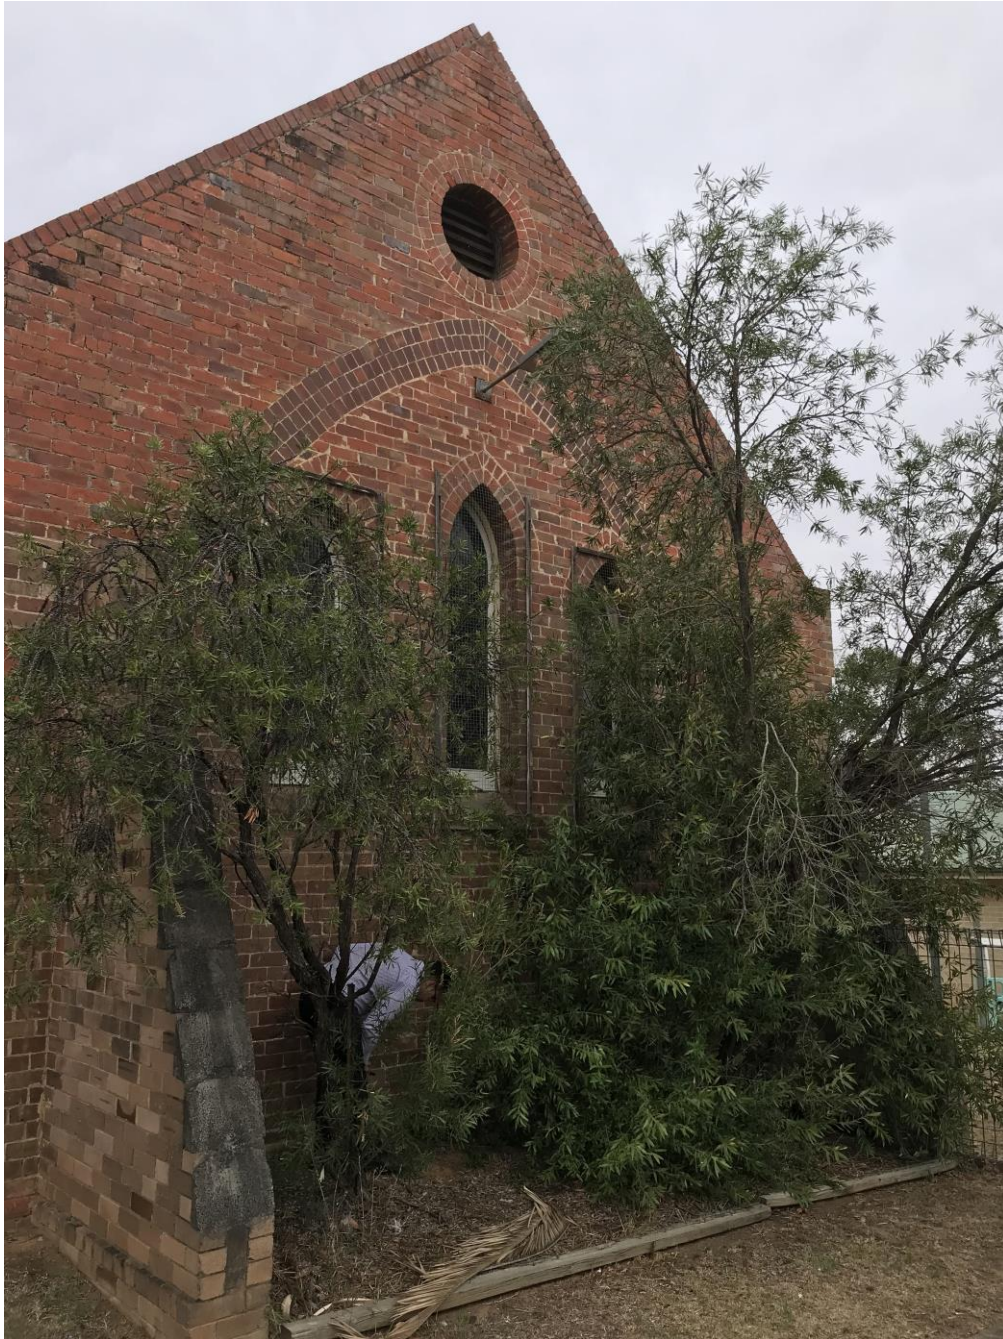
<b>Image caption</b>	Rear (eastern) elevation.				
<b>Image year</b>	2018	<b>Image by</b>	Heritage 21	<b>Image copyright holder</b>	Heritage 21

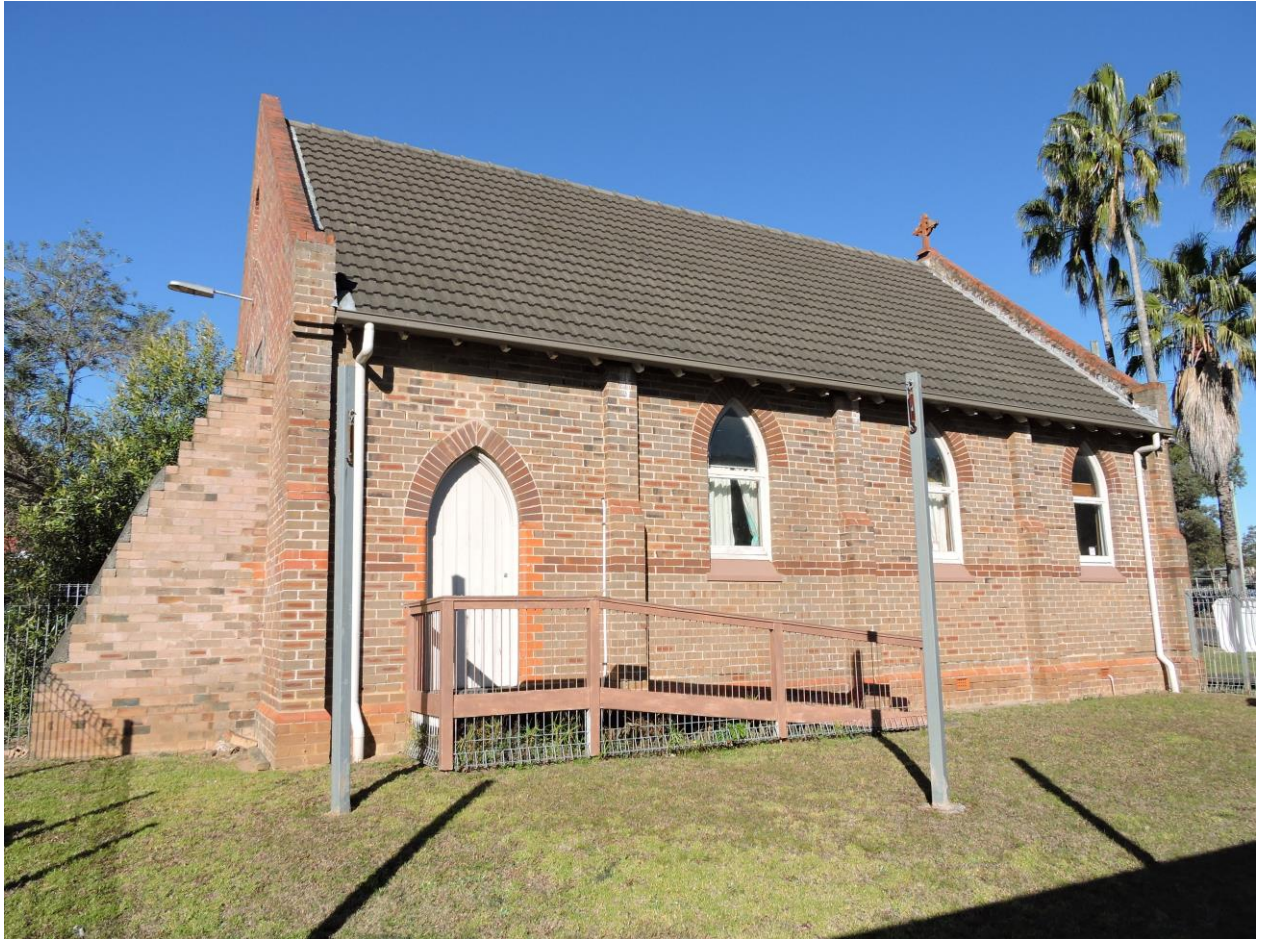
<b>Image caption</b>	Northern elevation.				
<b>Image year</b>	2017	<b>Image by</b>	Heritage 21	<b>Image copyright holder</b>	Heritage 21

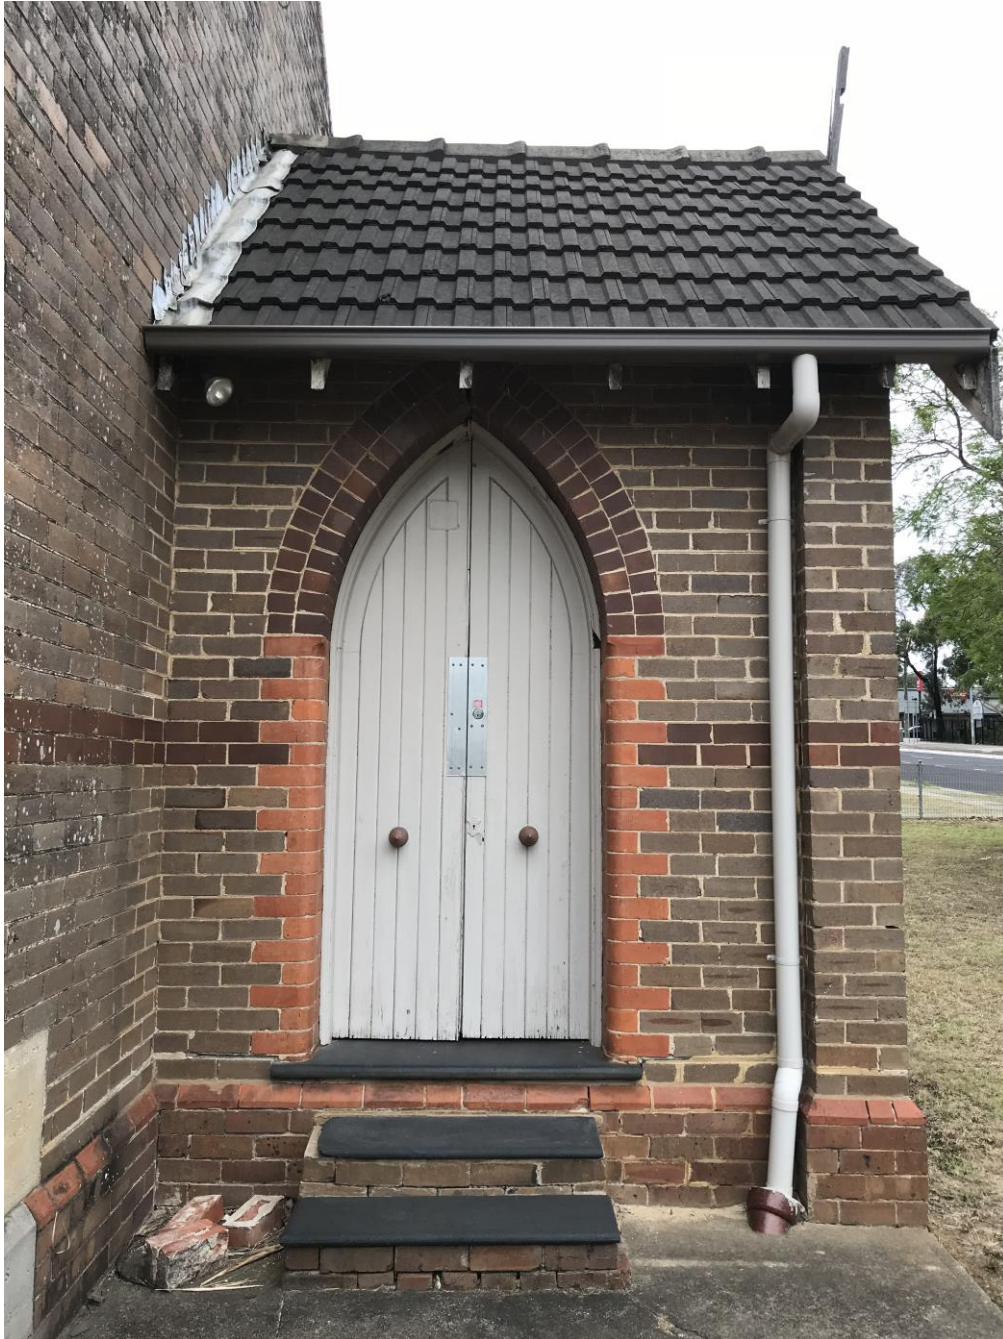
<b>Image caption</b>	Entrance at front gable.				
<b>Image year</b>	2018	<b>Image by</b>	Heritage 21	<b>Image copyright holder</b>	Heritage 21

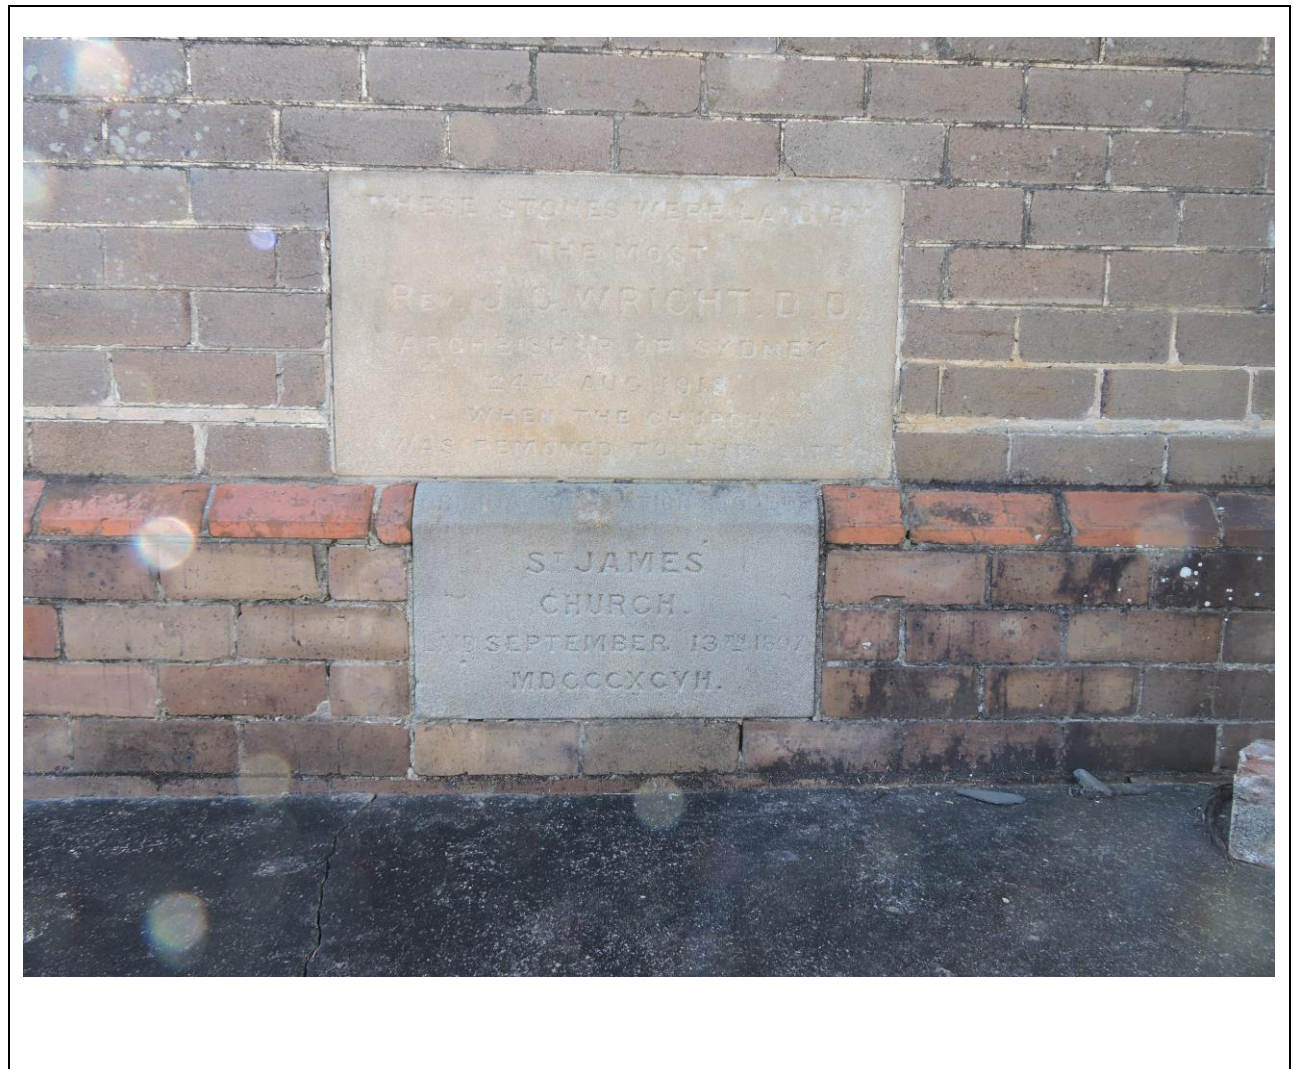
<b>Image caption</b>	Foundation stones, next to front entrance.				
<b>Image year</b>	2017	<b>Image by</b>	Heritage 21	<b>Image copyright holder</b>	Heritage 21

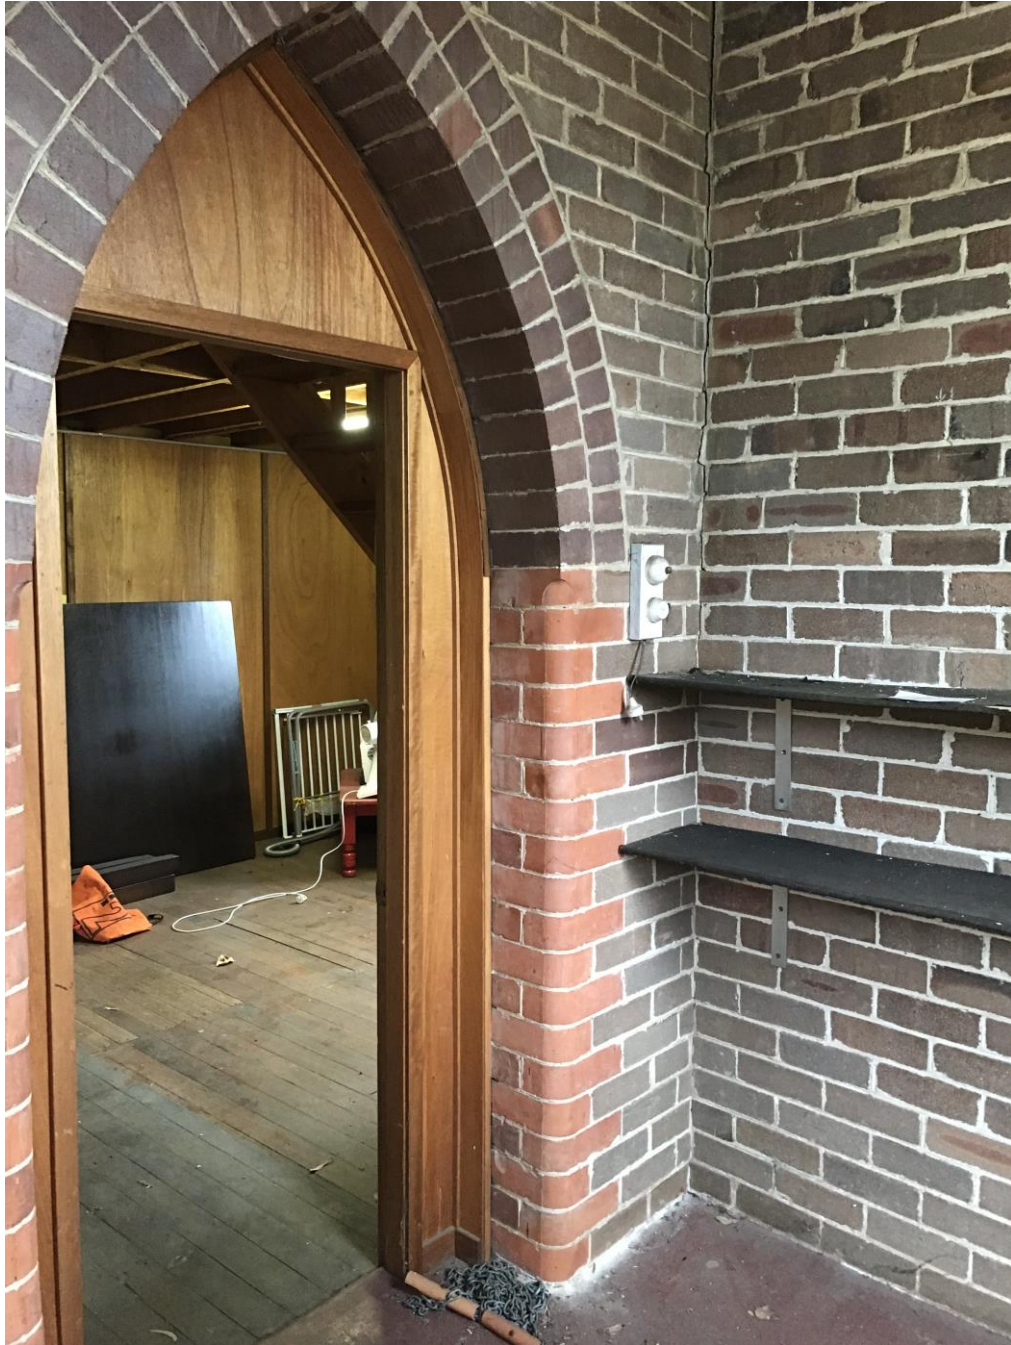
<b>Image caption</b>	Entrance to Church inside front gable.				
<b>Image year</b>	2018	<b>Image by</b>	Heritage 21	<b>Image copyright holder</b>	Heritage 21

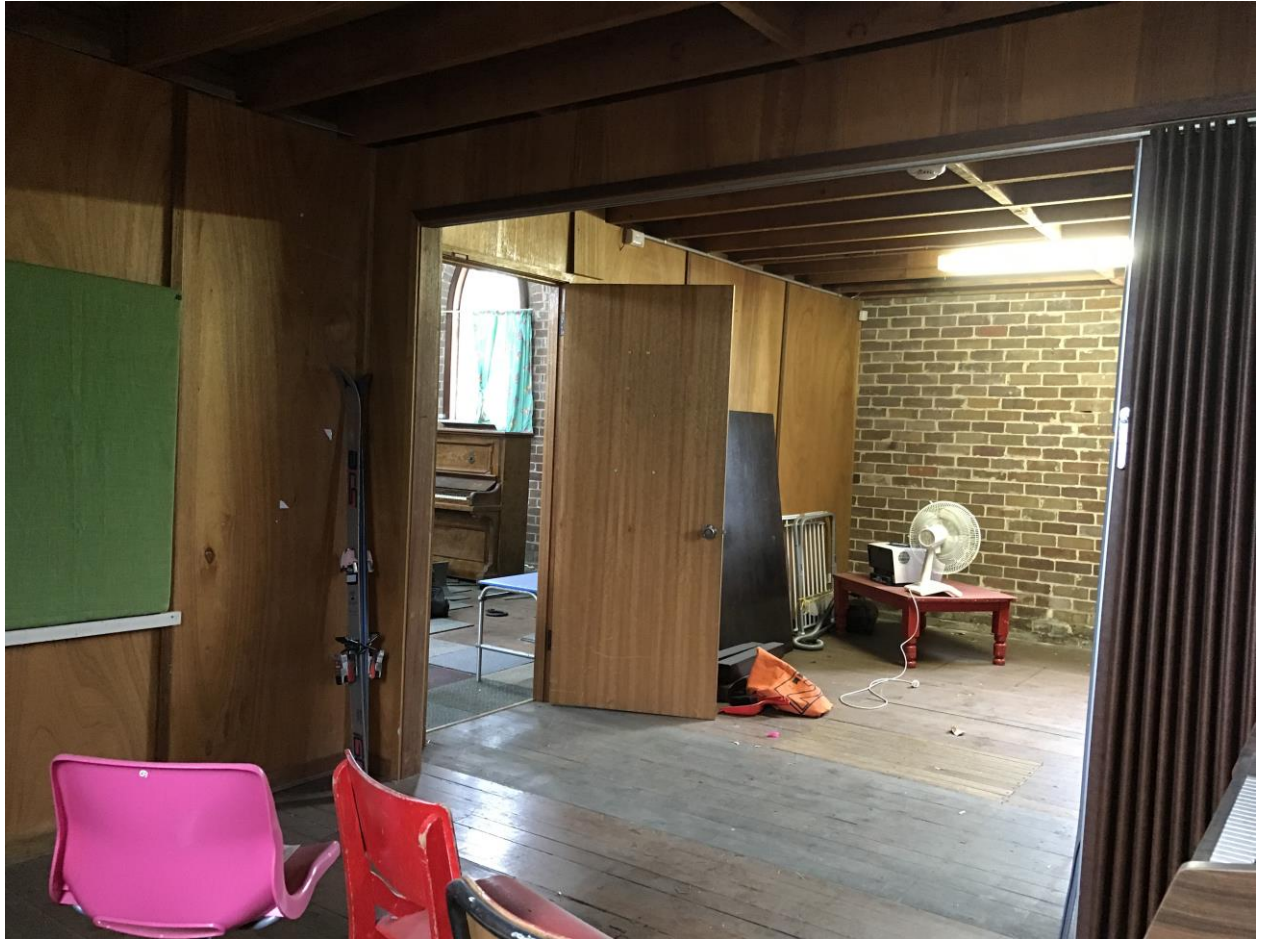
<b>Image caption</b>	Narthex.				
<b>Image year</b>	2018	<b>Image by</b>	Heritage 21	<b>Image copyright holder</b>	Heritage 21

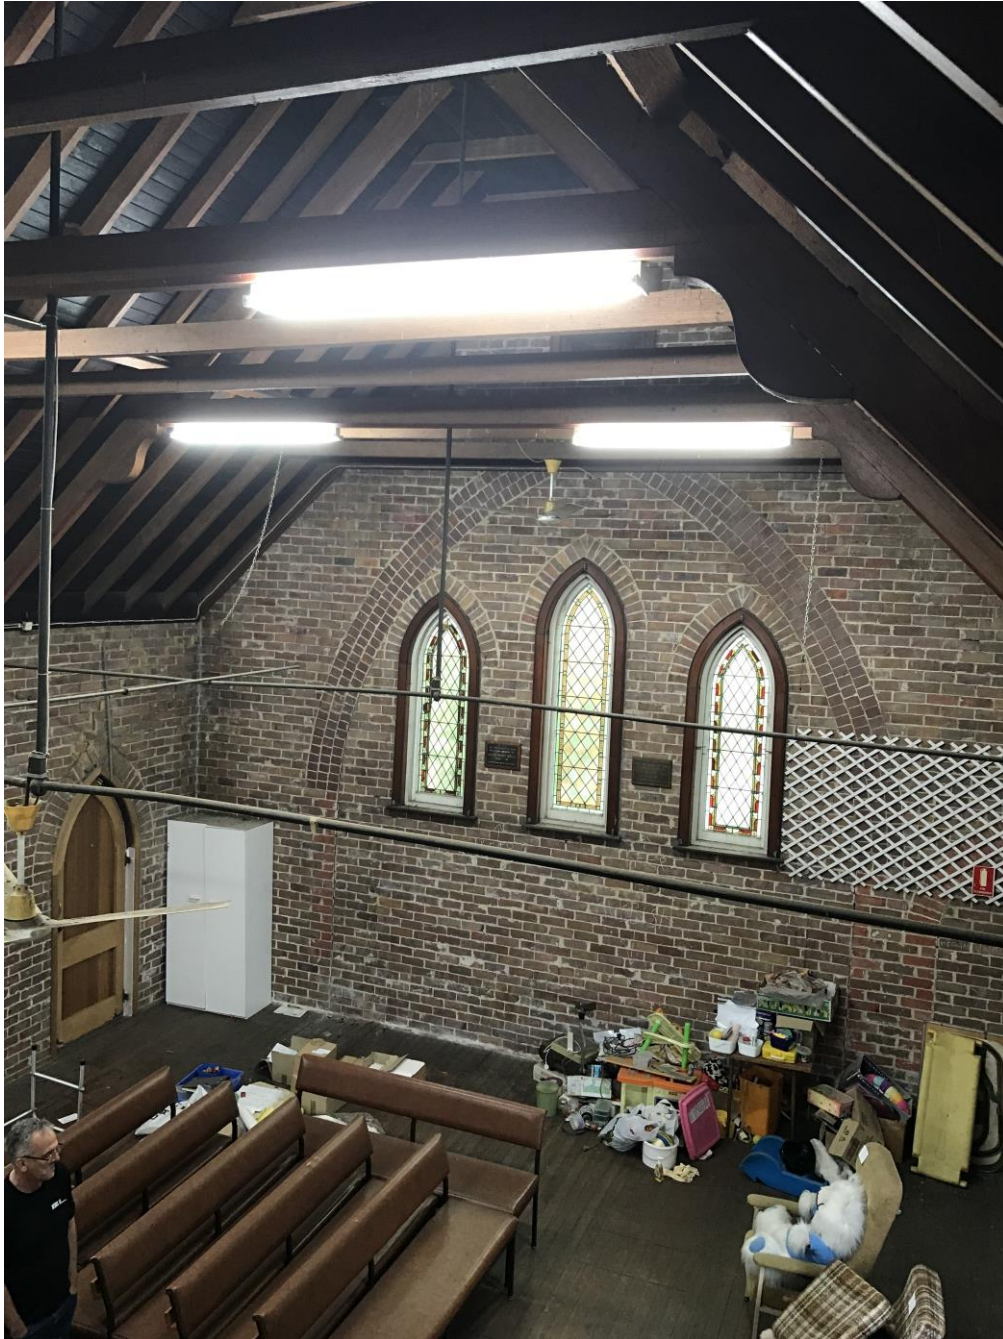
<b>Image caption</b>	Nave, as viewed from upper level.				
<b>Image year</b>	2018	<b>Image by</b>	Heritage 21	<b>Image copyright holder</b>	Heritage 21

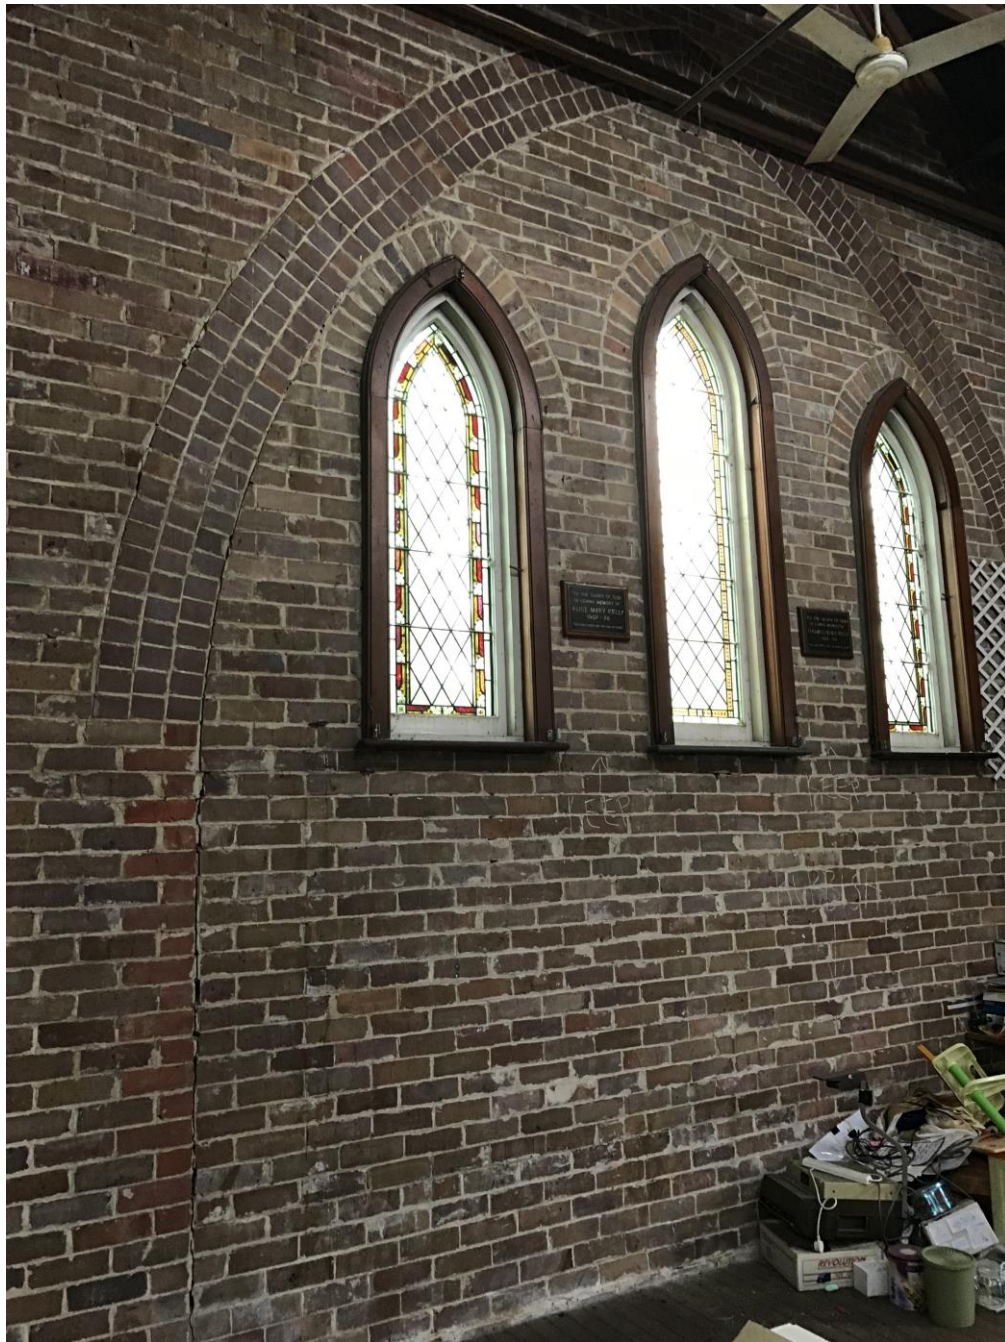
<b>Image caption</b>	Stained glass windows at rear (eastern) elevation.				
<b>Image year</b>	2018	<b>Image by</b>	Heritage 21	<b>Image copyright holder</b>	Heritage 21

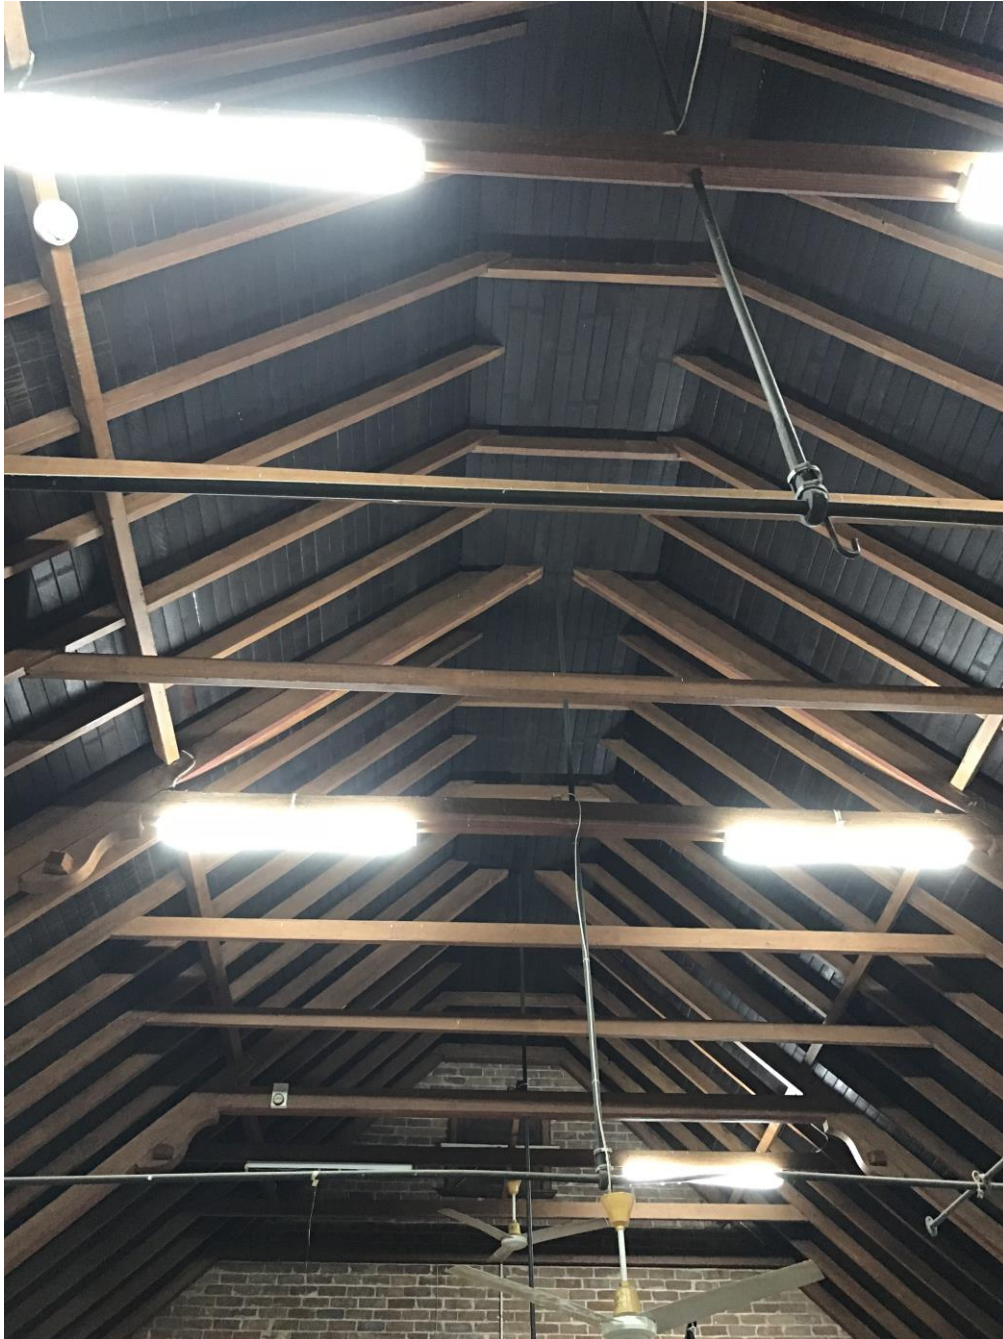
<b>Image caption</b>	Roofing, internal view.				
<b>Image year</b>	2018	<b>Image by</b>	Heritage 21	<b>Image copyright holder</b>	Heritage 21

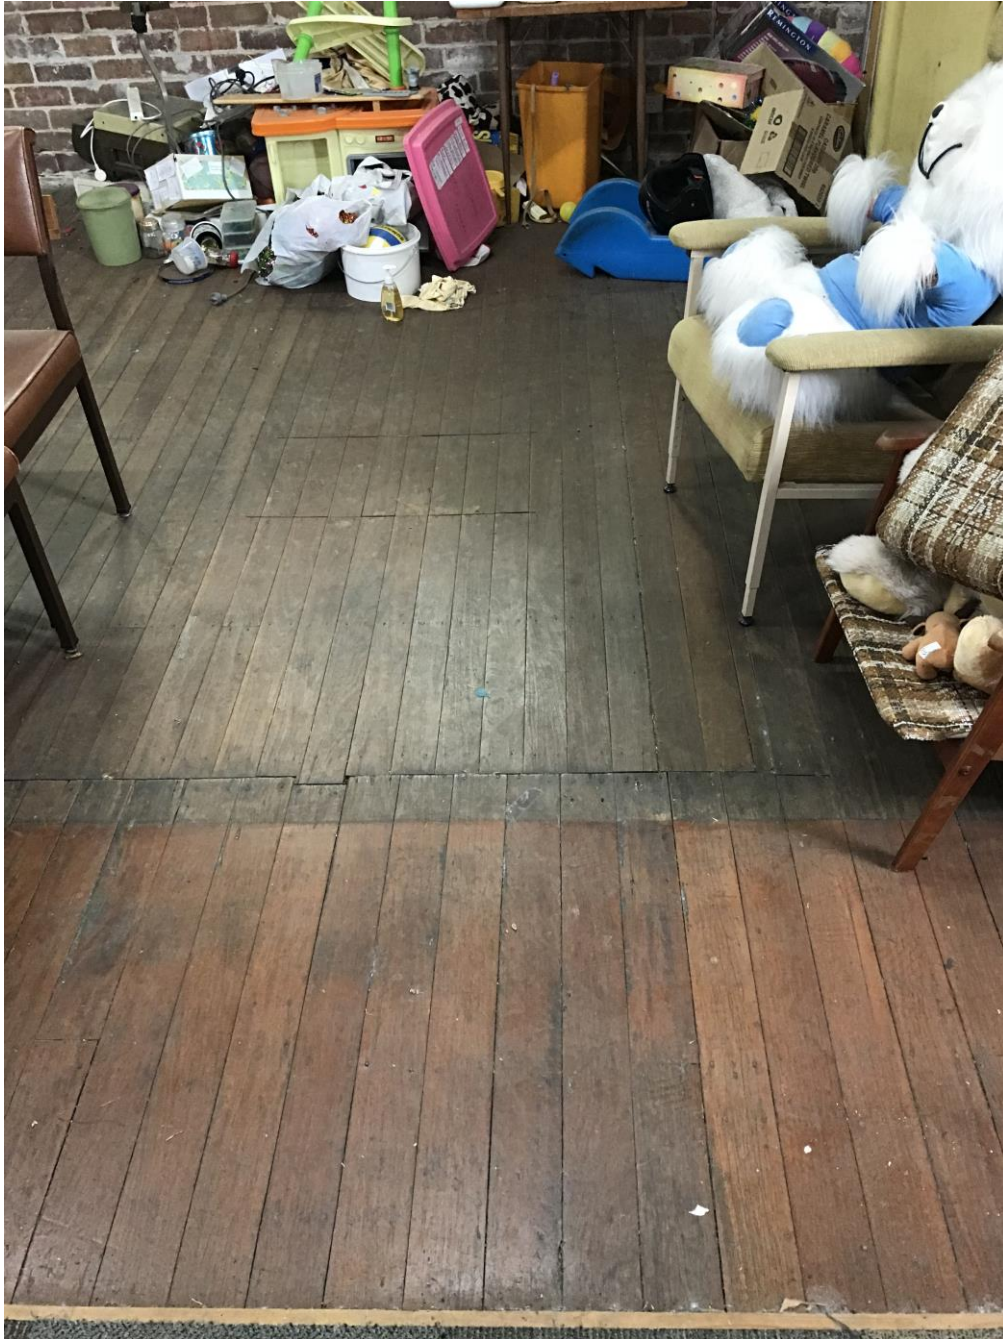
<b>Image caption</b>	Detail of floor.				
<b>Image year</b>	2018	<b>Image by</b>	Heritage 21	<b>Image copyright holder</b>	Heritage 21

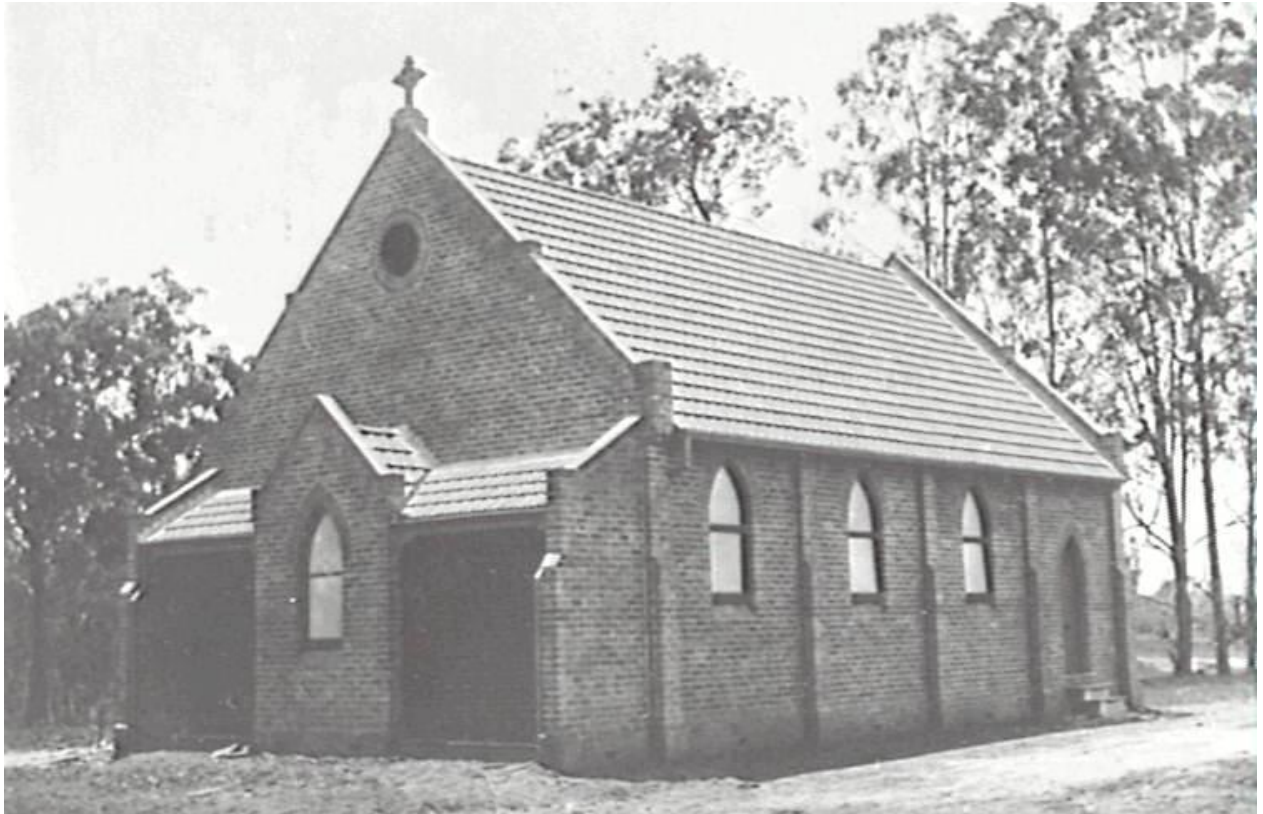
<b>Image caption</b>	Original St James Church, located on the intersection of Minto and Cumberland Roads.				
<b>Image year</b>	n.d.	<b>Image by</b>	Unknown	<b>Image copyright holder</b>	Campbelltown & Airds Historical Society

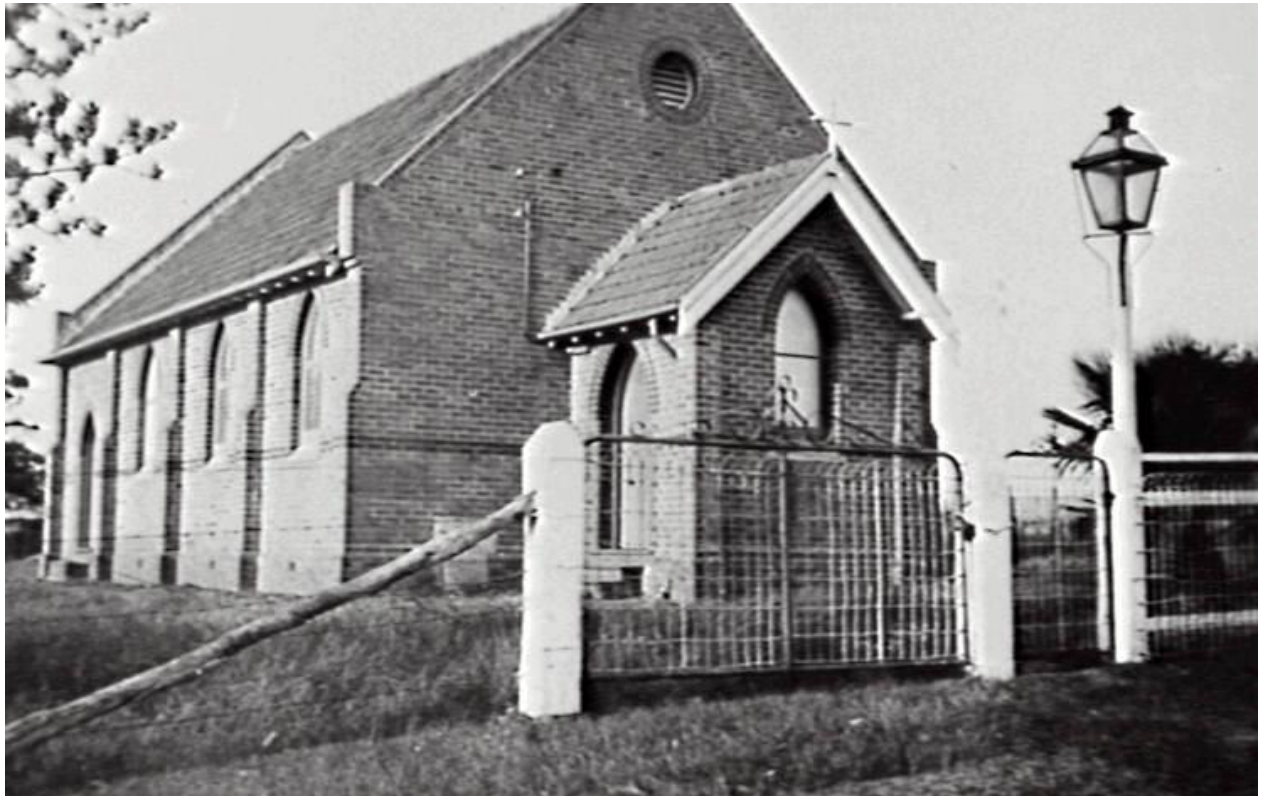
<b>Image caption</b>	St James Church in its current form and location.				
<b>Image year</b>	c.1937	<b>Image by</b>	Unknown	<b>Image copyright holder</b>	Campbelltown City Council (Follan Collection, Local Studies Collection)

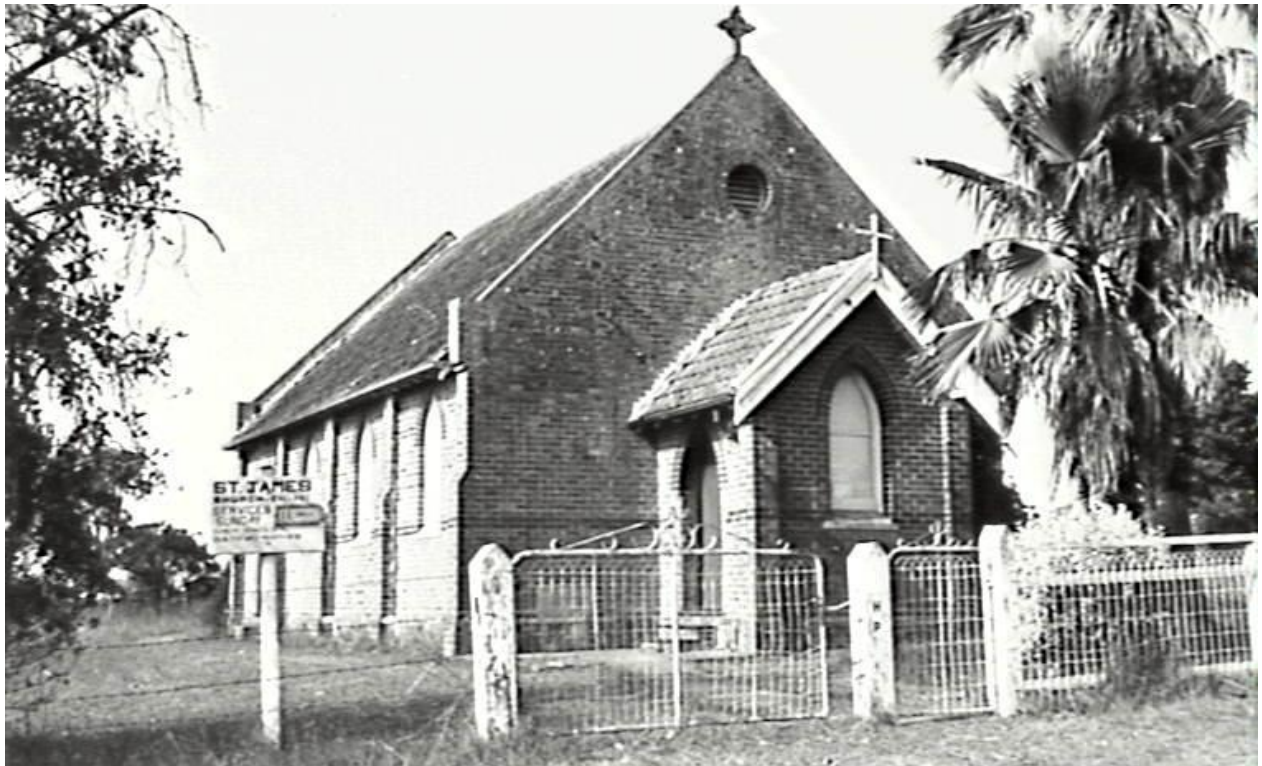
<b>Image caption</b>	Current St James Church, with palm trees at front.				
<b>Image year</b>	n.d.	<b>Image by</b>	Unknown	<b>Image copyright holder</b>	Campbelltown City Council (William Bayley Collection, Local Studies Collection)

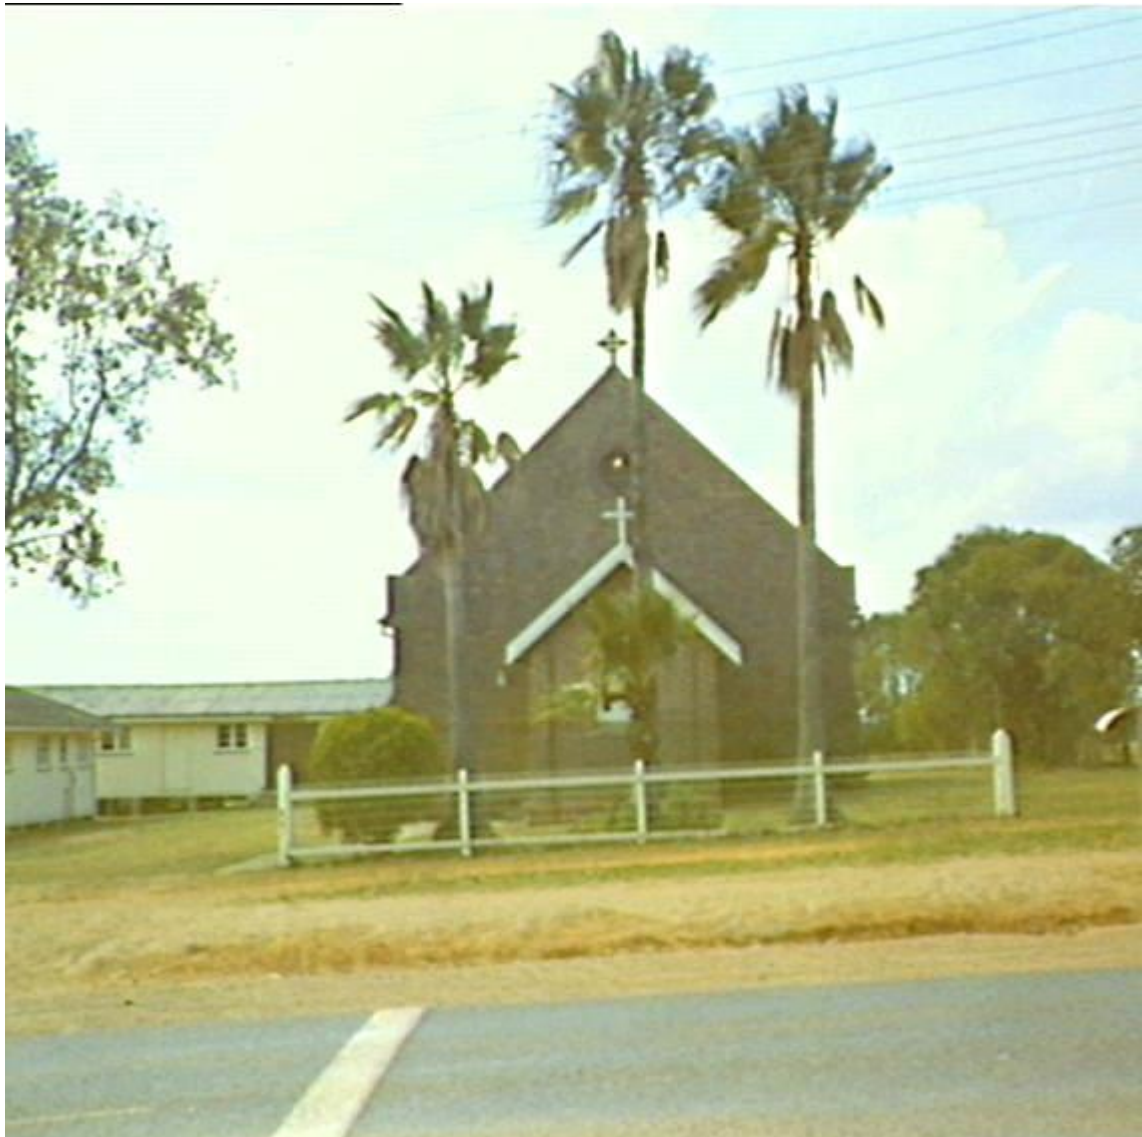
<b>Image caption</b>	Current St James Church, as viewed from Kent Street				
<b>Image year</b>	1979	<b>Image by</b>	Unknown	<b>Image copyright holder</b>	Campbelltown City Council (Local Studies Collection)
