Glenlee, outbuildings, garden & gatelodge

Lots 1, 2 & 3 DP713646, Glenlee Road, Menangle Park, NSW
SHR Listing No.00009

Conservation Management Plan

April 2023
REF: 1718: CMP
Issue 07

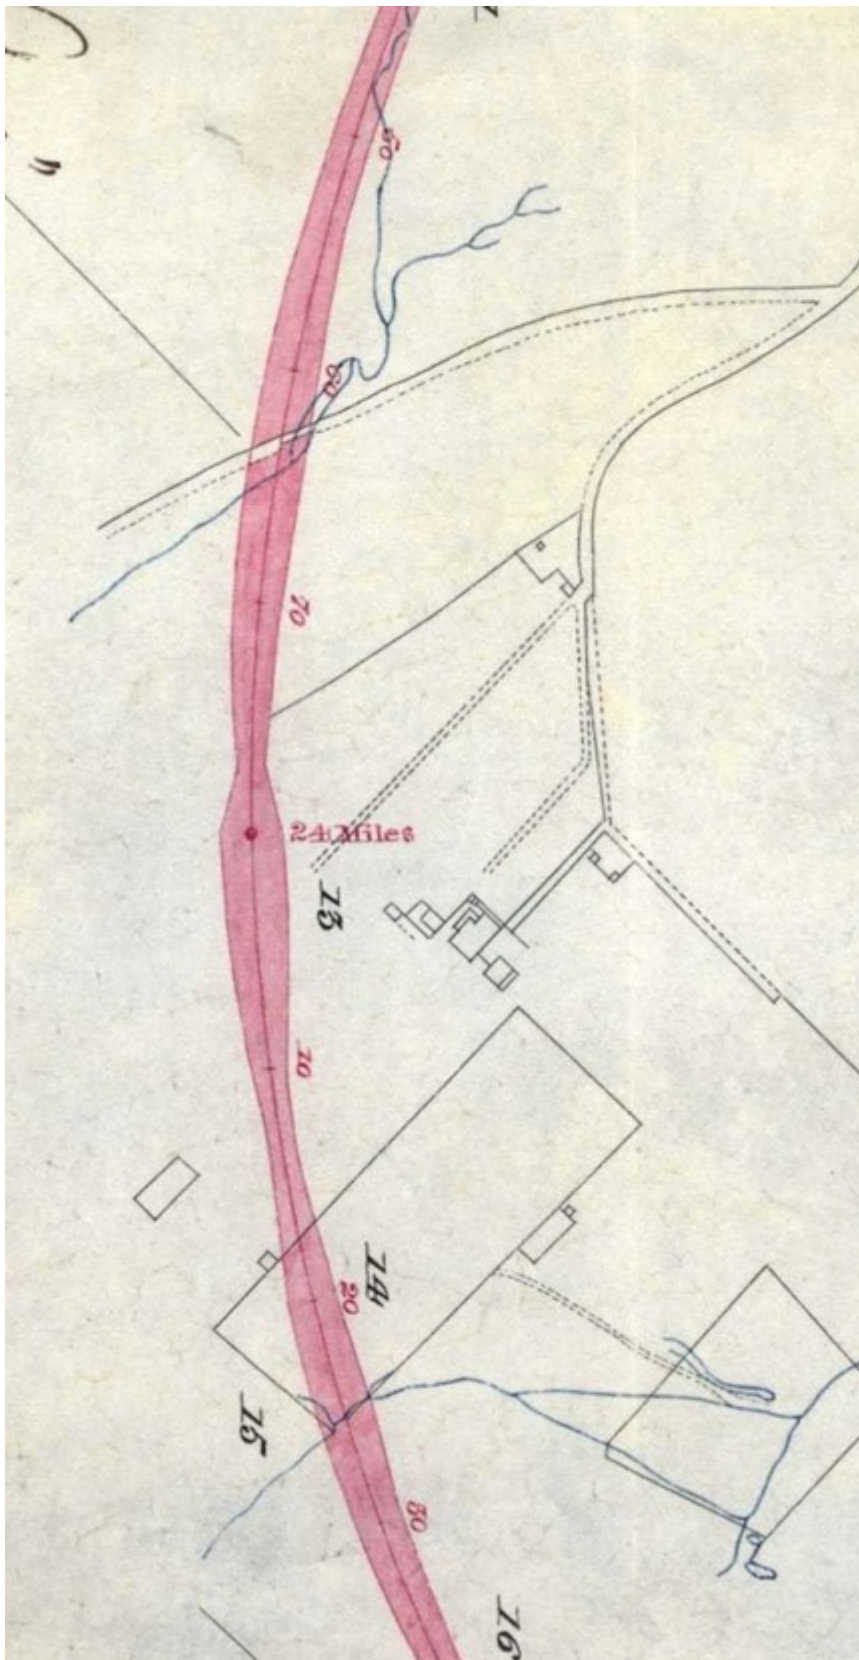
Figure 10: The deed of conveyance of land to the railway from Fitzpatrick included this plan showing the right of way for the railway plus detail of buildings at Glenlee. Source: OSD, No 475 Bk 80

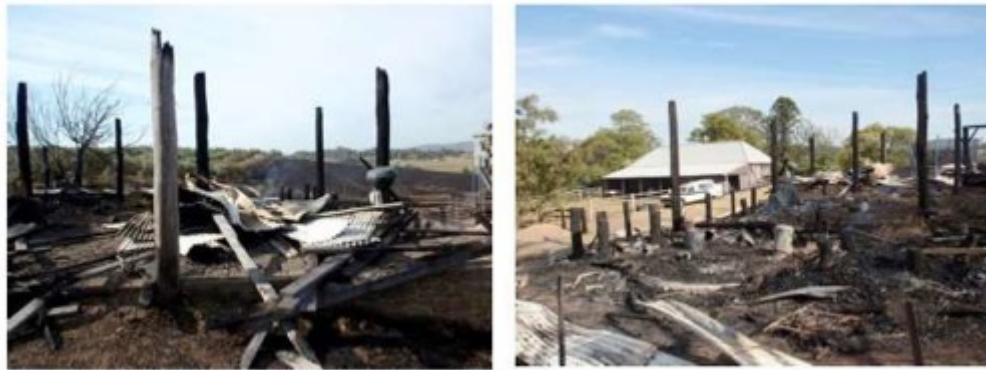
Figure 33: Fire Damaged Woolshed

Views of the site in January 2010. Source: DE Photos 2010.

Little detail is known about the so-called woolshed, which was destroyed by fire in 2009. Its date of construction has not been established and, although the owners have known it as the woolshed because of physical evidence of that use, its original function is not known. It was an undistinguished rural shed constructed with round hardwood pole framing and clad with corrugated galvanised iron or steel. Sheep grazing does not appear to have been a significant activity at Glenlee. Even so, evidence of the use of the building as a shearing shed was clear. The woolshed was in poor condition when Glenlee was acquired by the Wilsons. The photographs below show the poor condition of the building at the time the property transferred back into private ownership. Refer to Figures 33 & 34

The original building had a core structure (the original woolshed) 11850mm x 6550mm built with Eight round poles carrying a hardwood framed gable roof. The original roof and wall cladding (on three sides only) was corrugated galvanized iron. This wall cladding had been replaced with horizontal lapped boards. On the north side of the core structure a skillion roofed lean-to addition had been built at some time in the 1980s over a paved floor of re cycled sandstone flagstones 13175mm x 4600mm. This floor was not greatly affected by the fire. On the south side a 3650mm wide lean-to skillion roofed structure was added in the 1980s. It was fitted out for accommodation. Both lean-tos were finished in matching materials. It is proposed to build a replica of the fire damaged building on the site of the original, Incorporating the surviving sandstone paved floor. The only conscious departure from the original design will be the treatment of the interior and the fit-out of the southern lean-to in particular. Accommodation of a suitable modern standard will be included in the design.

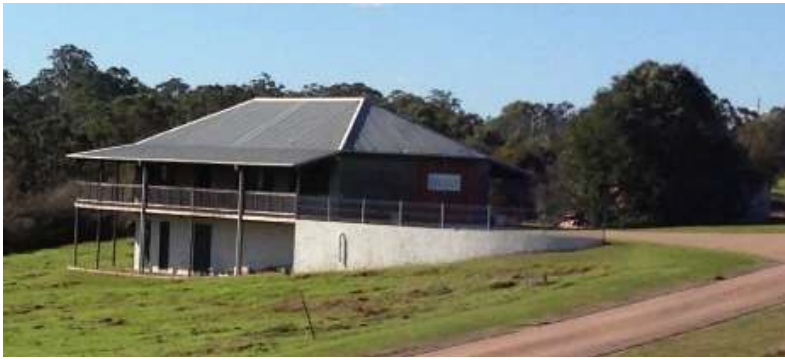
Figure 35: Former Olive Oil Processing Pavilion & former gatelodge (hidden by overgrown plant).

The processing pavilion was constructed in 2002 adjacent to the former gatelodge – refer to Figure 35 - 37.

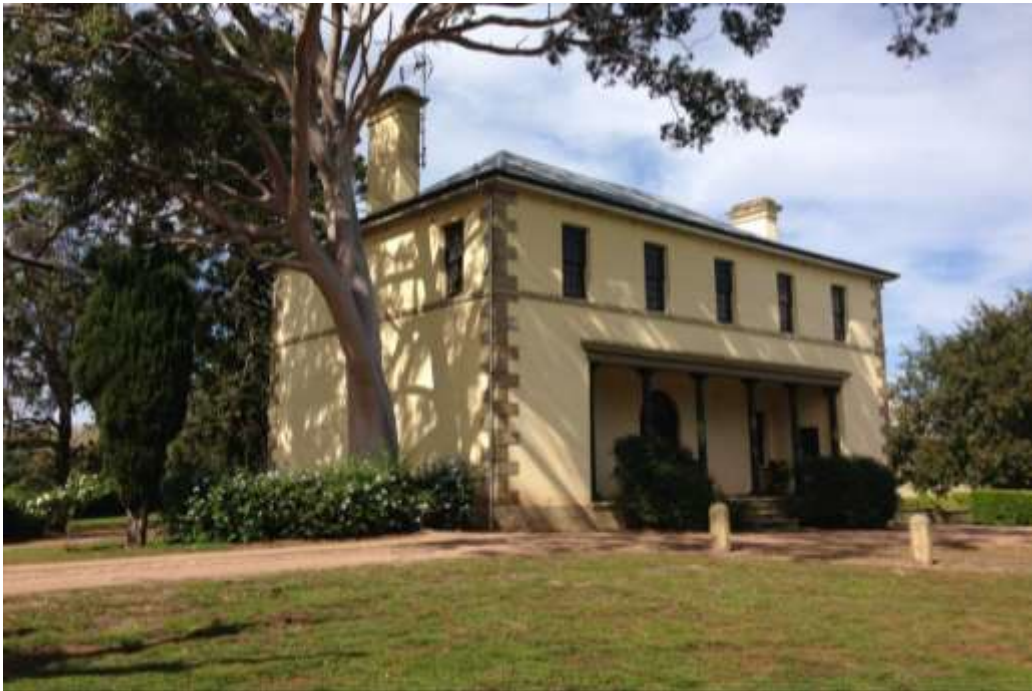
Figure 48: Front (west) elevation of the homestead showing the recessed entry portico colonnade.

The original columns to the recessed entry portico on the western elevation were replaced in 1883 with cast iron columns, and no evidence of the original appearance of the arcade/ colonnade survives. The rear verandah is also recessed and features timber columns, beams, decorative fringe and timber lattice balustrading.

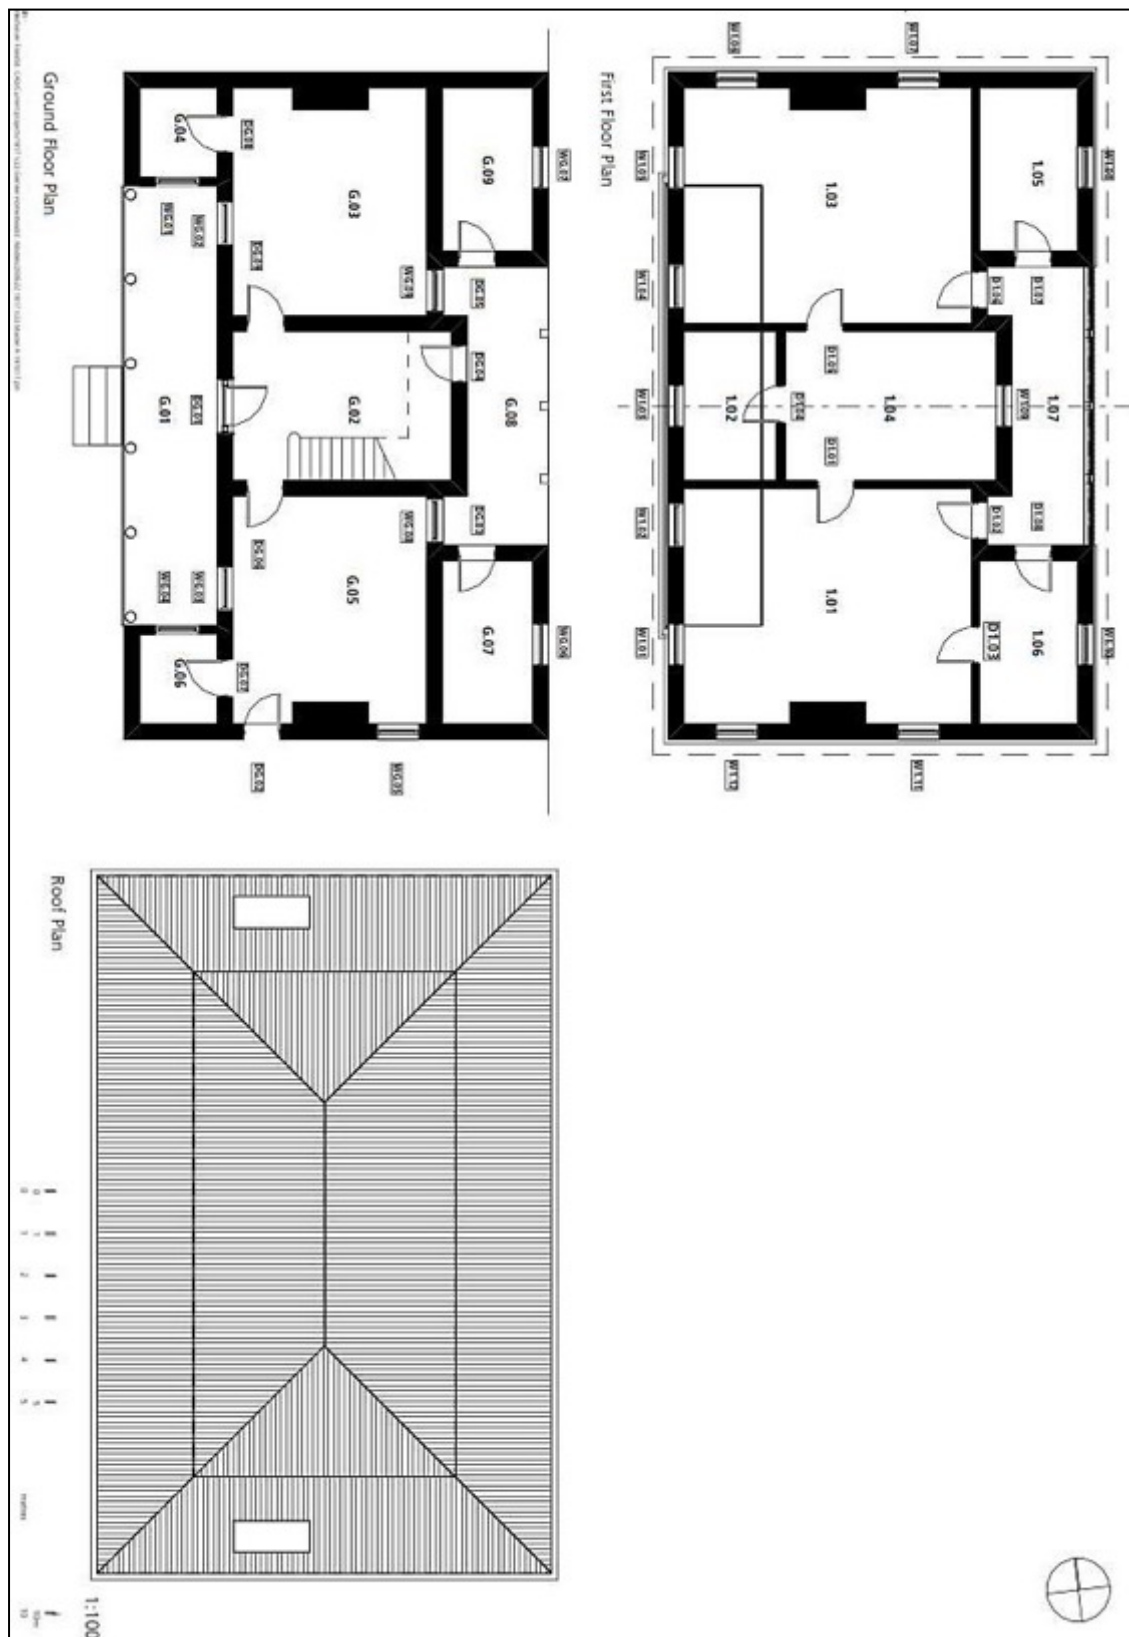
Figure 55: Glenlee Homestead – Plans: Ground Floor; 1st Floor & Roof
 Source: Architectural Projects P.L., Dwg No. 1817 MD.129, date 01.07.20

The planning of Glenlee is formal and symmetrical. A substantial central entry hall accesses the one room to either side and box rooms at the corners. The layout is repeated at the upper level, resulting in two oversized bedrooms. The entry hall features a fine cantilevered stone staircase, stone flagging, and marbled painted wall finishes. Interior finishes to the rooms include set plaster wall finishes, and lath and plaster ceilings with decorative cornices are in good condition. The joinery is clear finished and comprises architraves, chair rails and skirting. The polished timber tongue and groove floors are in good condition. The kitchen and bathrooms have contemporary fitouts.

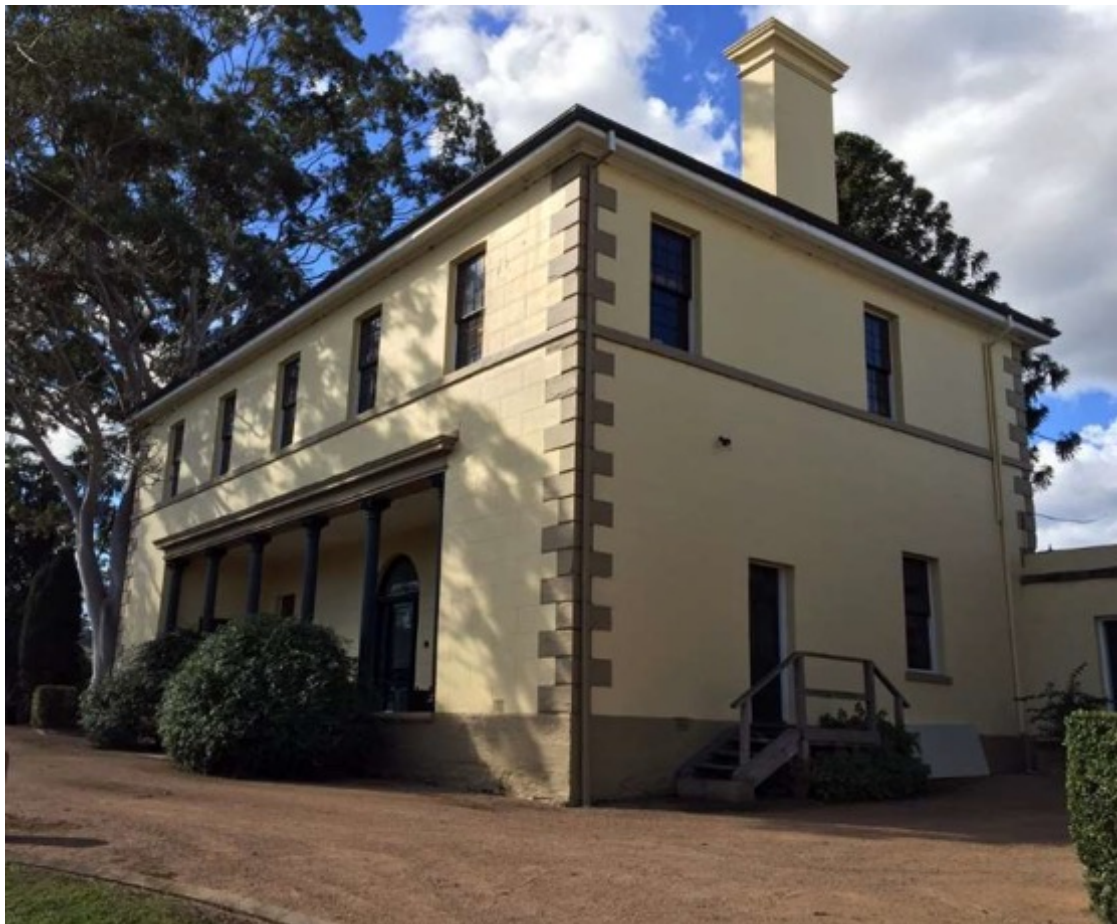
Figure 49: Front (west) and side (south) elevations of Glenlee homestead.

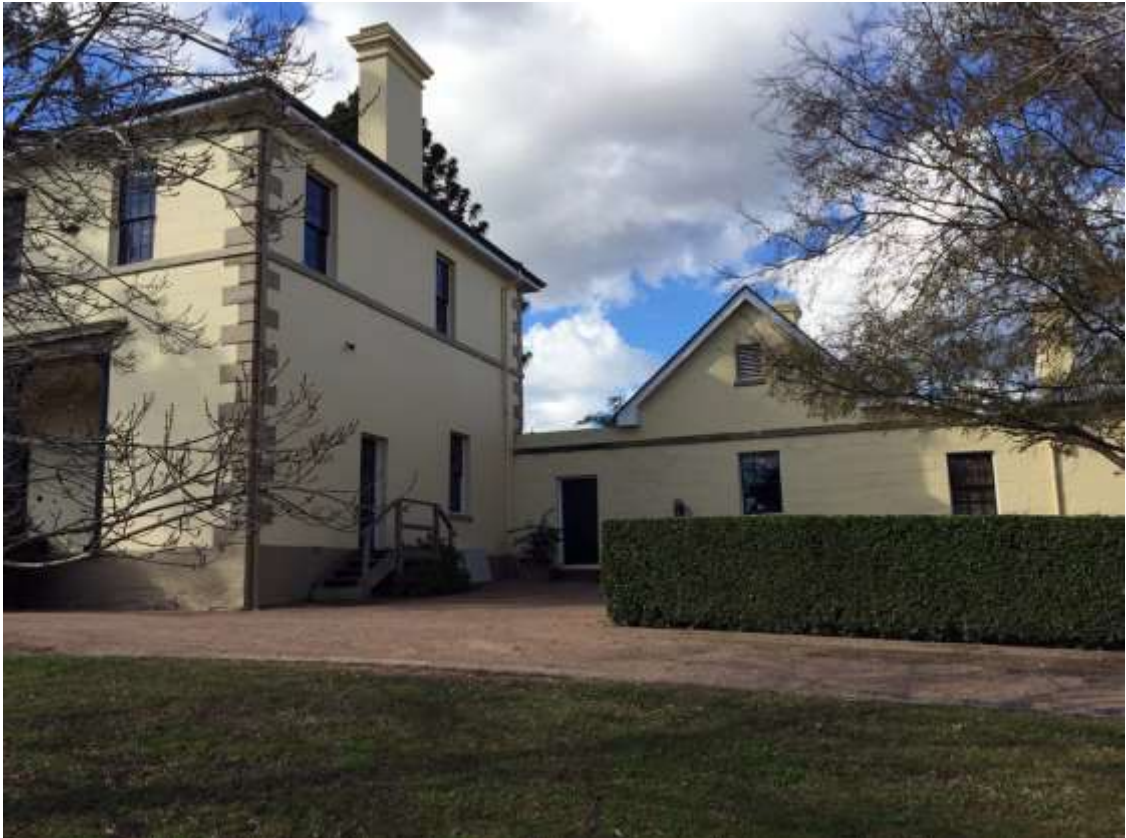
Figure 50: Servant's wing attached to the south elevation of the homestead.

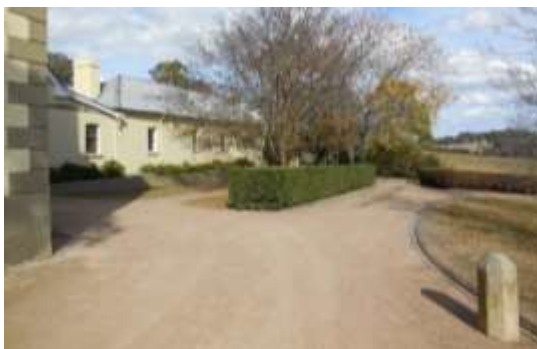
Figure 57: Former servants quarter's

The former Servants Quarters have been restored circa 1984 and adapted for residential uses, and the bathrooms and laundry fitouts date from this time. While the condition of the former Servants Quarters is generally good, there is significant subsidence and cracking evident to the scullery /kitchen at the junction of the component buildings and along the western edge.

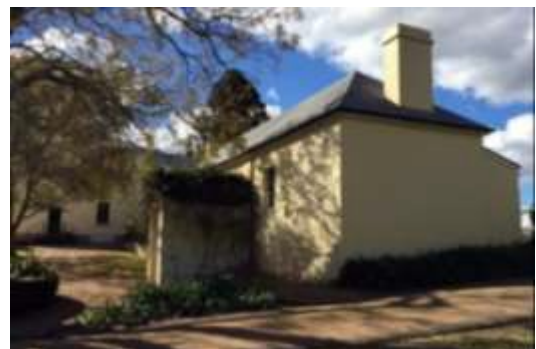
Figure 58: West elevation of the former servant's quarters.

The subject site has a substantial single storey detached former servants quarters – refer to Site Plan, Figure 54 and Figures 57 - 62. These quarters are of the same date and construction as the house, rendered masonry buildings with multi-paned timber framed sash windows, corrugated metal hipped roofs and rendered masonry chimneys.

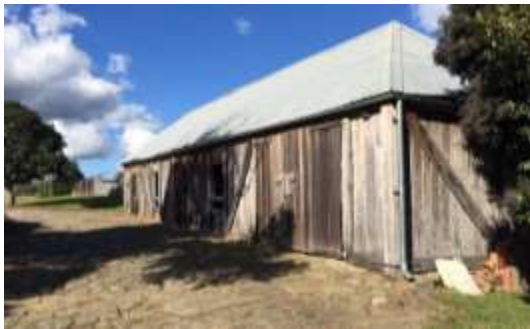
Figure 63: Former milking shed

The former Milking Shed was restored in c.1984, with the exposure of the early cobblestone surface. The major issues evident in this building relate to water penetration, termite damage to specific slabs, and rot of timbers at ground level.

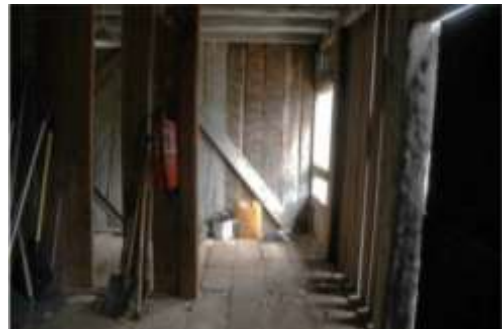
Figure 64: Interior of former milking shed.
Photo: Casey & Lowe

The former Milking Shed is a timber slab building, with a gabled roof that has been extended to the south with a skillion roof to create a barn which is partially open to the yards – refer to plan Figure 54 and images, Figures 63 - 68. The shed originally had a timber shingle roof and has been reclad in corrugated metal sheet. The timber shingles are evident beneath the corrugated metal sheet. The Former Milking Shed features vertical timber slab construction, with split and adzed timber slabs set into grooved top and bottom plates between timber posts. The structure is braced externally and internally with timber. Openings in the slab walls were limited to rudimentary braced timber slab doors, and stall doors. The former milking shed has a stone flagged floor, and earth floor to the lower barn section. With the original wall construction of timber posts, rafters, beams, bottom plate, top plate and infill timber slabs there were no internal wall linings. The ceiling is lined with timber boards in the shed, and unlined to the barn. With the original wall construction of timber posts, rafters, beams, bottom plate, top plate and infill timber slabs there were no internal wall linings. The ceiling is lined with timber boards in the shed, and unlined to the barn.

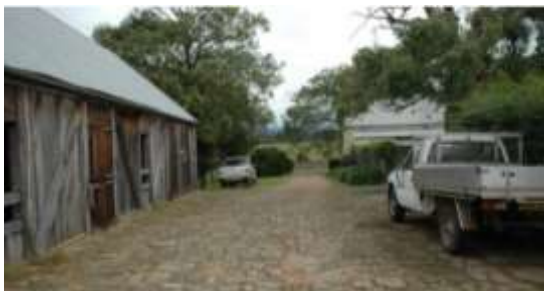
Figure 65: Sandstone flagging in front of former milking shed, looking west to the former servant's quarters. Photo: Casey & Lowe

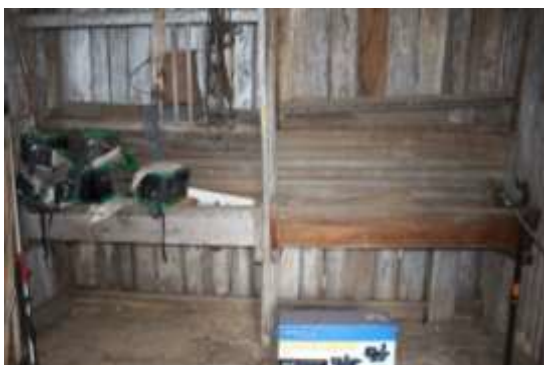
Figure 67: Fixed and moveable heritage technology in former milking shed

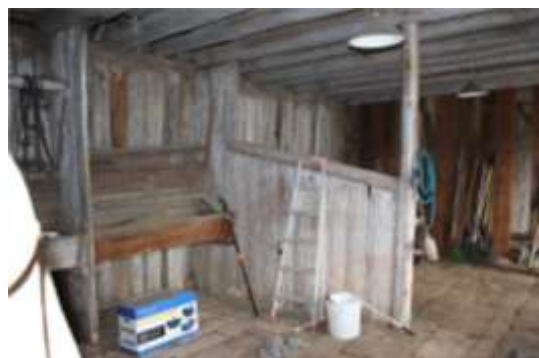
Figure 68: Fixed and moveable heritage technology in former milking shed

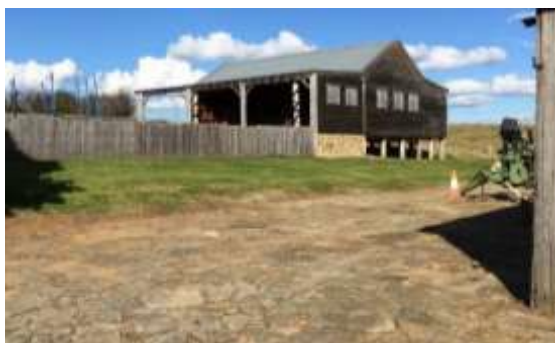
Figure 70: Reinstated interpretive woolshed (built 2011), timber and stone looking east. This building replaced an earlier building destroyed by fire c2009.

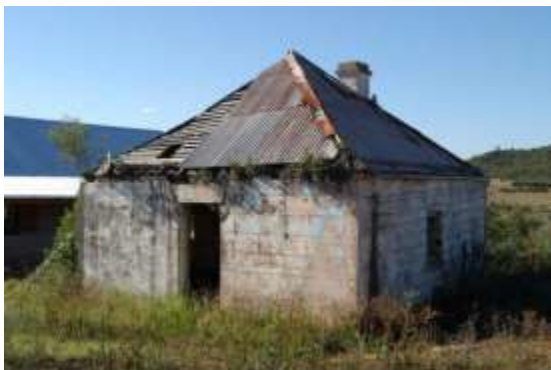
Figure 72: Former gatelodge prior to collapse and 1956 aerial image indicating extended building footprint, turning circle and perimeter fencing²¹².

Rendered masonry construction with a hipped corrugated iron roof (originally shingled). The building is now a ruin in a state of partial collapse and disrepair. The former gatelodge previously had a turning circle as indicated on the 1858 site survey plan and aerial images from 1956 – 1990 – refer to Figures 57 and 72 – 80.

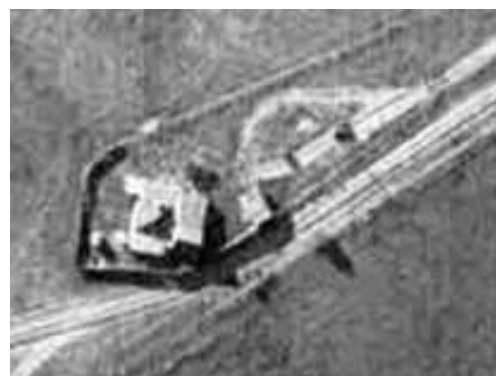
Figure 73: 1956 aerial image of Former gatelodge indicating extended building footprint, turning circle and perimeter fencing

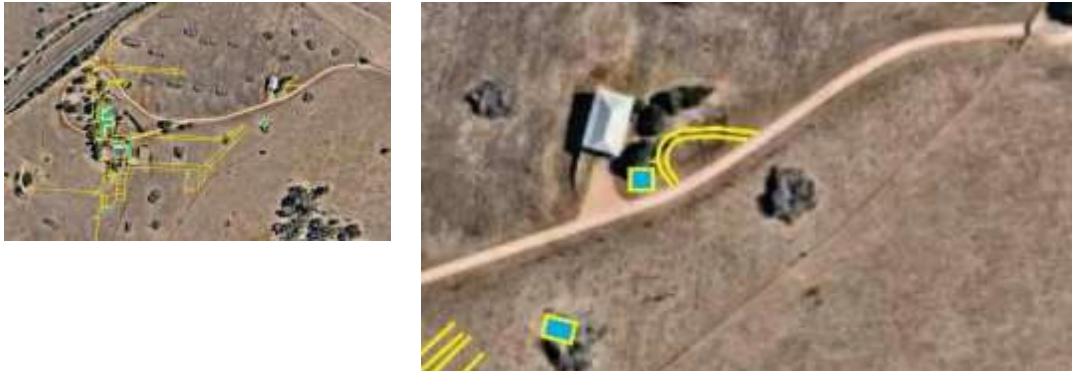
Figure 74: Detail of former turning circle and gatelodge indicated on 1858 site survey overlay
(Source: Casey & Lowe, 2017)

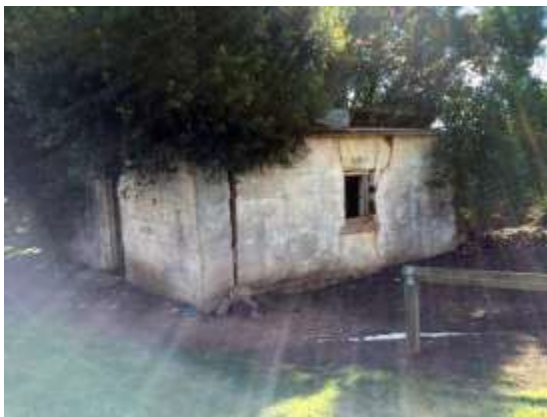
Figure 75: Former gatelodge, now in disrepair.

This study in brief concludes that Glenlee homestead and outbuildings are generally in good condition. The gatelodge is in poor condition.

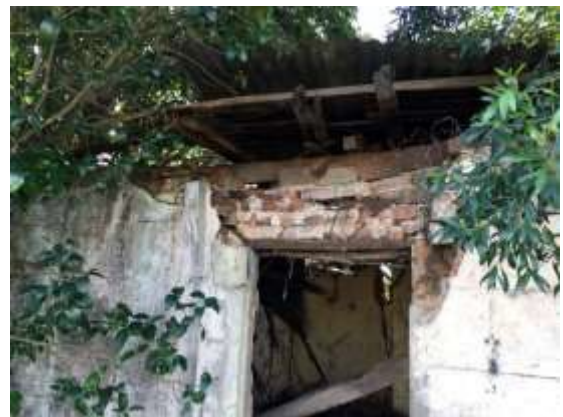
Figure 76: Former gatelodge showing brick & render.

The former gatelodge which dates from 1858 survives in a derelict state. Vegetation surrounding the building including Privet and Olive are destabilising the structure. The former gatelodge was originally constructed of face brick which has been stuccoed most likely at the same time as the house c 1890. The walls have major cracking and are currently propped. The roof of the former gatelodge has collapsed, however remnants of timber framing and corrugated roof sheeting remain. The extension evident in the 1956 aerial has been removed. Openings in the former gatelodge walls were limited to an entry door, two original windows and a later opening. Window framing is not original, and no door or windows have survived, although remnant door framing is evident. While the condition of the single room interior is ruinous, plaster wall finishes, a brick fireplace and the remains of a tongue and groove timber floor survive.

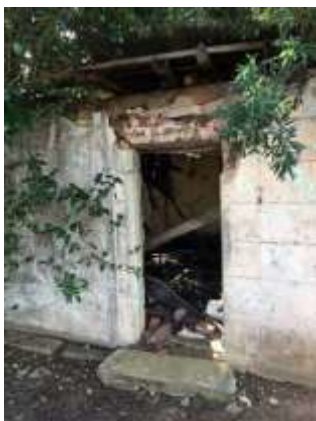
Figure 77: Former gatelodge entry.

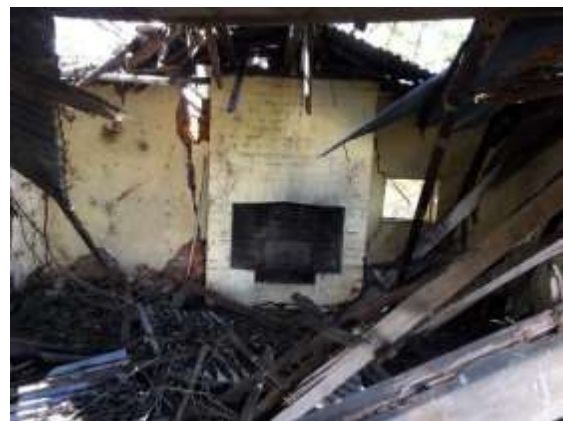
Figure 78: Former gatelodge interior. Roof has collapsed and structure unsound.

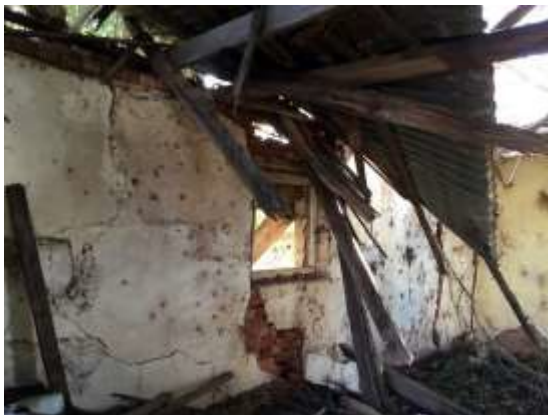
Figure 79: Former gatelodge interior.

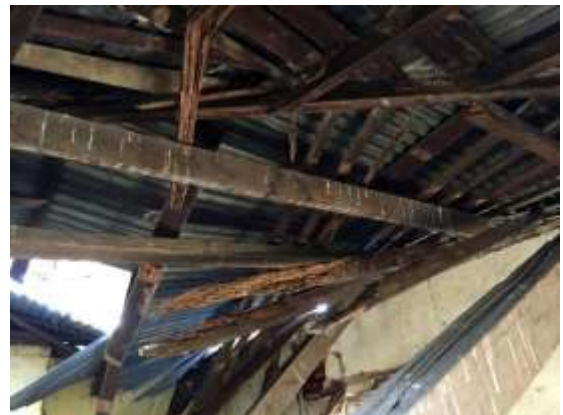
Figure 80a: Former gatelodge roof structure.

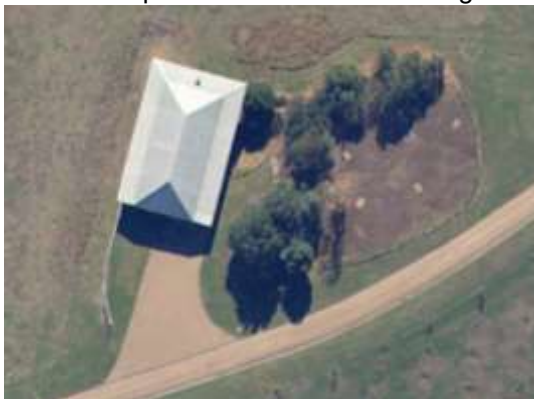
Figure 81: Aerial image of Former Olive Oil
Processing Pavilion Source: SIX Maps

This building was constructed in the late 1990s to process olive oil and is prominently located adjacent to the former gatelodge, overlooking the former olive plantation (removed in 2014). It is a large one and two storey hipped roof building with a wrap around verandah on three sides. The building has a masonry base, and timber clad upper level. The roof is clad in galvanised corrugated sheet. Refer to Figures 81 – 82.

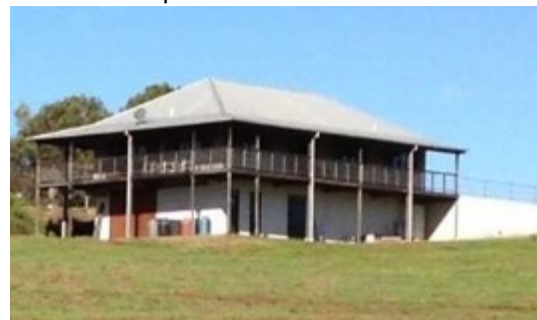
Figure 82a: Former Olive Oil Processing
Pavilion

The proximity of the large building to the c 1830s gatelodge is tempered by the vegetation surrounding the ruin. This vegetation need to be removed. The building has little heritage value. The simple rural form of the building lends it to future adaptation.

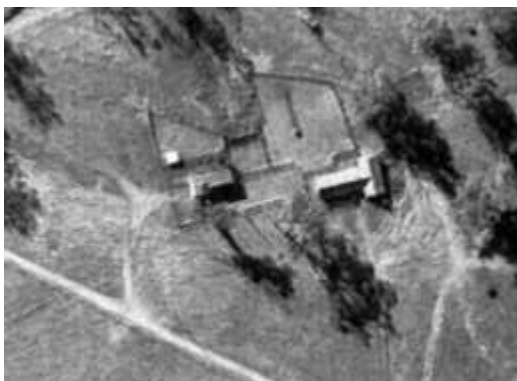
Figure 83: 1961 aerial image of Former milking sheds and fencing

Remnant of Former Milking Sheds – Figures 83 - 86: This building remnant is located to the north of the subject site outside the property boundary and is the only remaining evidence. The structural integrity of remnant structure appears to be poor and would appear to require total reconstruction.

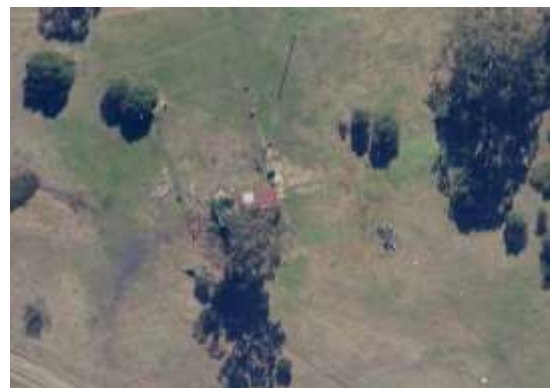
Figure 84: 2020 Former milking shed ruins

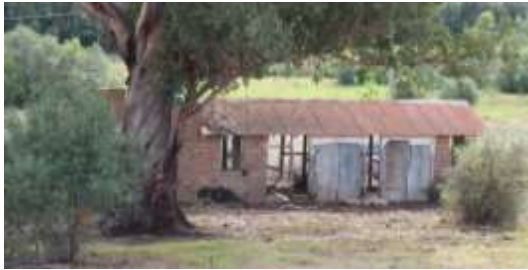
Figure 85: 2018 – Former milking shed remnants

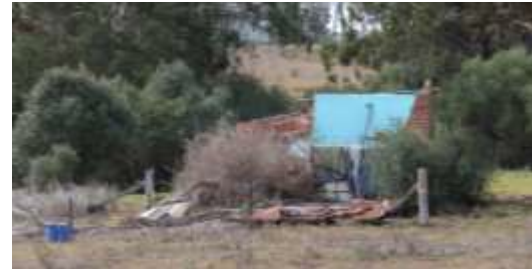
Figure 86: 2018 – Former milking shed remnants

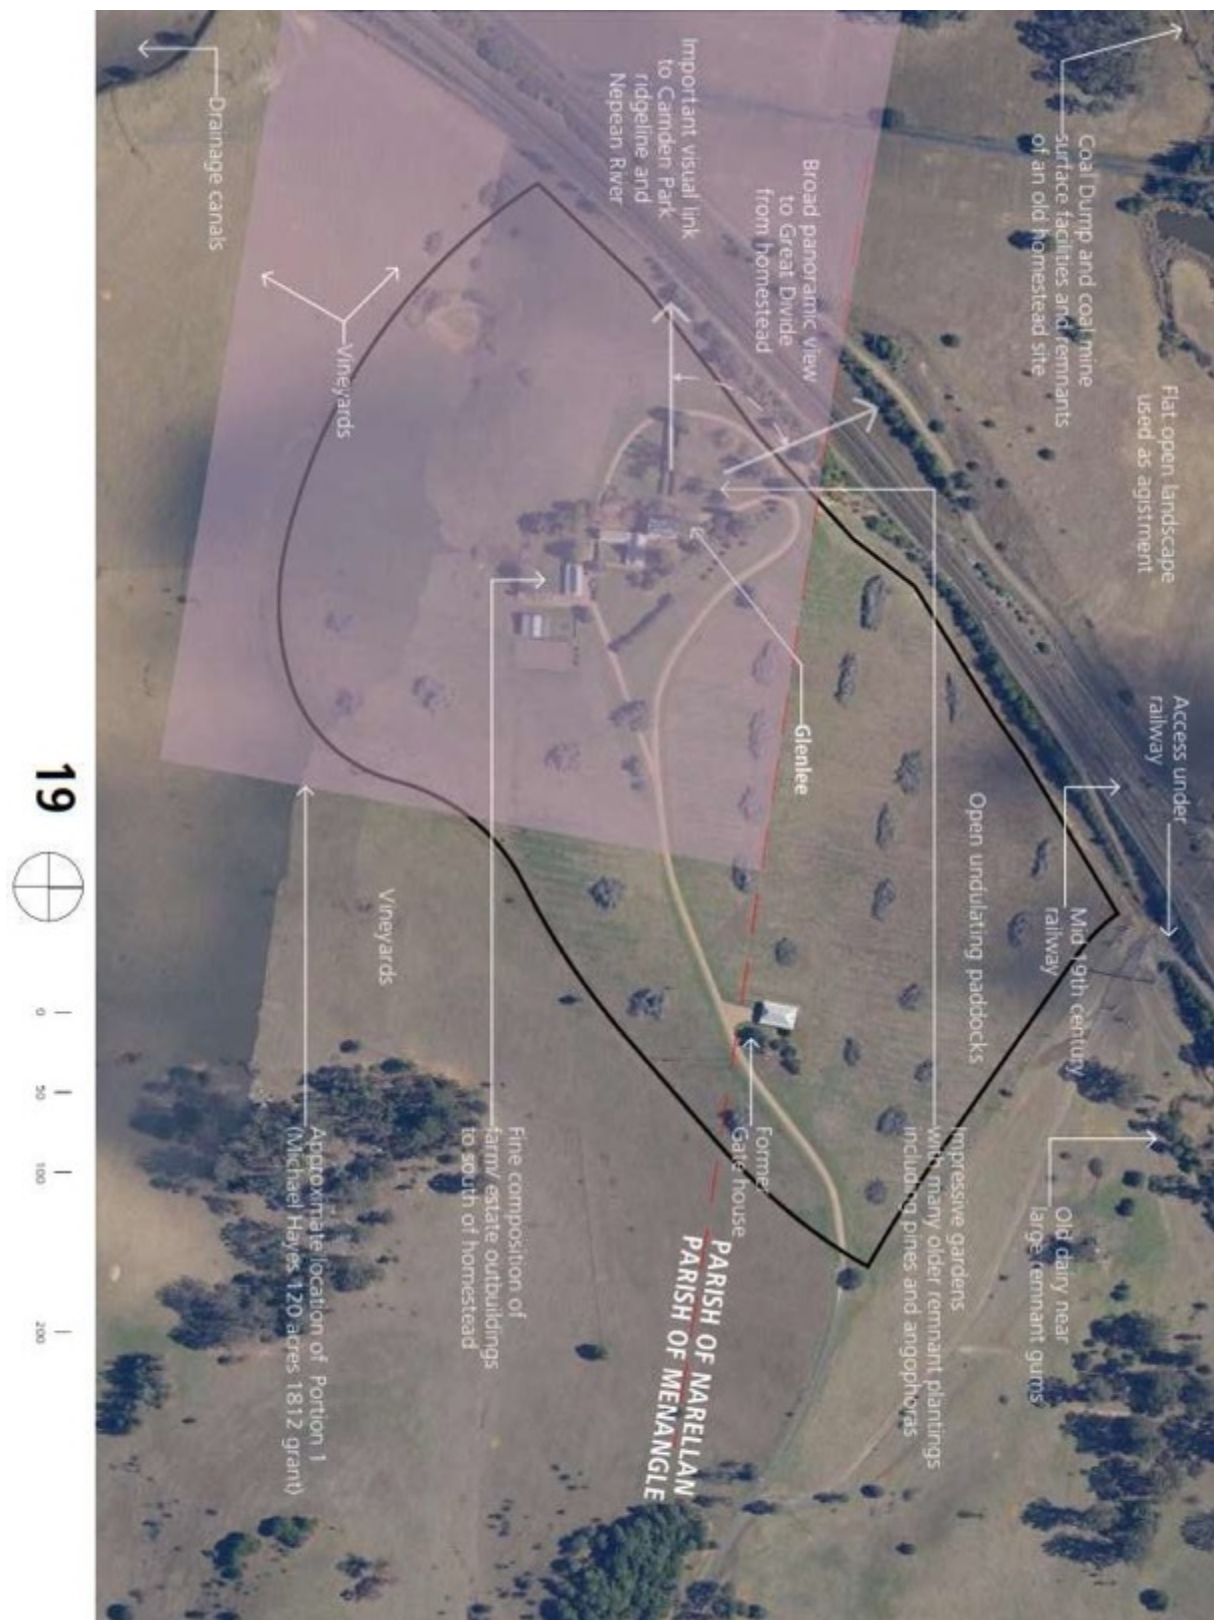
Figure 89: Current Glenlee site plan, indicating features identified by Morris and Britten, 2000
 Source: Architectural Projects P. L.

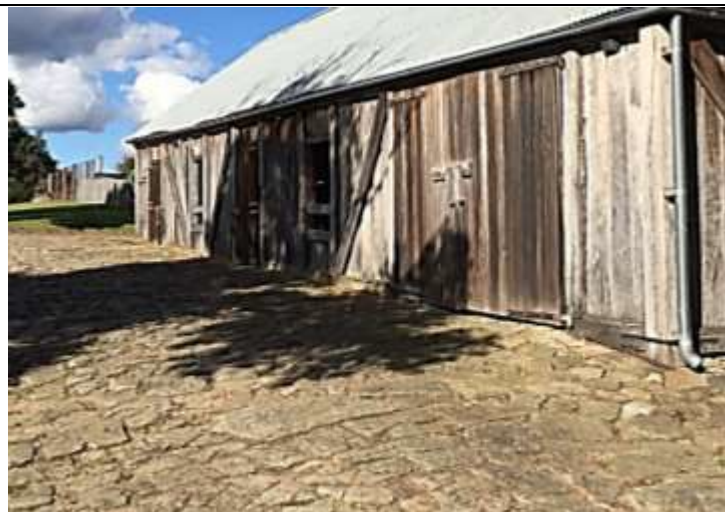
Figure 8.1

8. Cobblestone zone -
adjacent to former
milking shed & pens
and
extending alongside
former servants
quarters fence

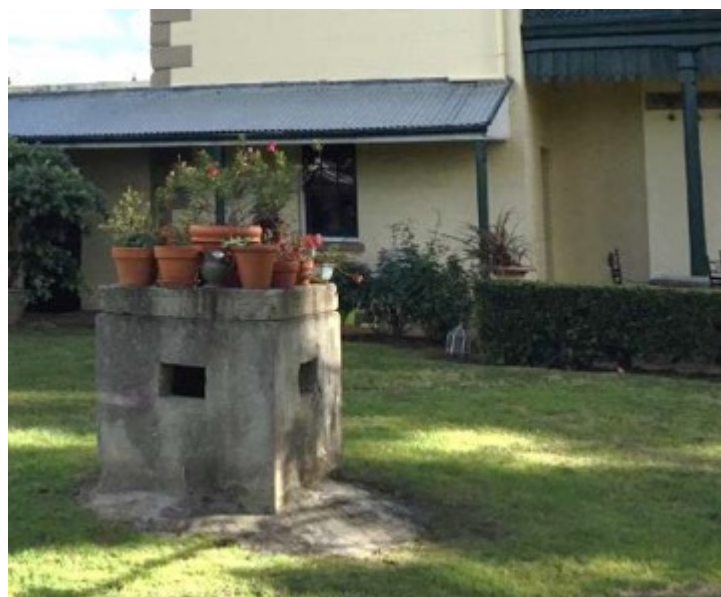
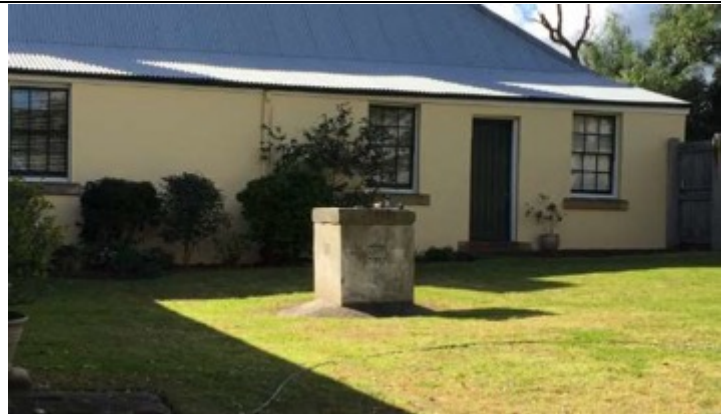
16. In-ground cisterns
(including irrigation
system - refer to
Landscape Dwg. by
Michael Bligh &
Associates -
Appendix F)

Figure 16.1: Cistern to east terrace and cistern to servants courtyard

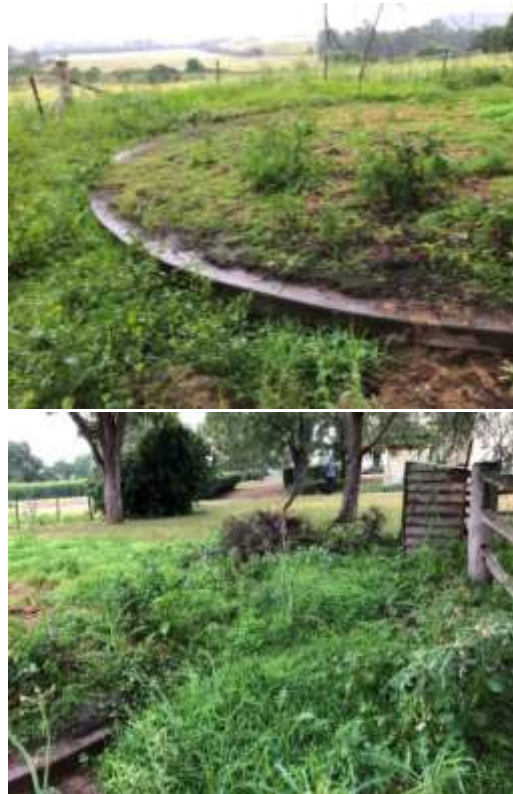
Figure 16.2: In-ground water storage & pump house – south of privy

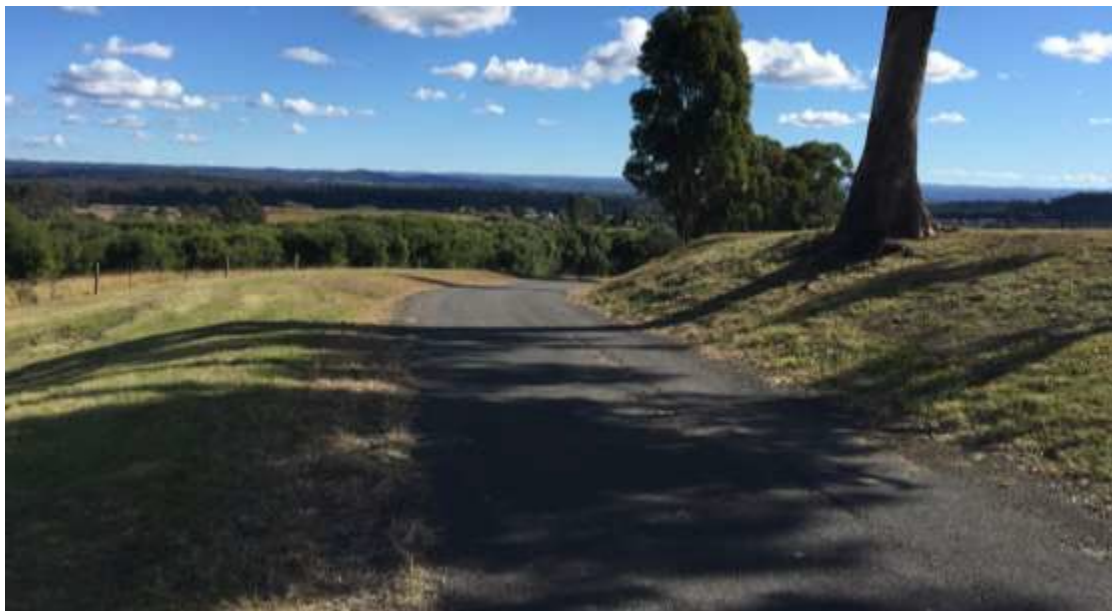
Figure 108: Crest of the hill along the Glenlee Road access roadway looking straight to the Glenlee homestead and property. TTA 2017

Views from the rear of the Homestead to the north/north-east/east to the gatelodge and Mt Annan are limited due to the undulating landscape, winding entry drive and location and size of plantings. Views to the building cluster of Glenlee from the north and east are intermittent. Figures 108 – 112 (pp.110 & 111) indicate the limited nature of these views.

Glenlee is accessed by Glenlee Road off Menangle Road, wending its way through the landscape – refer to entry sequence Figures 108 - 118. It is not until reaching a bend in the road at a crest/hill that a view of the Glenlee property and broader landscape below opens up. The access road continues through a set of timber gates onto a gravel driveway that splits into two – one accesses the working farm, while the other continues to the carriage loop (installed by James Broadbent in 1985), the presentation garden and formal entry of the homestead.

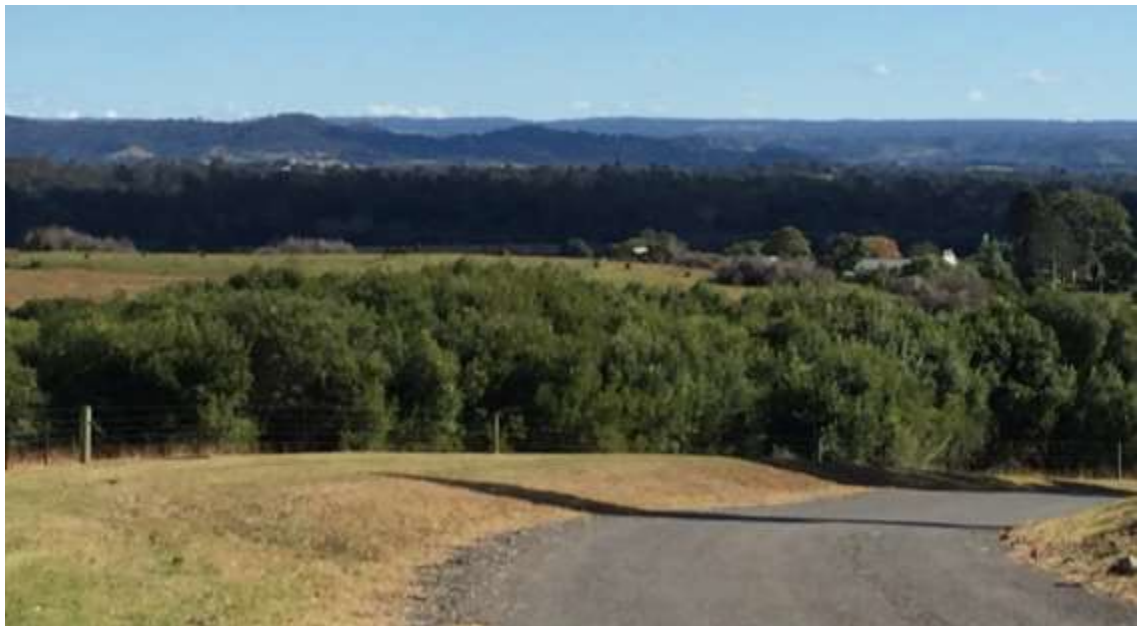
Figure 109: Zoomed in view from the crest of the hill looking to the Glenlee buildings and pastures.

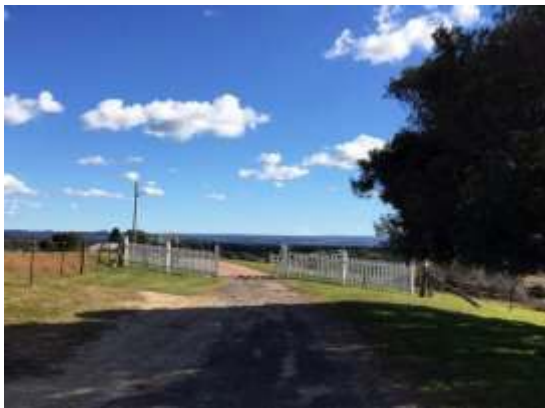
Figure 110: Timber picket entry gates to Glenlee.

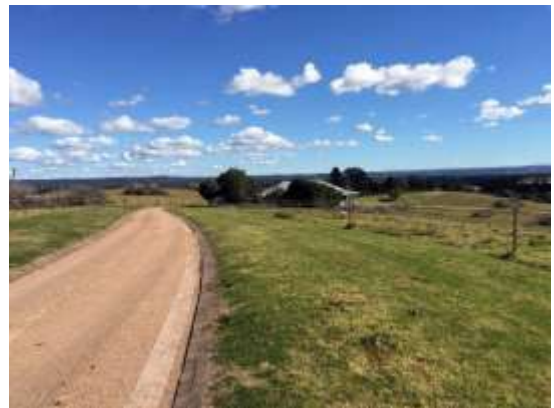
Figure 111: Gravel drive with brick drainage leading to Glenlee buildings. Looking to the former olive processing shed.

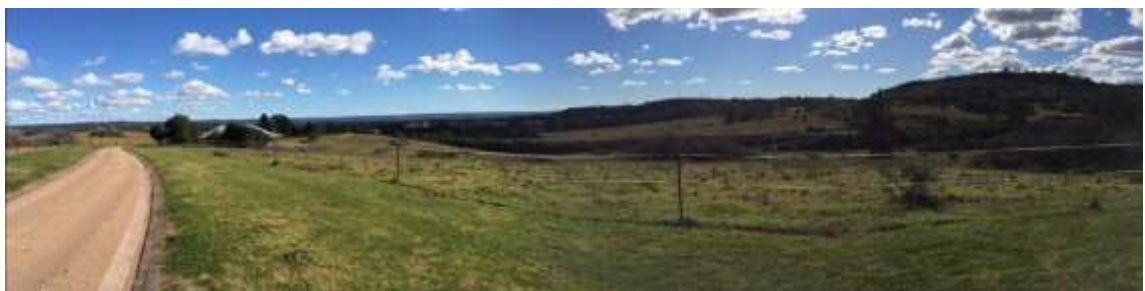
Figure 112: Glenlee looking north-west to north from the access road.

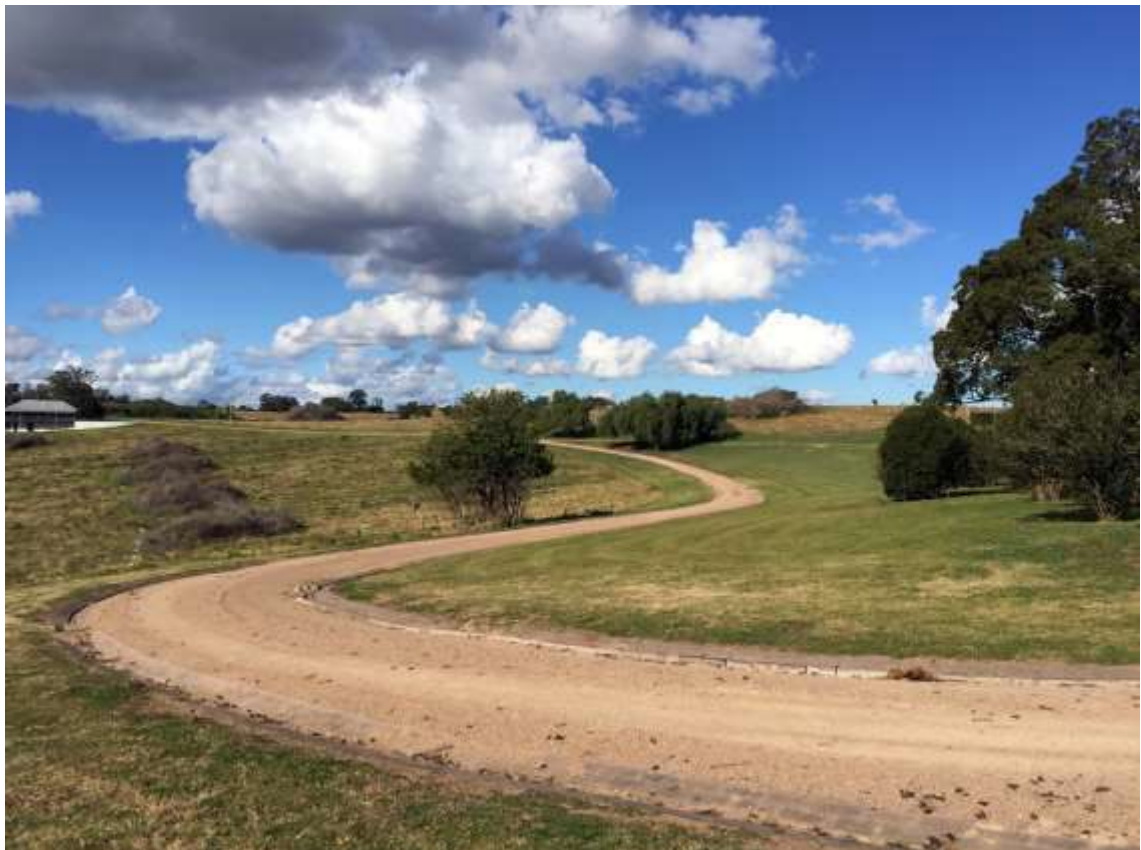
Figure 113: The winding gravelled driveway looking back to the former Olive Oil processing shed (left of frame).

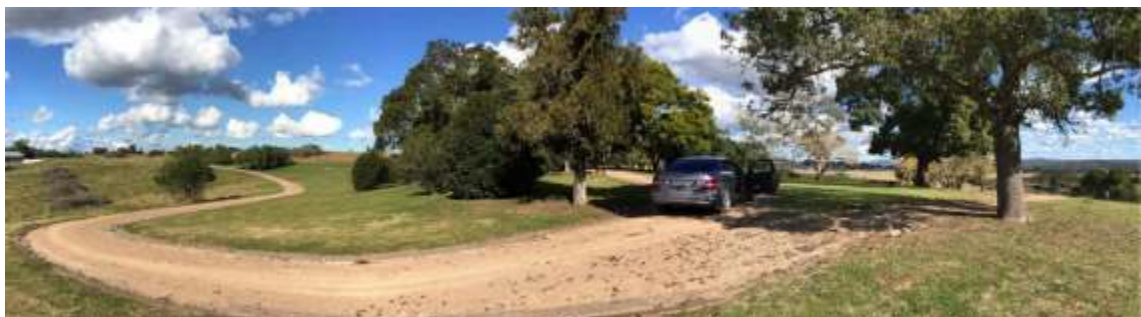
Figure 114: Panorama of the winding driveway. The car is parked where the driveway branches off to the left to the farm building/out building complex (rear of Glenlee) and the branch to the right takes the driver to the carriage loop in front of the house.

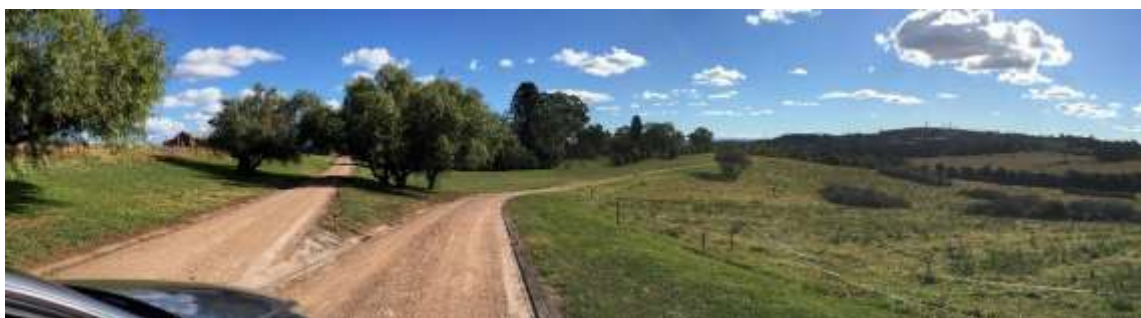
Figure 115: The fork in the driveway – left to the farm/outbuildings, right to the homestead.

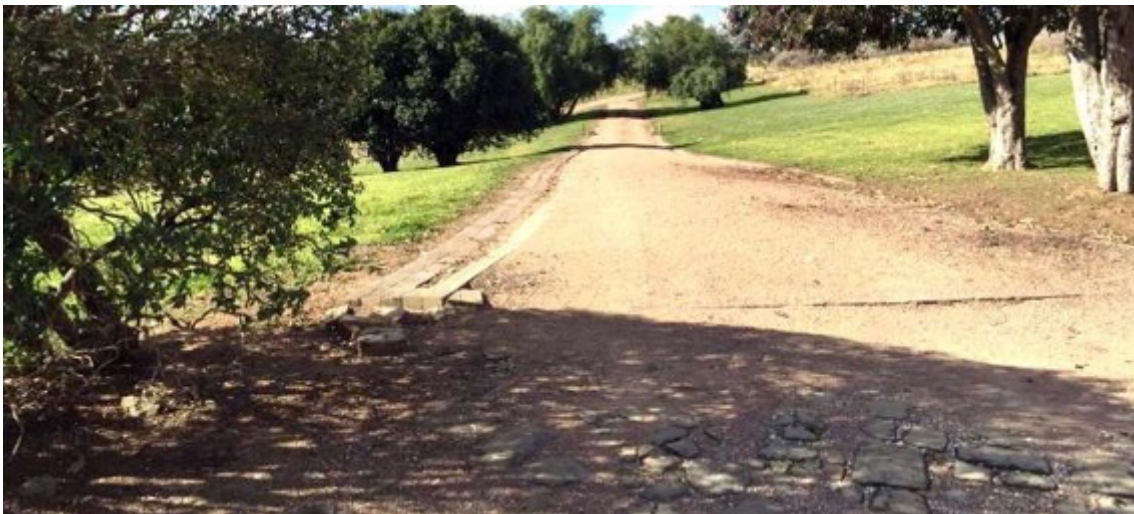
Figure 118: Looking east along the farm entry drive back to the fork in the road. Note the start of the cobblestones.
