Glenlee, outbuildings, garden & gatelodge

Lots 1, 2 & 3 DP713646, Glenlee Road, Menangle Park, NSW
SHR Listing No.00009

Conservation Management Plan

April 2023
REF: 1718: CMP
Issue 07

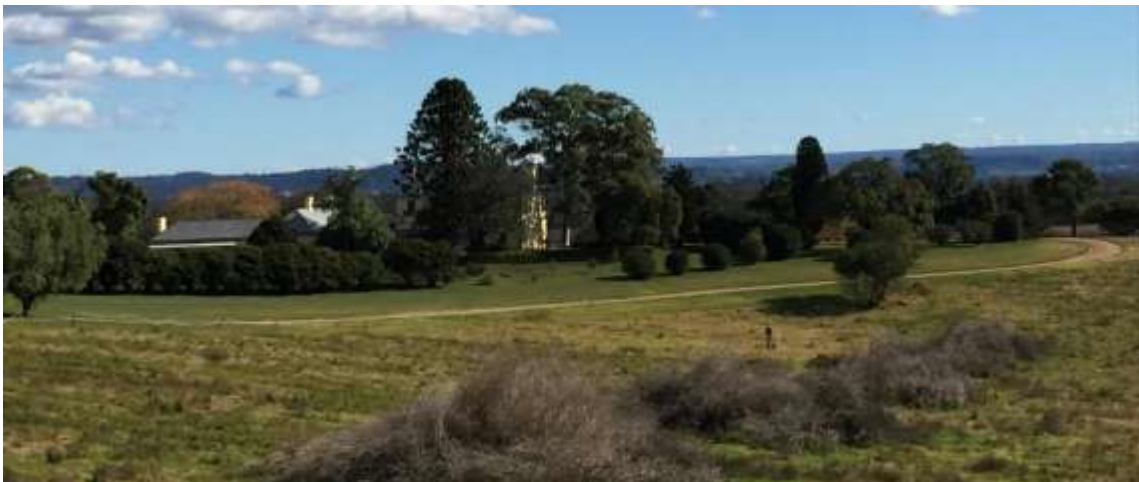
Figure 119: The mature Bunya Pine tree signals the location of the house.

Hedge rows and manicured shrubs have been planted to demarcate areas within the homestead and farm building complex. The gravelled drive with brick drainage edge effectively creates a barrier between the working land and the manicured lands surrounding the building complex – refer to Figures 119 & 120.

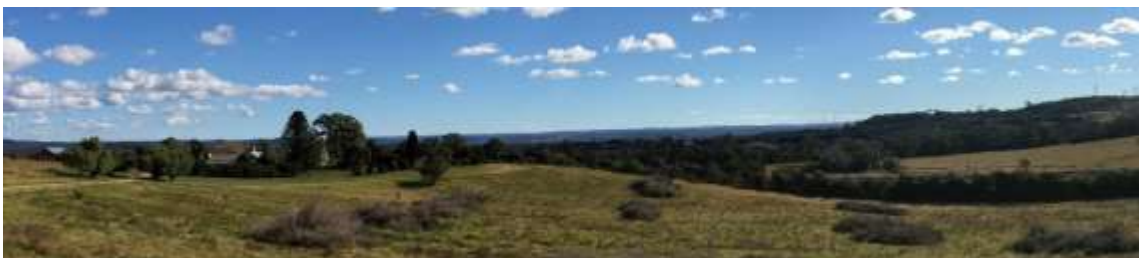
Figure 120: The Glenlee group, including house, outbuildings and gardens forms a magnificent composition on its bench and together with surrounding landscape features forms an outstanding cultural landscape. There is clear definition between the cultural landscape surrounding the homestead and associated structures, to the working lands and broader natural landscape beyond.

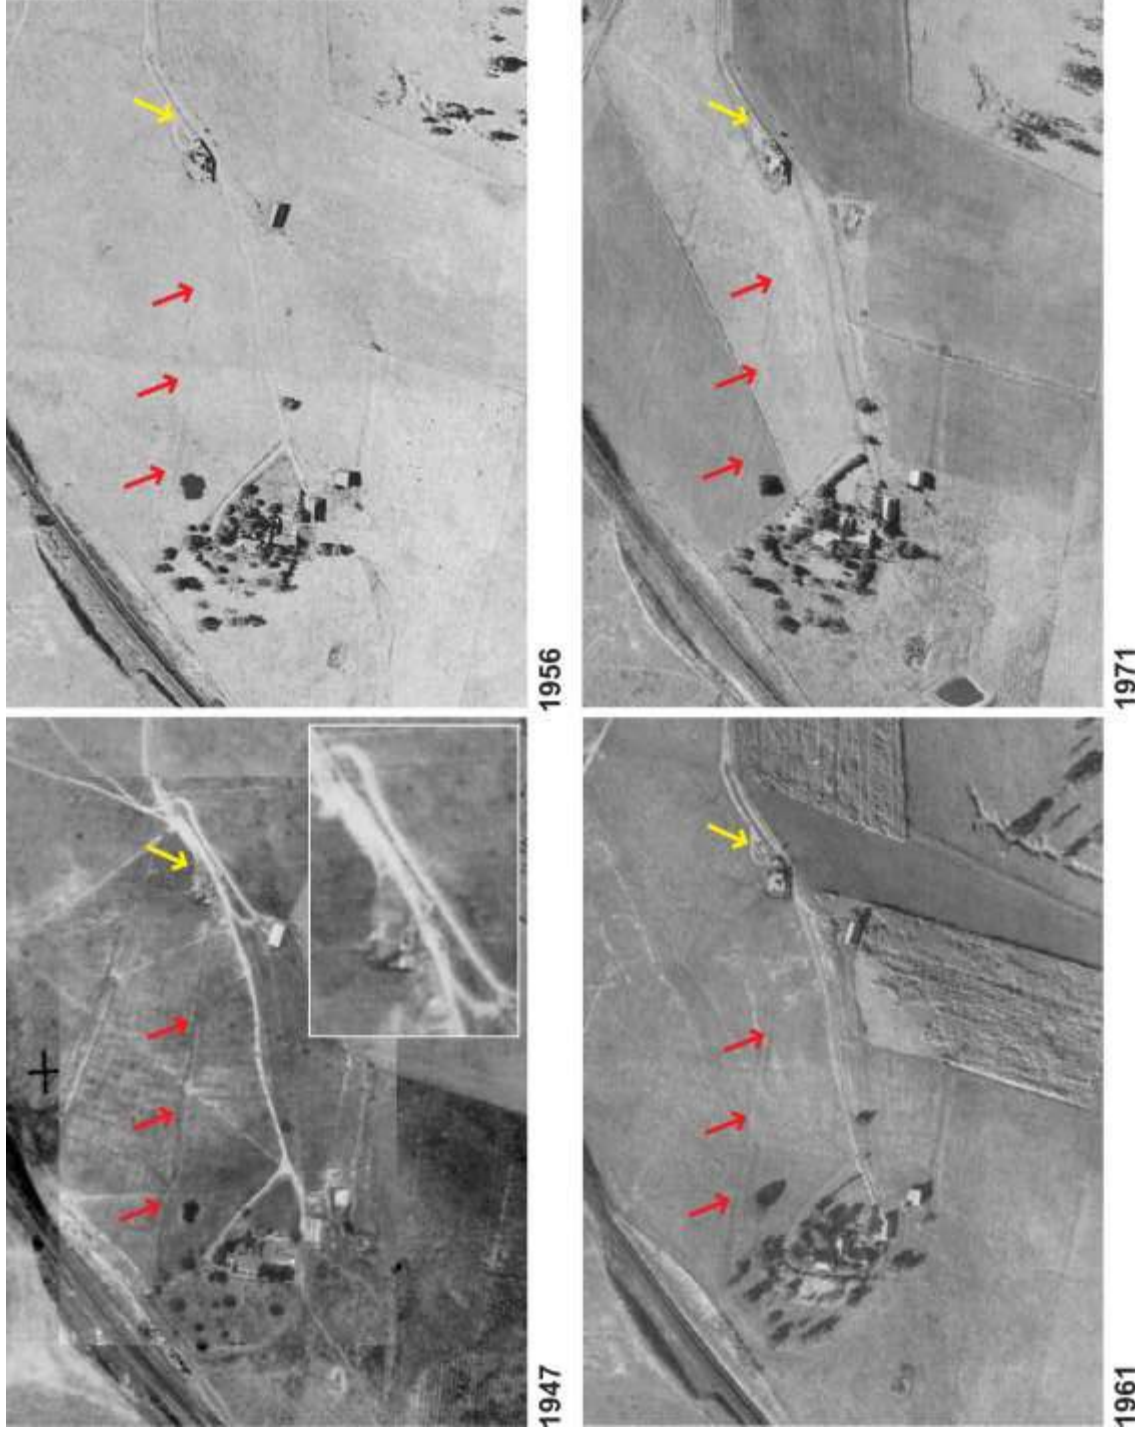
Figure 128b:
C & L Figure 2.4: Aerial photographs showing existing buildings and roadways. Note the visible line of the original carriageway from the gatelodge to homestead (marked with red arrows). The carriage loop at the gatelodge (yellow arrow) does not appear to be formalised until the 1950s (see inset on 1947 aerial). Source: Tropman & Tropman 2016.

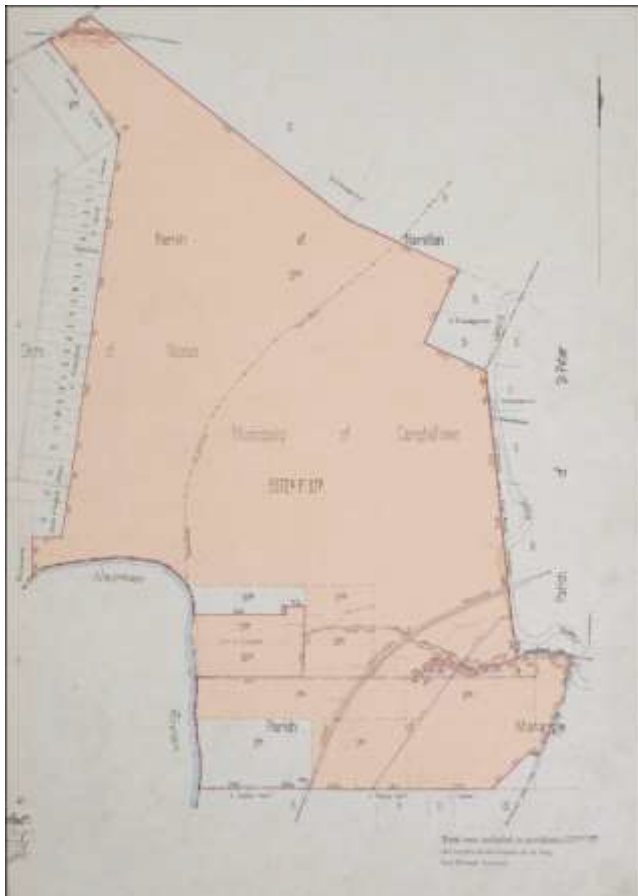
Figure: Phase 1: 1816-1858 (Source: Architectural Projects Pty Ltd)

1837 – Significant cultivator of hay for Sydney market; famous as first dairy farm to manufacture butter;

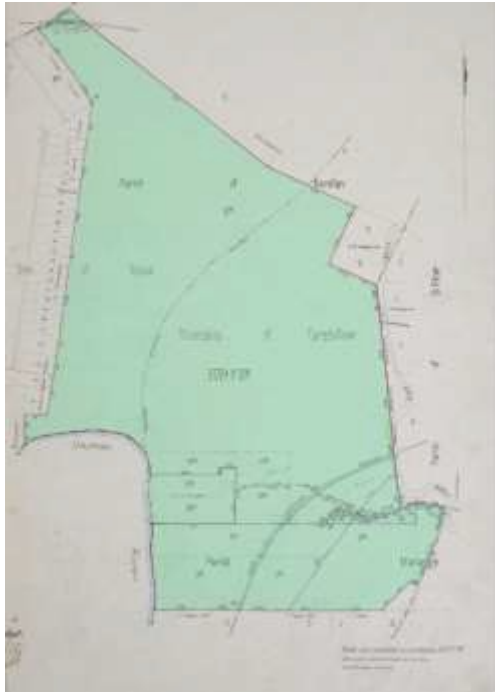
Figure: Phase 2: 1859-1900 (Source: Architectural Projects Pty Ltd)

1859 – Following the death of William Howe Jnr, the property is sold to James Fitzpatrick;
1866 – Southern Railway line constructed, including station platforms;
1870 – Large portion of the estate was leased to small tenant farmers;
1890s - House was remodelled including removal of original joinery.

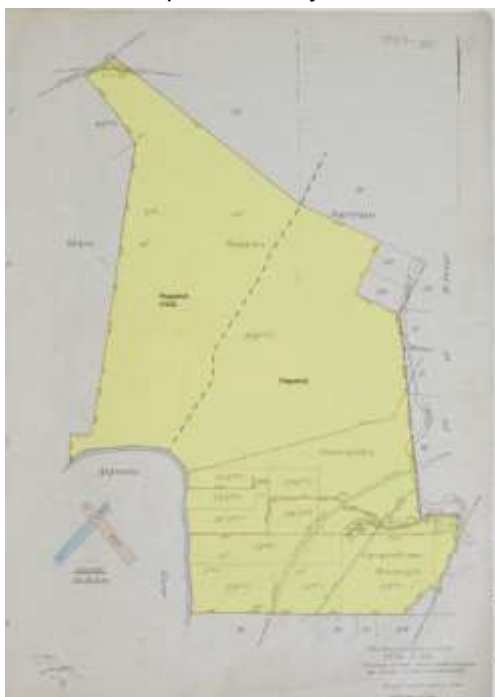
Figure: Phase 3: 1900-1960s (Source: Architectural Projects Pty Ltd)

1910s – Members of Fitzpatrick family operate the dairy and employing herdsmen;
1950s – Sale of land for coal washery & rail spur;
1968/9 - State Planning Authority/Macarthur Development Board acquired property from Fitzpatrick family.

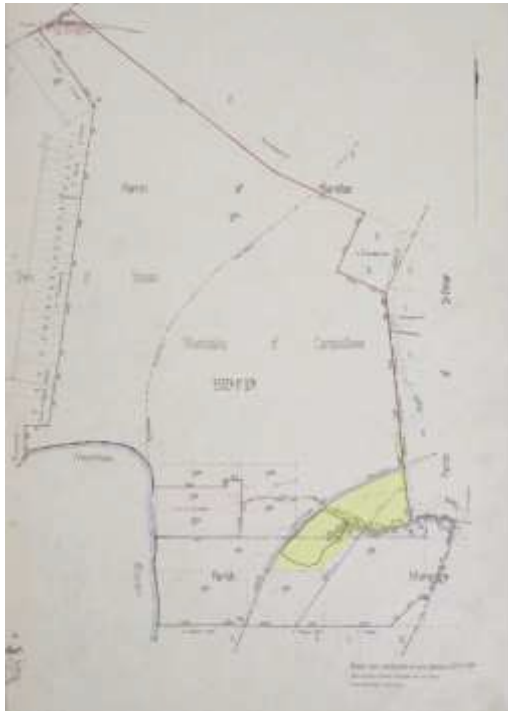
Figure: Phase 4: 1970s-Present (Source: Architectural Projects Pty Ltd)

1973 – State Planning Authority gazetted the estate as a place of historic interest;
1978 – Extensive restoration and waterproofing works were undertaken;
1982 – Permanent Conservation Order for the house and part of the estate. 45 acre SHR curtilage established & returned to private ownership of Wilson family;
1983 – Further internal changes and landscaping were undertaken;
1980s - Further portions of property set aside for Australian Botanic Garden (Mt Annan) & William Howe Regional Park;
1990s - An olive grove with 7000 trees and a modern processing shed was established by Wilson family, discontinued in mid-2014.
c2009 – Milking shed destroyed by fire, replaced in 2011.

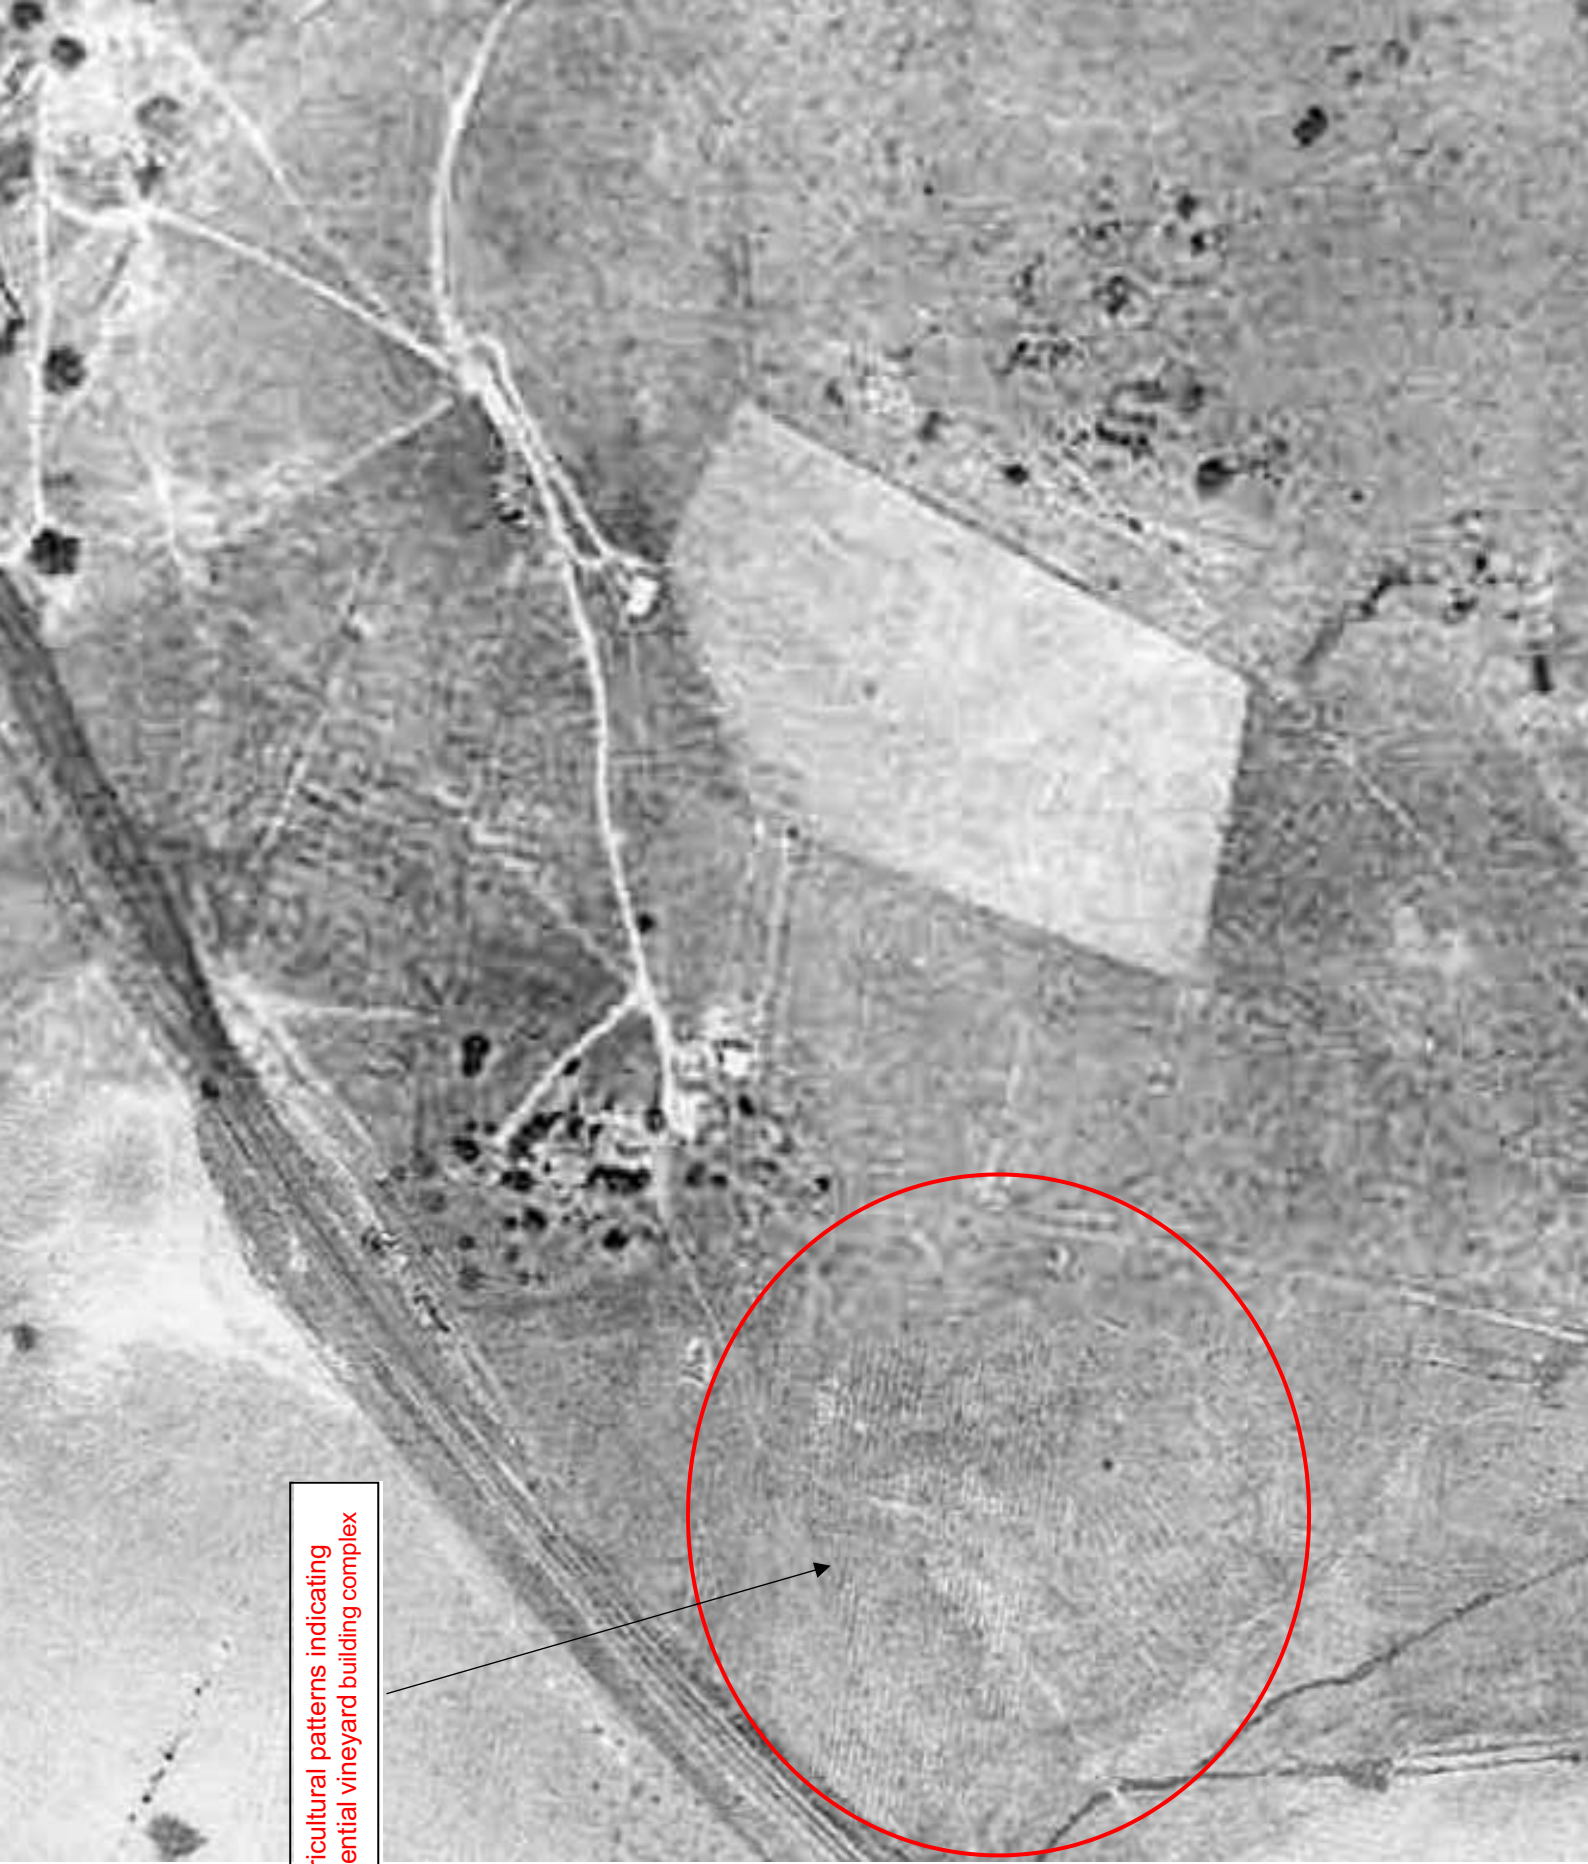
Figure 130: 1917 aerial photograph [PI]

Agricultural patterns indicating
potential vineyard building complex

Level crossing over railway line retaining access from Glenlee to the alluvial flats/dairy grazing paddocks

Glenlee building complex. Note the absence of carriage loop. The triangular homestead complex is fenced.

The Colonial Landscapes of the Cumberland Plain (CLCP) report details the same important views and vistas to and from the property described above. The site plan also indicates the location of vineyards, however the aerial photographs from 1947 (Figure 130, p.148) to the present do not indicate the presence of any vineyards on the Glenlee property. Refer to Figure 88, p.97.

Aerial photographs from 1947 to 2017 show the evolving landscape of the Glenlee Estate – refer to Figures 130 - 140. These aerial photographs give a clear indication of what was happening on and around the Glenlee property during this period of time.

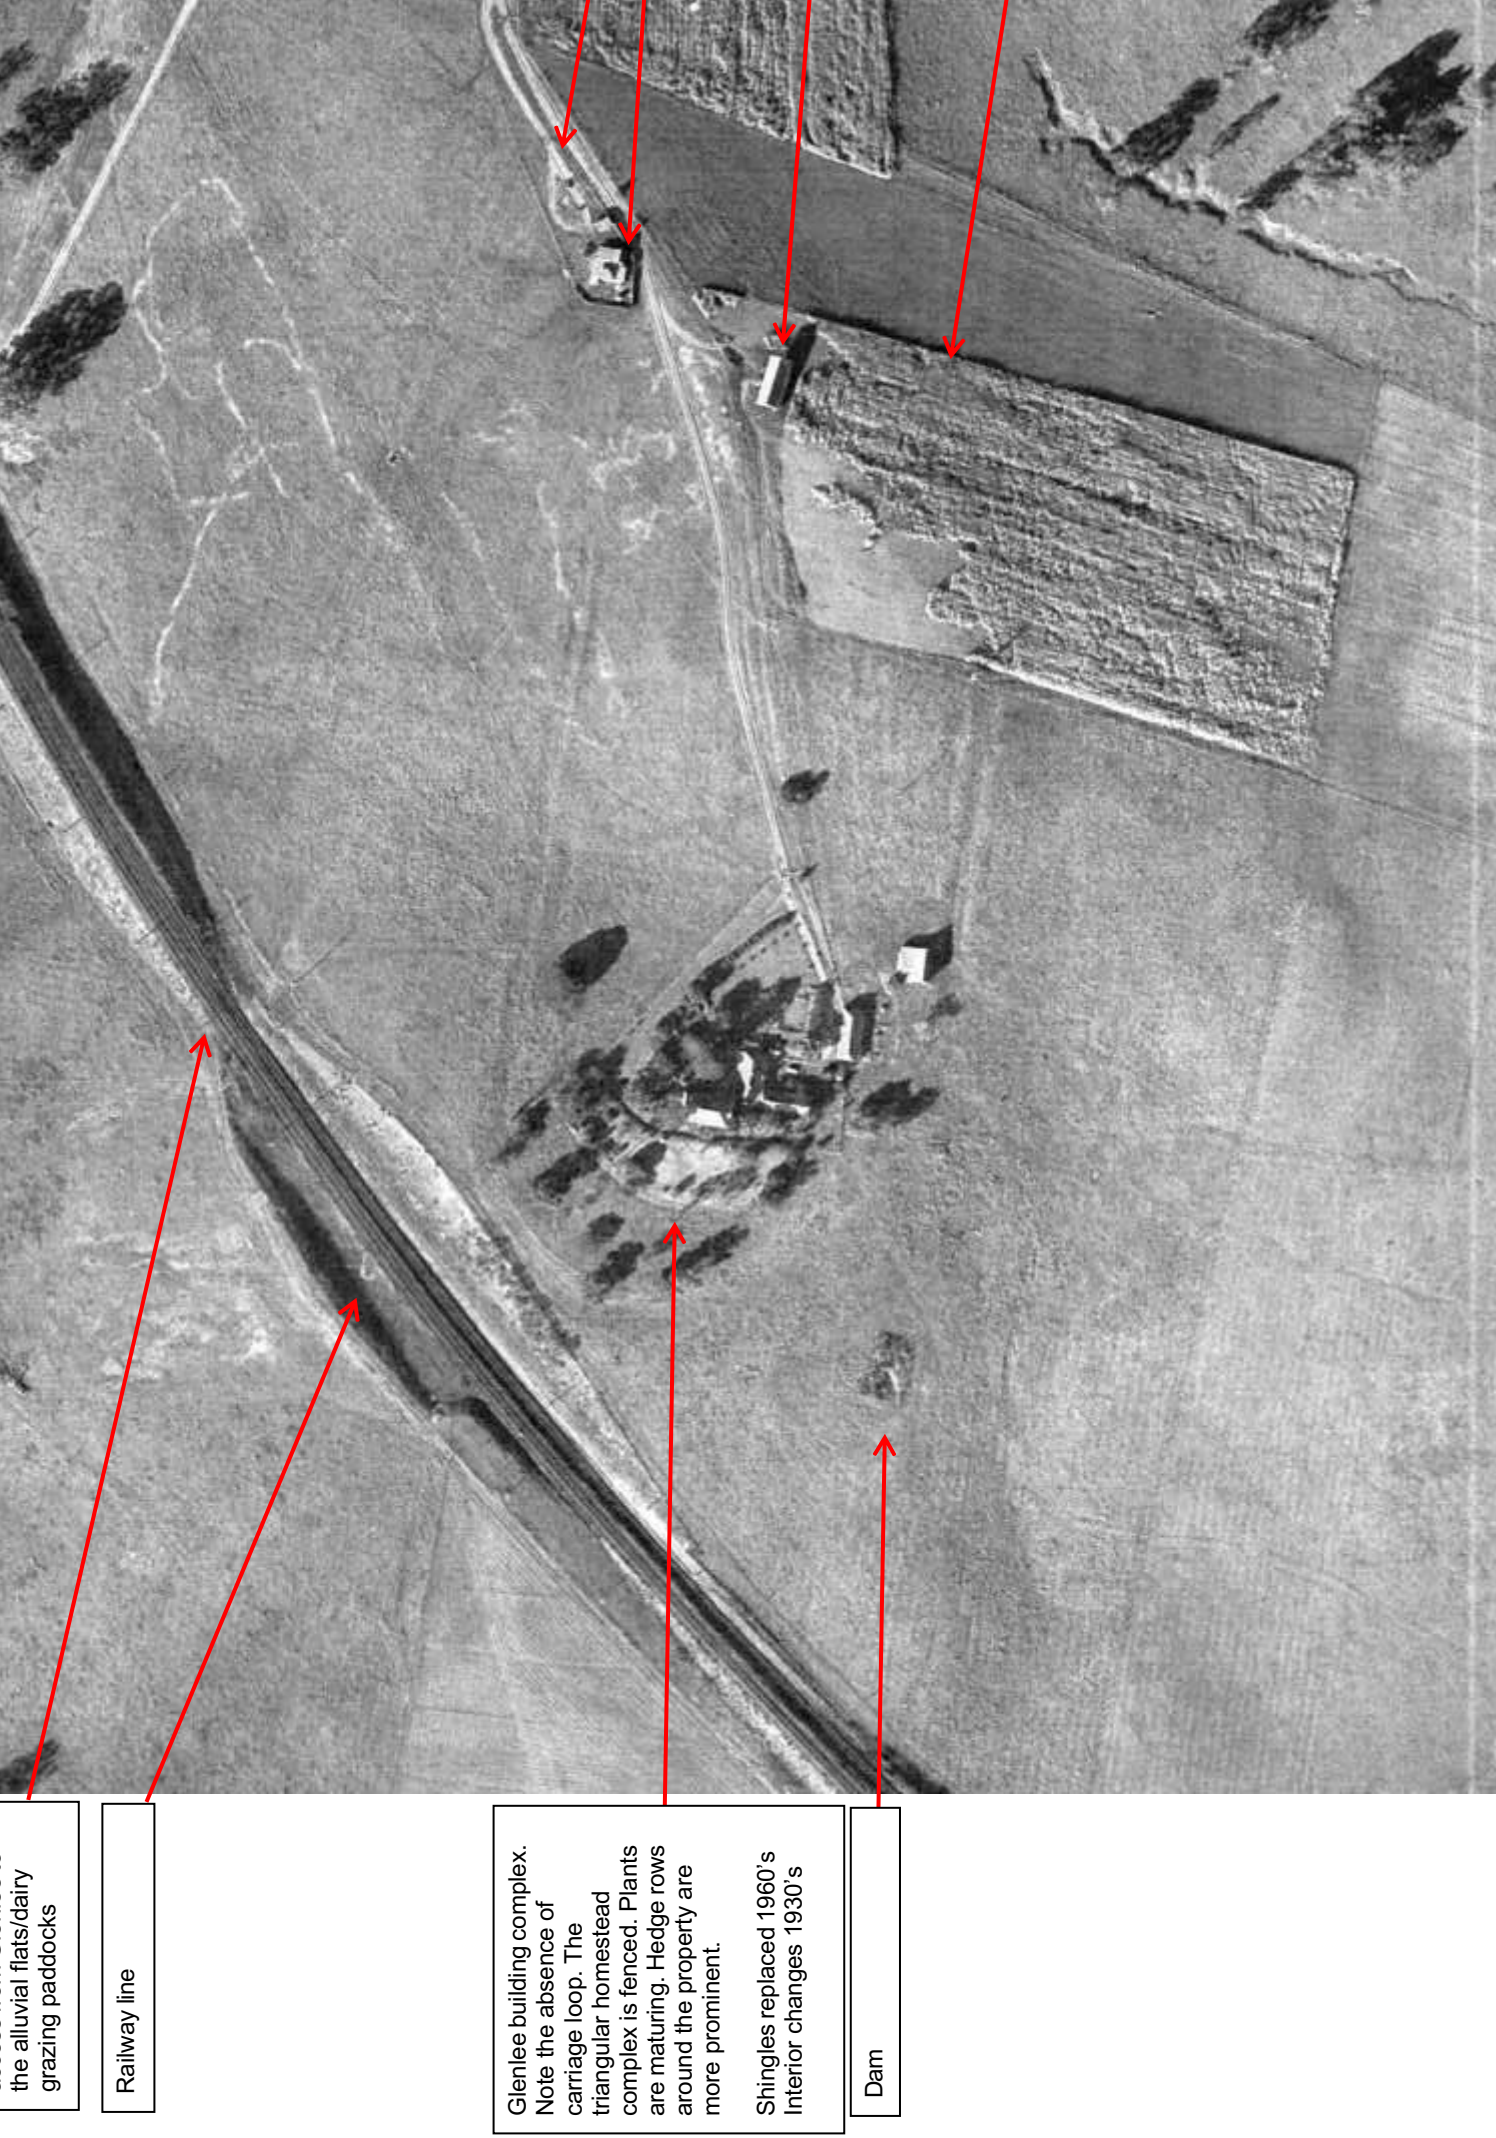
Figure 132: 1961 aerial photograph. LPI.

the alluvial flats/dairy
grazing paddocks

Shingles replaced 1960's
Interior changes 1930's

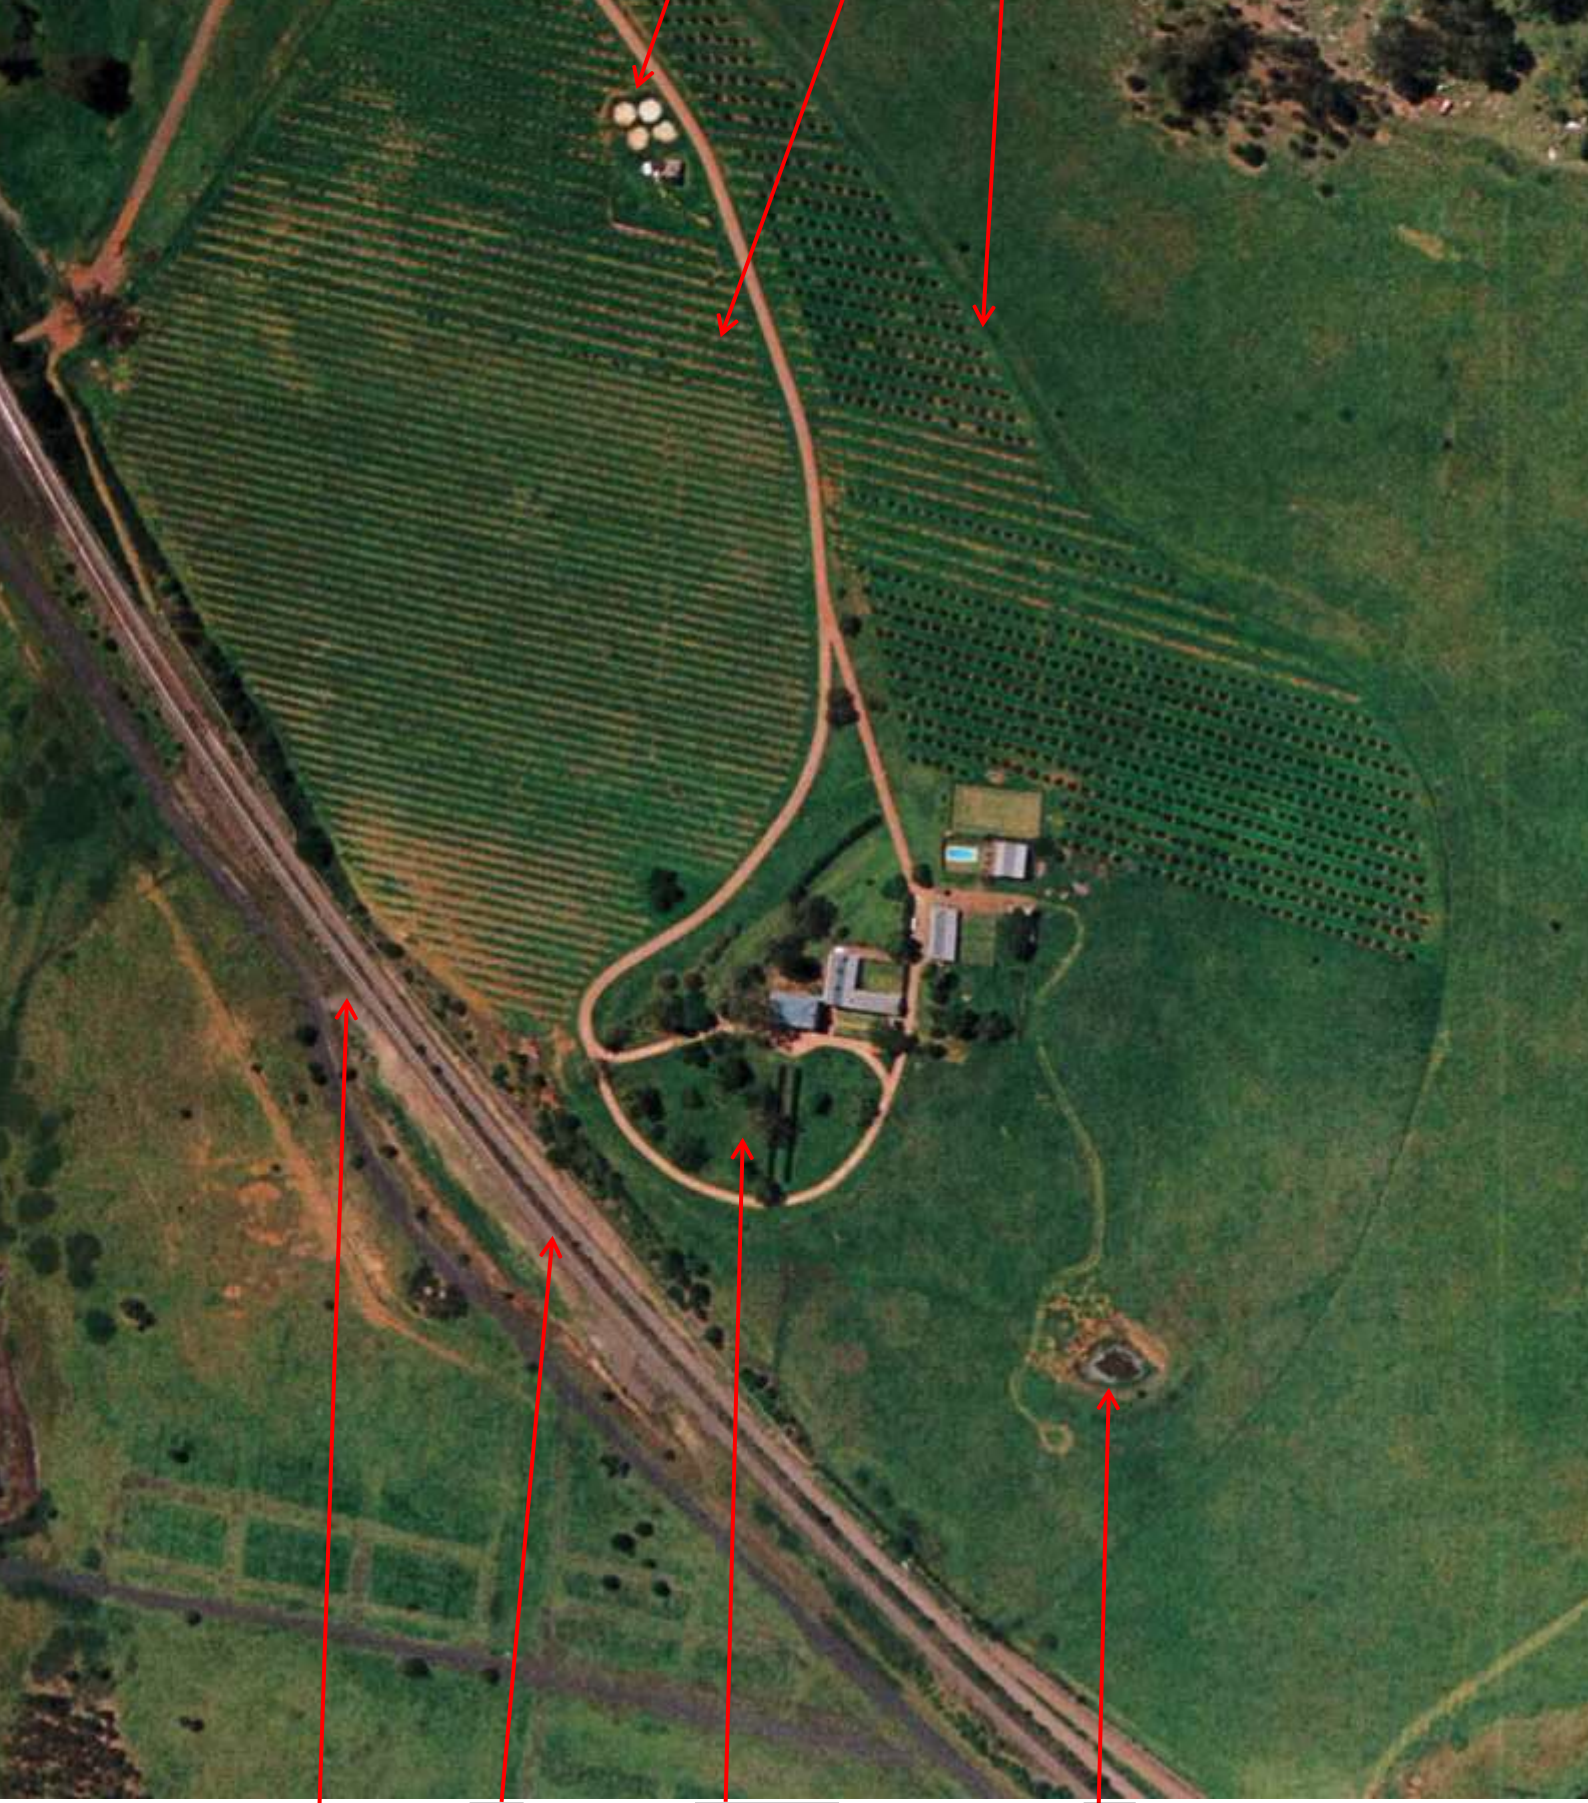
Level crossing over railway line retaining access from Glenlee to the alluvial flats/dairy grazing paddocks

Maturation of trees and shrubs around the Glenlee homestead complex

Dam 1970

The series of aerial images from 1947 through to 2020 (refer to Figures 130 - 139) show that there has not been a great deal of change to the Glenlee property in this time. The most substantial change was the planting of the groves of Olive Trees (7,000 trees) between the 1990 and 2002 aerial photographs, and the construction of the Olive Oil Processing Shed adjacent to the former gatelodge around this time. The Olive Trees were removed post 2014, because the ventured proved to be commercially unviable.

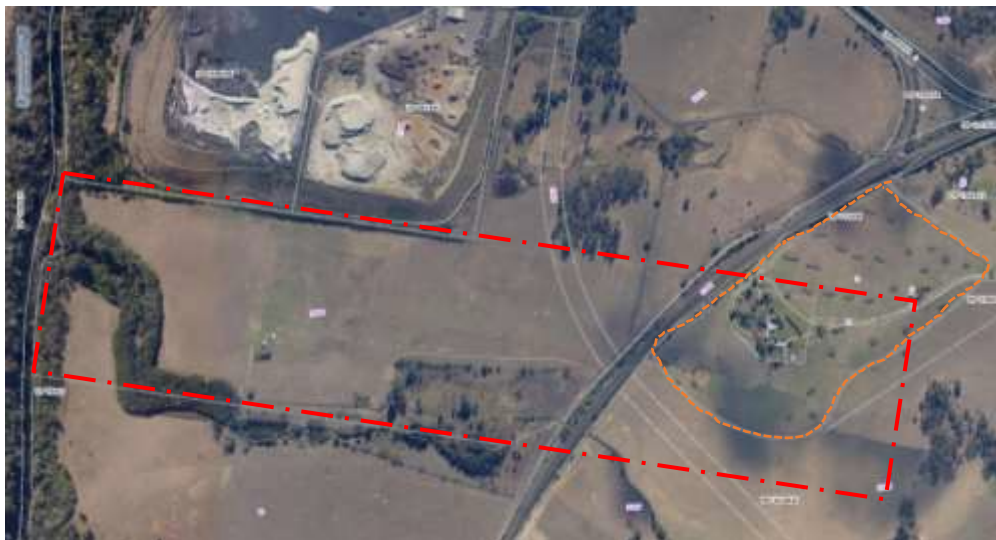
Figure 155: The SHR curtilage of Glenlee indicated in the context of the location of Portion 1 (Michael Hayes 120 acres 1812 grant – indicated by the red dashed line) purchased by William Howe in 1816 on which he erected Glenlee homestead Ca 1823.

Appreciation of the full extent of the 7,000 acres Howe controlled in 1830 (Figure 153) can best be achieved via appropriate interpretation media. A more achievable visual interpretation might be to investigate opportunities regarding Portion No. 1, purchased by William Howe in 1816 on which he erected Glenlee homestead – Figure 155. The northern, western and southern boundaries are evident in the alluvial pasture area to the west of Glenlee Interpretation of the remnants of the other two portions which make up the SHR should be explored. However the rural character of these portions is less evident.

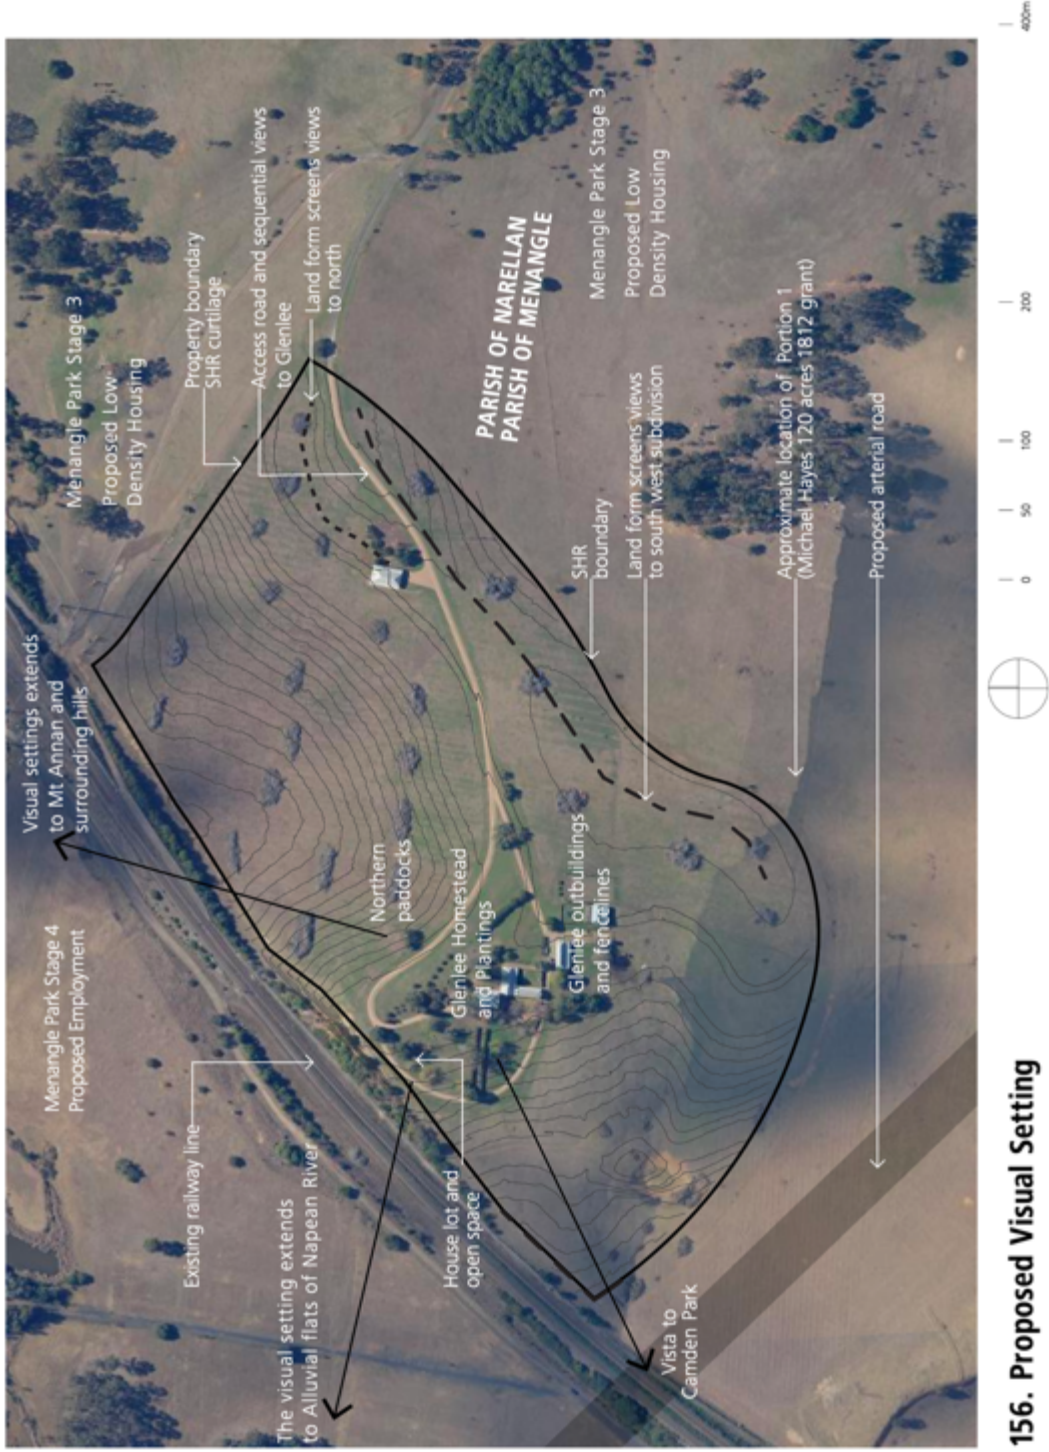
156. Proposed Visual Setting

Figure 156: Glenlee Estate: Proposed Visual Setting

- the Glenlee homestead and significant plantings surrounding the homestead;
- former Servants Quarters and courtyards;
- former Milking Shed and yard;
- the interpretive woolshed;
- former gatelodge and associated farm buildings;
- the site's archaeological potential and plantings (with the exception of the Bunya pine) while not reflective of early plantings contribute to the rural setting;
- the access driveway to the property and sequential views to Glenlee from the driveway;
- the old fencelines south west of the house evident on the 1858 plan;
- the prospect to the western paddocks;
- the prospect of the northern paddocks;
- visual catchment of the alluvial flats extending from the homestead to Nepean River generally following the original grant lines west of the railway line (outside the current property boundary - refer Figure 156);

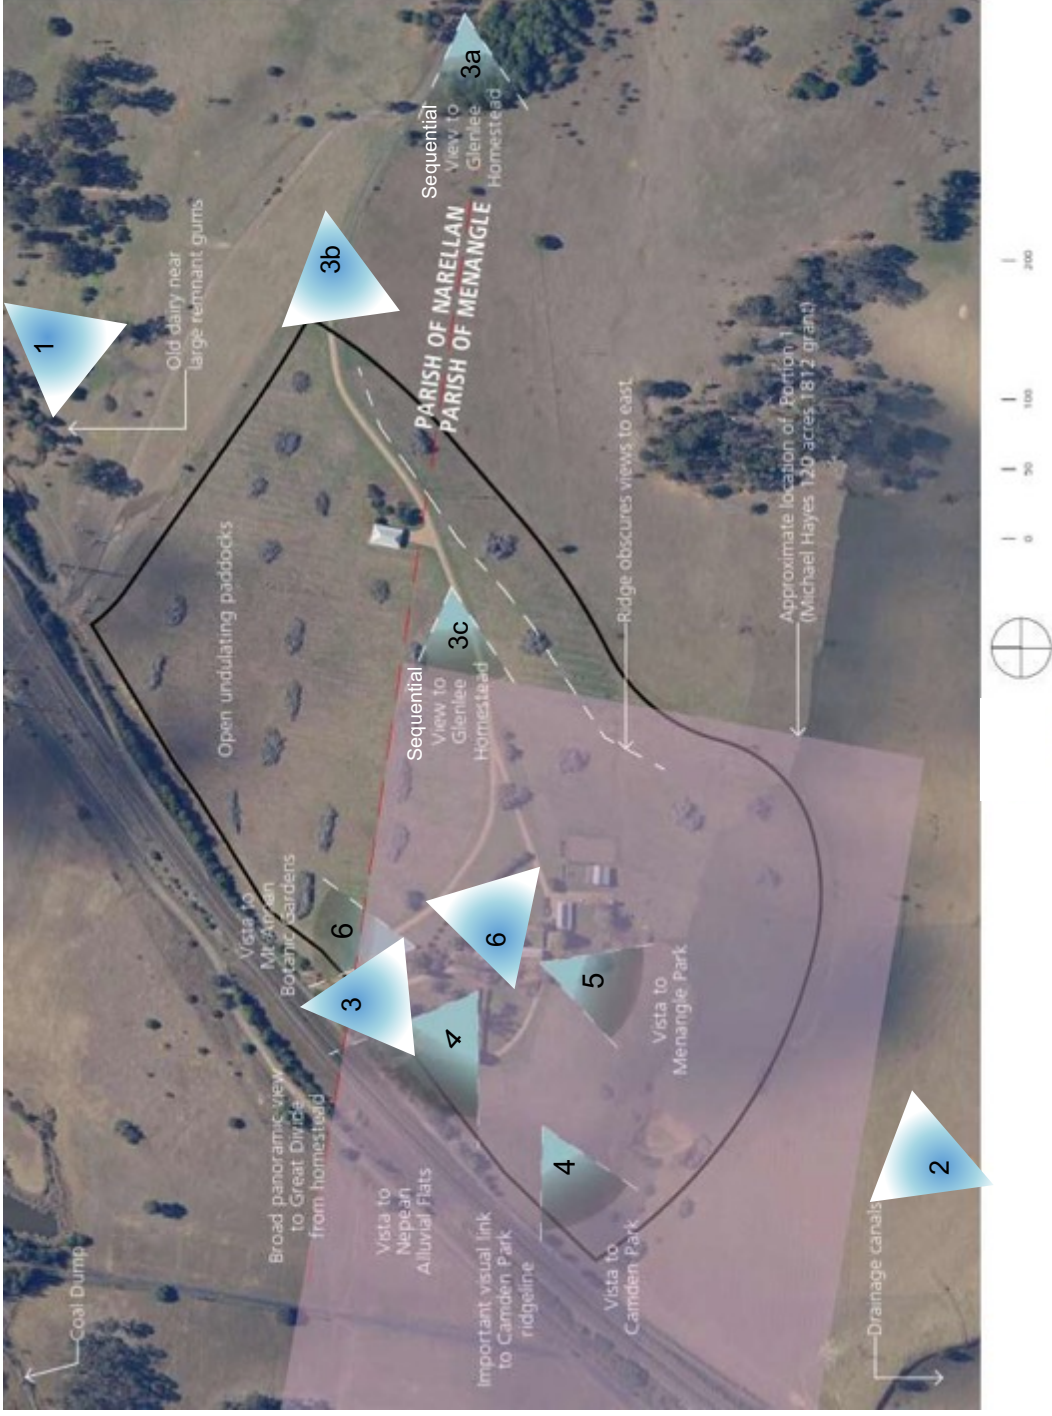
1718 GLENLEE CMP: VIEW ANALYSIS - Identification of Significant views
MAP 1: VIEW ANALYSIS - refer to TABLE 1 (Historic property lots plan overlaid on SIX Aerial Image)

MAP 1 and TABLE 1 below provide an analysis of the primary views towards and away from the Subject Site and Homestead and Gradings of Significance.

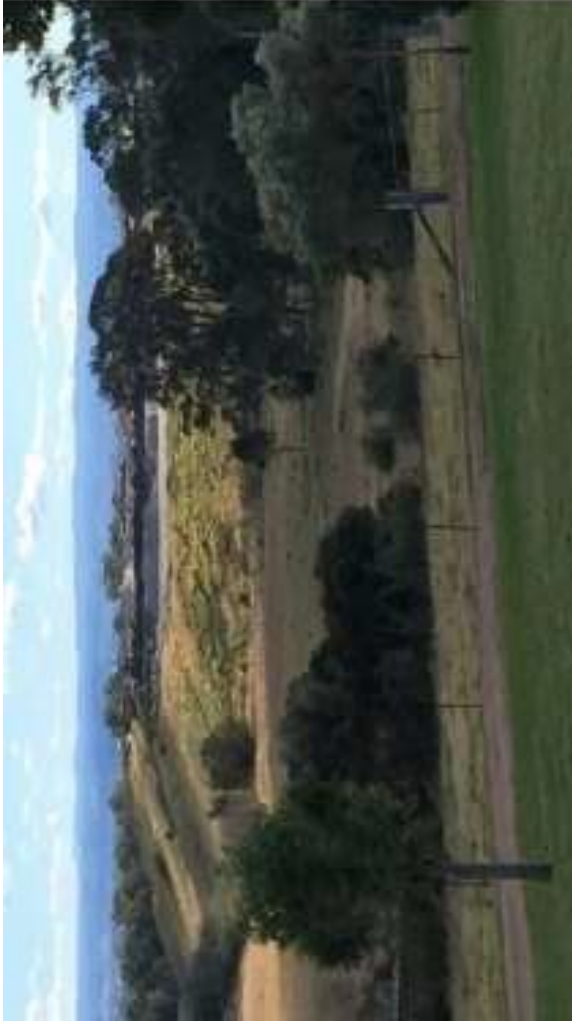
5.	<p>Part of View 4: View of coal washery & transhipment facility (constructed in 1950s).</p>

Intrusive element within a Significant View Exceptional	
6.	<p>Part of View 4: Closer views of Railway line (dates from 1866)</p>  	Significant view affected by railway corridor) Exceptional

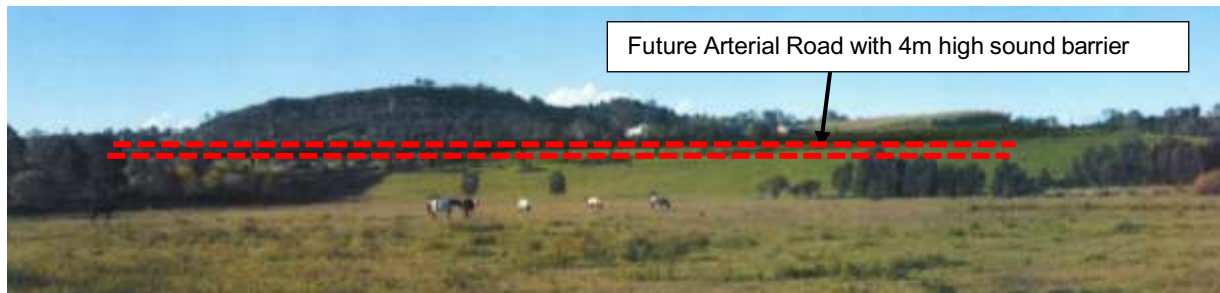
Figure 161: Site Analysis – Proposed Elevated Arterial Road & 4m high sound barrier development superimposed on image viewed from Menangle Park with Glenlee .

This future elevated road will pass (over the Main Southern Railway Line) will effectively sever the highly significant views – refer to Figures 160 – 163.

Similarly, the siting of the homestead, within a rural setting, will no longer be readily appreciated from Menangle Park due to the impact of the adjacent subdivision and future elevated arterial road & 4m high sound barrier development in Figures 158, 159 and 160. To reduce the visual impact of these future developments will require careful consideration.

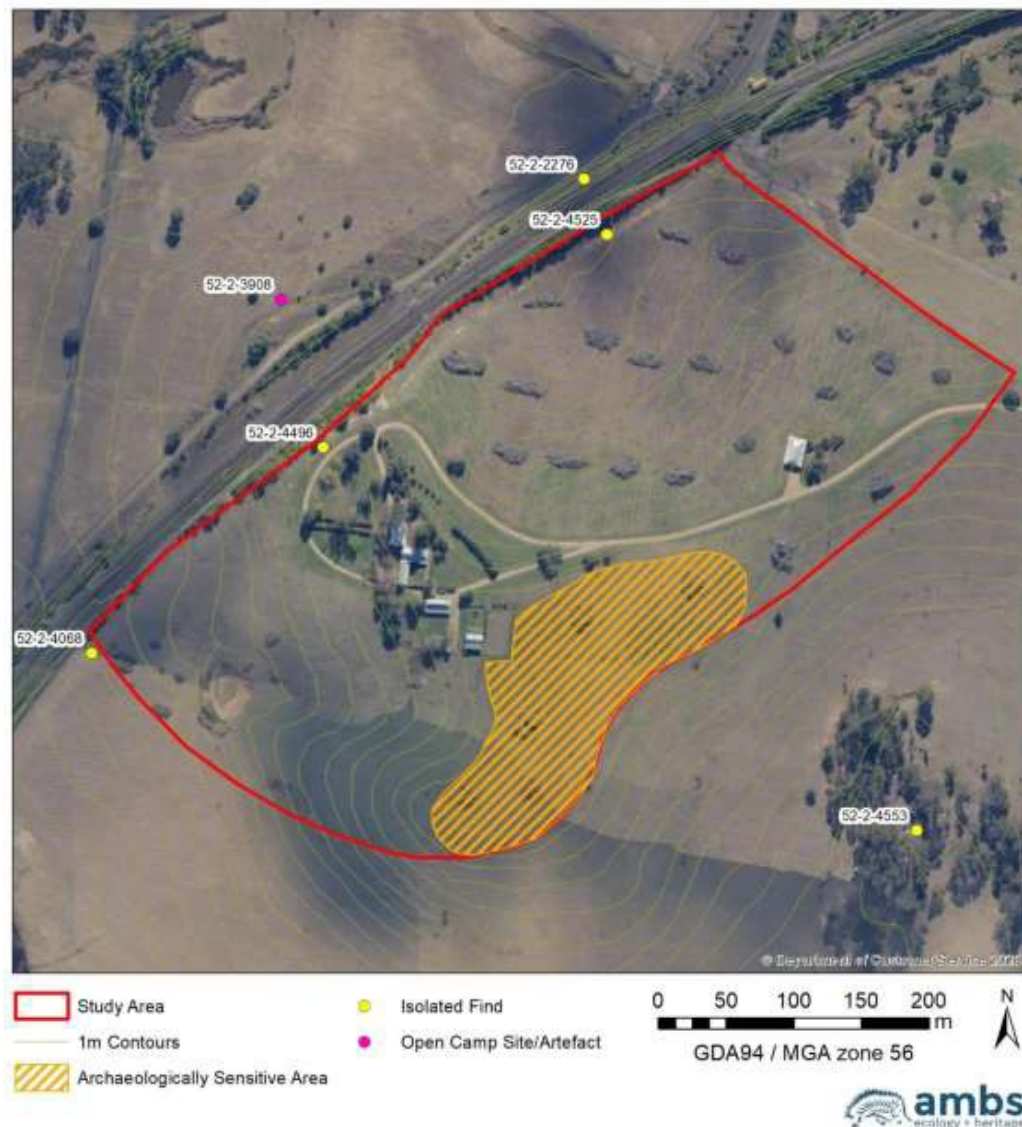
Figure 167: Indigenous Archaeology Restraints

Source: AMBS Ecology & Heritage, *Glenlee Estate Aboriginal Heritage Assessment*, July 2020, p.29, Figure 5.14

- 6.2.4 The existing significant fabric and features should be retained in-situ and conserved. (Refer Section 5.4).
- 6.2.5 There are two identified Indigenous archaeological resources of significance located on the subject site (AHIMS sites #52-2-4525 and #52-2-4496, and there is an archaeologically sensitive landform as identified in AMBS Ecology & Heritage Archaeologist Assessment, July 2020, p. 21. Refer to Figure 5.14, p. 29 of AMBS report.

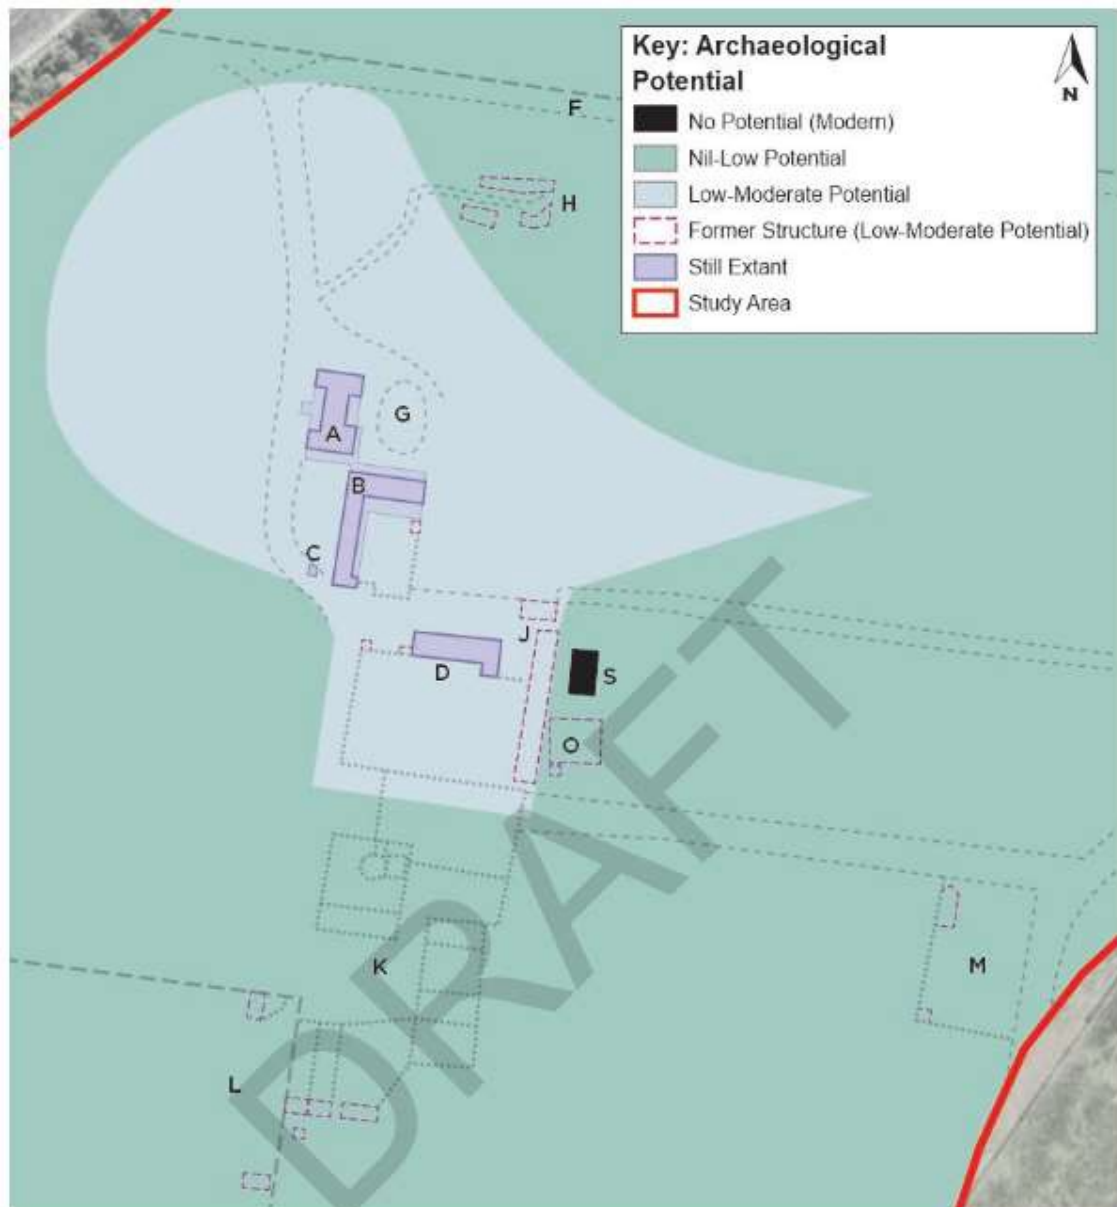
TTA Figure 169: (C & L Figure 2.20): Detail showing the predicted Archaeological Potential and main archaeological features (see C & L Table 2.2) within the core of the Glenlee estate. Base image Nearmap.

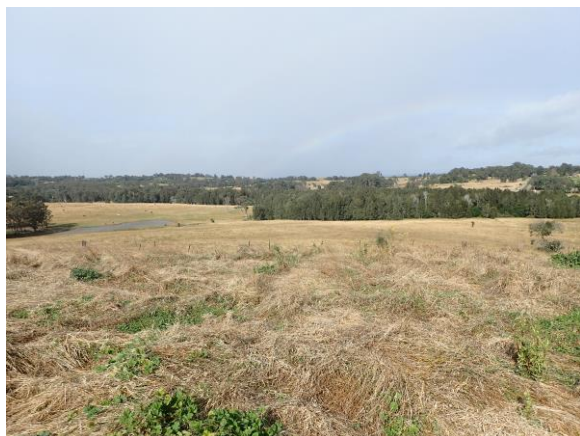
Figure 3.4 Ridge landform typical of the Blacktown soil landscape. View to south.

The natural topography of majority of the study area has been modified and levelled to allow construction of the homestead and associated buildings, and terracing for the garden (Figure 3.5). Areas that have not been modified are consistent with the topographical features of the Blacktown soil landscape including gently undulating rises on Wiannamatta Shale with local relief 10-30m and slopes are >5% to 10%. Crests and ridges are broad (200-600m) and rounded with convex upper slopes grading into concave lower slopes (Figure 3.4). Outcrops of shales do not occur naturally on the surface but may occur in areas where soils have been removed. The topography of the Theresa Park soil landscape consists of floodplains with levees and meander scrolls and terraces with local relief up to 60m. Slopes are generally <5%, except on edges of terraces where some slopes may exceed 10%.
