Glenlee, outbuildings, garden & gatelodge

Lots 1, 2 & 3 DP713646, Glenlee Road, Menangle Park, NSW
SHR Listing No.00009

Conservation Management Plan

April 2023
REF: 1718: CMP
Issue 07

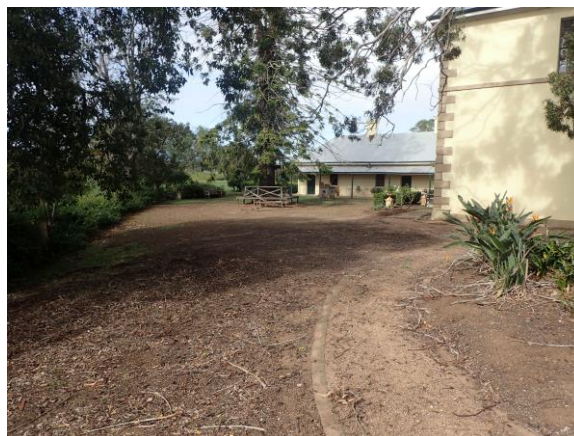
Figure 3.5 Where levelling has occurred for the construction of the homestead. View to east.

The natural topography of majority of the study area has been modified and levelled to allow construction of the homestead and associated buildings, and terracing for the garden (Figure 3.5). Areas that have not been modified are consistent with the topographical features of the Blacktown soil landscape including gently undulating rises on Wiannamatta Shale with local relief 10-30m and slopes are >5% to 10%. Crests and ridges are broad (200-600m) and rounded with convex upper slopes grading into concave lower slopes (Figure 3.4). Outcrops of shales do not occur naturally on the surface but may occur in areas where soils have been removed. The topography of the Theresa Park soil landscape consists of floodplains with levees and meander scrolls and terraces with local relief up to 60m. Slopes are generally <5%, except on edges of terraces where some slopes may exceed 10%.

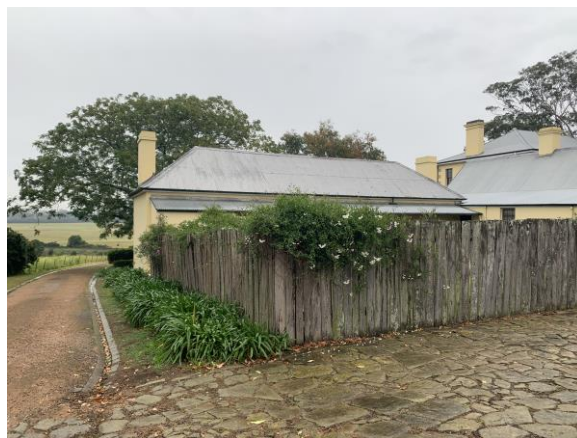
Figure 3.7 Stone paving and fence adjacent to homestead. View to east.

The study area has experienced varying levels of disturbance associated with initial vegetation clearing, use of the land for both agricultural and pastoral practices, the construction of multiple buildings on the property during the 1800s, and the construction of the current house, associated infrastructure and surrounding garden (Figure 3.6; Figure 3.8). No native vegetation remains, and majority of the plants comprise introduced species, and have been intentionally planted. A gravel driveway leads from Glenlee Road to the house, and stone paving has been installed adjacent to the homestead and stables (Figure 3.7; Figure 3.9).

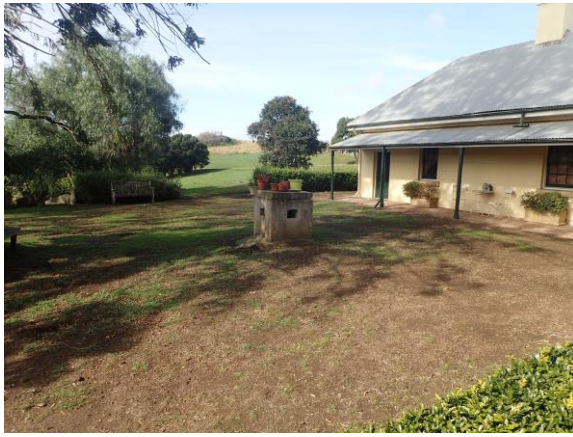
Figure 5.3 Cistern located in the rear courtyard. View to south east.

Levelling has occurred for the driveway which leads from Glenlee Road to and around the homestead (Figure 5.5). Guttering and cement posts have been installed on either side of this driveway. A high level of disturbance has occurred for the construction of the homestead and associated buildings (Figure 5.1). Stairs have been established leading to the rear courtyard, where the land has been levelled and terracing has occurred for the garden (Figure 5.2, Figure 5.4). A cistern dating to c.1858 is located in this area, suggesting subsurface disturbance (Figure 5.3). A wooden seating structure has been assembled around the Bunya Bunya pine.

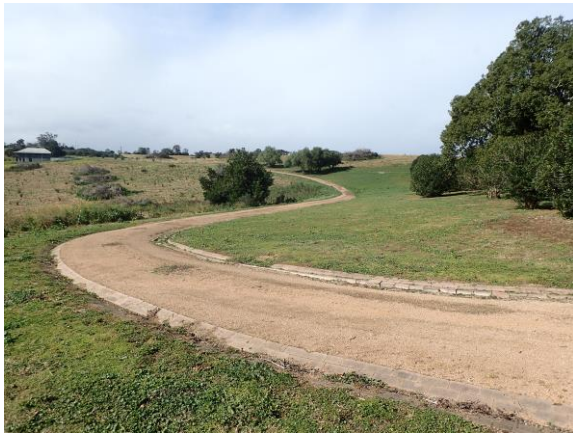
Figure 5.5 The natural landform has been levelled for the driveway and stone paving has been installed either side. View to east.

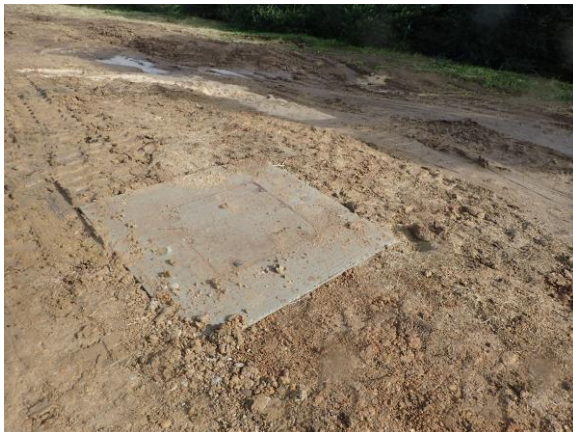
Figure 5.6 Graded area in western extent. View to south.

property boundary in this this area (see Figure 5.6-Figure 5.10). Two AHIMS site have previously been recorded within this area; AHIMS site #52-2-4525 was subject to AHIP No.C0000393 in 2019, and AHIMS site #52-2-4496 was unable to be reidentified by Artefact during a survey in 2019. Artefact mentioned that AHIMS site #52-2-4496 was located in close proximity to the Substation and Feeder study area, and its location would be recorded on construction drawings to ensure it is not impacted (Artefact 2019:9). Due to recent disturbance along the entire boundary, it is possible that the location of the artefact has since been disturbed. Several large cement manholes, yellow Endeavour energy posts and a concrete telecom pit are present within this area, suggesting extensive sub-surface disturbance (Figure 5.7-Figure 5.10). A constructed dam is present in the south western extent of the study area suggesting further disturbance. Some regrowth trees are present along the fence line and thick grass and weeds surround the graded area. A fence line separates this area from the driveway, homestead and associated buildings, and garden. The Southern Railway Line is adjacent to this area and is located out of the study area.

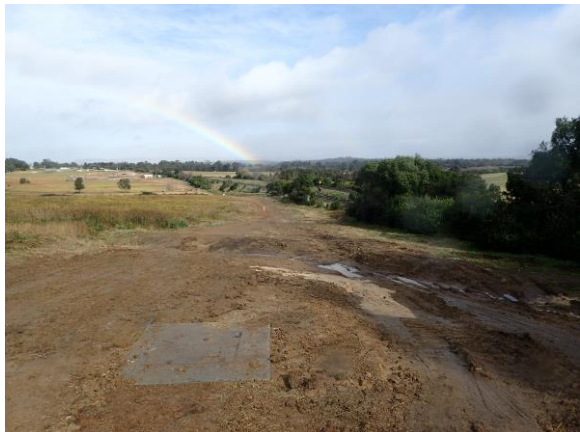
Figure 5.7 Cement man hole cover in graded area. View to south west.

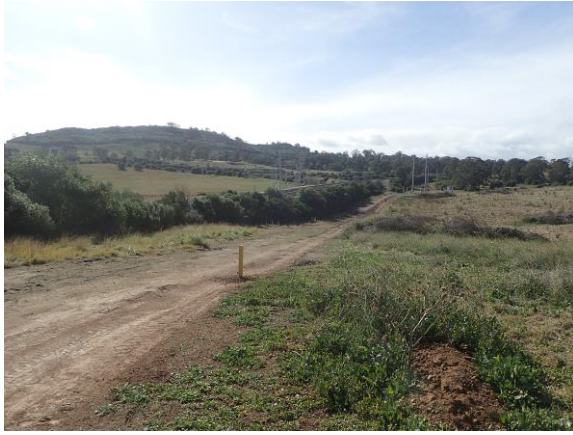
Figure 5.8 Significant disturbance in graded area. View to south.

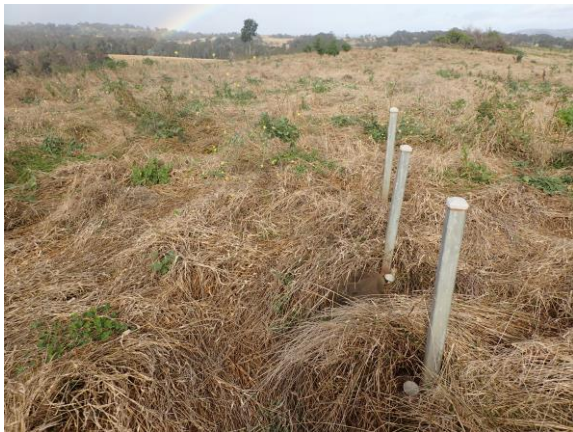
Figure 5.13 Borehole testing locations on the south eastern ridgeline. View to south.

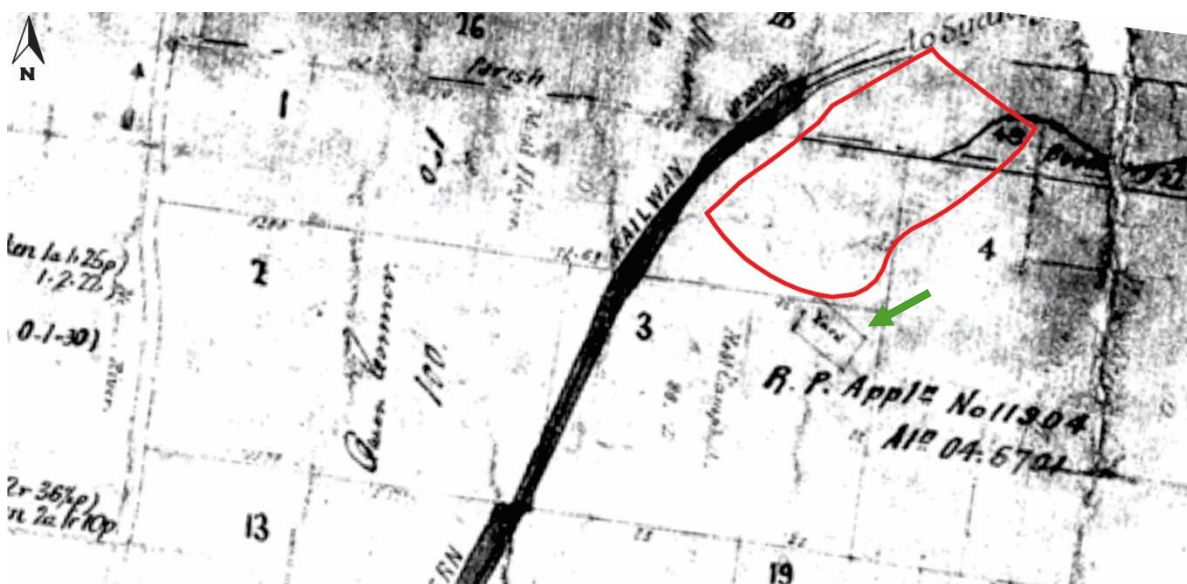
Figure 2.1: Undated plan of farms in Airds by surveyor James Meehan showing a 'Yard' (arrowed) depicted on Robert Campbell's property (Portion 3) to the south of the study area (outlined in red). Source: SA Map 1137, NSWSR (reproduced in Kass 2020).

Date	Historical Event
Phase 1: 1816-1858	
Aug 1812	Mary Reibey granted 200 acres (80 ha) in the District of Airds (Portion 4). The north-west portion of this grant forms part of the current study area. ²¹
Aug 1813	Michael Hayes granted 120 acres (48 ha) in the District of Airds (Portion 1), known as “Hayes’s Farm”. ²²
Oct 1816	William Howe, a Scottish free settler, purchases Hayes’ land grant, on which Glenlee was subsequently built.
Jan 1818	Howe granted 3000 acres (1214 ha) of land (‘Eskdale’ / Glenlee) in the District of Minto (Portion 10), situated largely to the north of but including part of the study area (including the site of the gatehouse). This grant formed the bulk of the Glenlee estate. ²³
1822	The 1822 Muster shows Howe held 7200 acres (2914 ha), with 520 acres (210 ha) cleared and various crops planted (wheat, maize, barley, oats, peas or beans, and potatoes), livestock included as sheep, cattle and pigs. ²⁴ The 9 acres (3 ha) of garden or orchard is likely to have been situated nearer to the homestead. An undated plan by surveyor James Meehan shows a ‘Yard’ to the south of the property but outside the current study area (Figure 2.1).

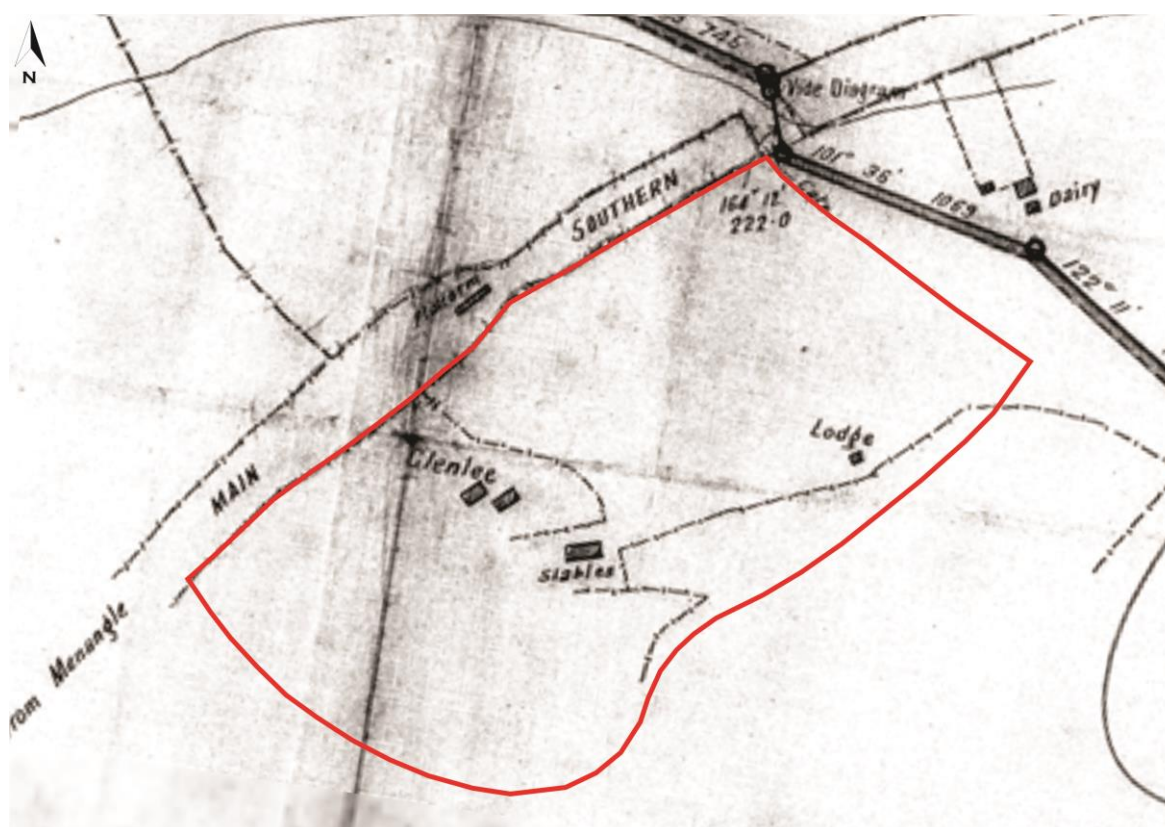
Figure 2.2: 1907 plan showing the right of way for Old Minto Road, Glenlee and its stables, as well as the lodge (gatehouse) and dairy (north of Minto Road). Note, the orientation of the buildings is indicative only. Source: NRS 17513, RPA 11904 (reproduced in Kass 2020).

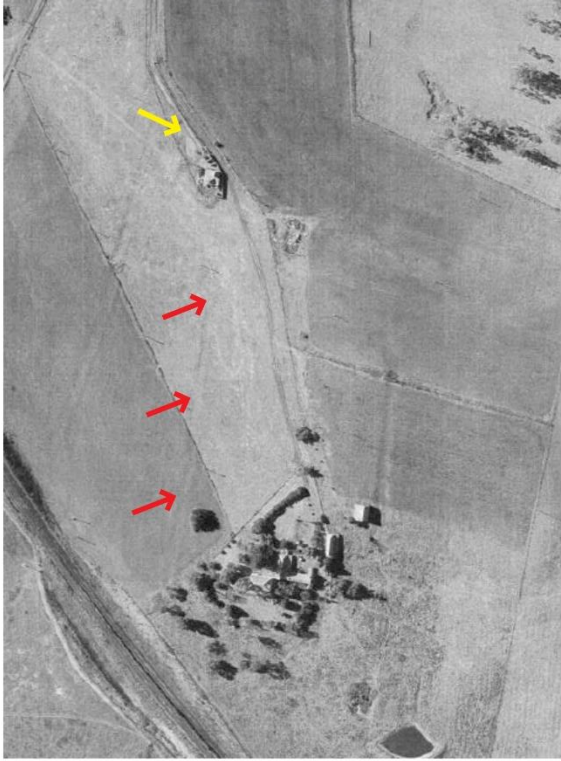
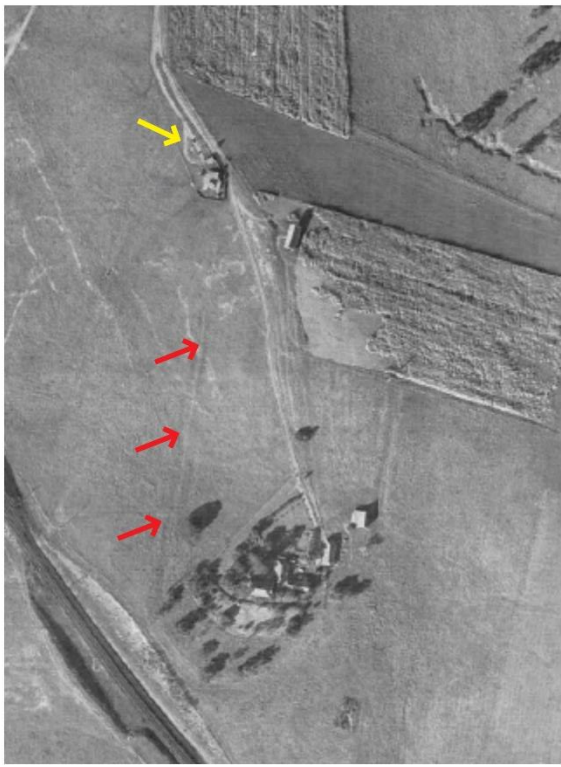
Figure 2.4: Aerial photographs showing existing buildings and roadways. Note the visible line of the original carriageway from the gatehouse to homestead (marked with red arrows). The carriage loop at the gatehouse (yellow arrow) does not appear to be formalised until the 1950s (see inset on 1947 aerial). Source: Tropman & Tropman 2016.

The changing uses of the surrounding land on the property for crop growing, pasture and cattle grazing and more recently as an olive grove (1999-2014) is likely to have impacted on more ephemeral remains in those areas over time. C & L Figure 2.4 above indicates some of the modifications throughout the 20th century, where structures and landscape elements have been removed or replaced since the mid-1800s. The dense ground cover within the paddocks prevented any close inspection of much of these areas, however previous inspections by C & L did not indicate additional sites (C & L Figure 2.18, Figure 2.13).

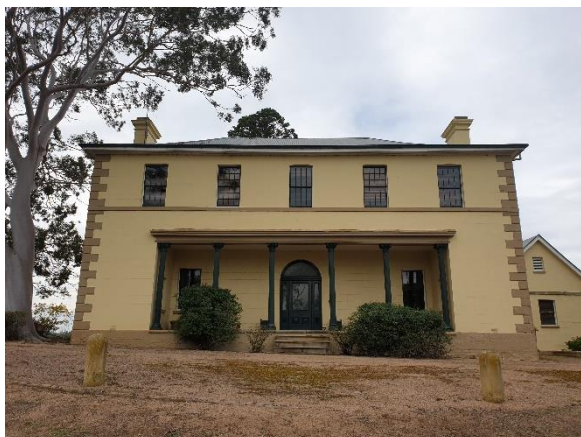
Figure 2.5: Front (west) elevation of the Glenlee homestead. Casey & Lowe 2020.

The Glenlee homestead complex, including the main house (Figure 2.5, Figure 2.6), servants' wing and kitchen buildings (Figure 2.7, Figure 2.8) and subsidiary farm buildings 'milking shed'/stables (Figure 2.9, Figure 2.10), are in excellent condition, having been subject to various conservation and maintenance programs since the 1980s. The former farm outbuilding (likely a woolshed, perhaps dating to the 20th century) to the southwest of the stables was destroyed by fire c.2009 and replaced with a new structure in 2011 (Figure 2.11, Figure 2.12). The gatehouse is in a state of disrepair and partial collapse (Figure 2.13 - Figure 2.16).

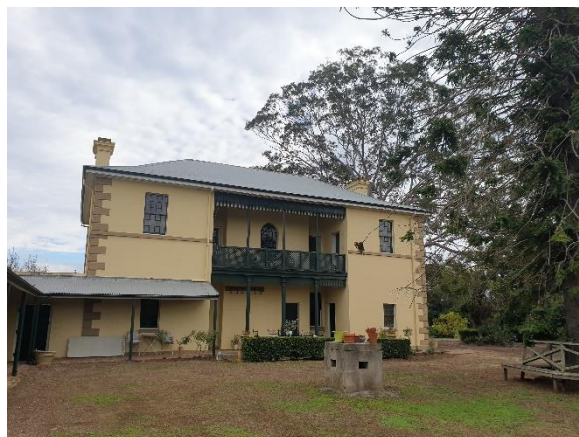
Figure 2.6: Rear (east) elevation of the Glenlee homestead. Casey & Lowe 2020.

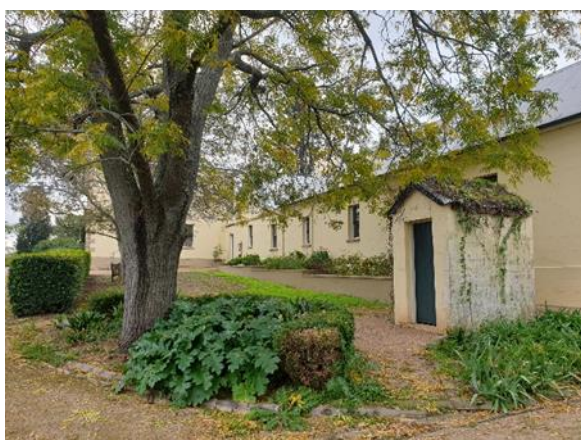
Figure 2.7: Outbuilding to the rear of the former servants' wing (c.1823-4). View to north. Casey & Lowe 2020.

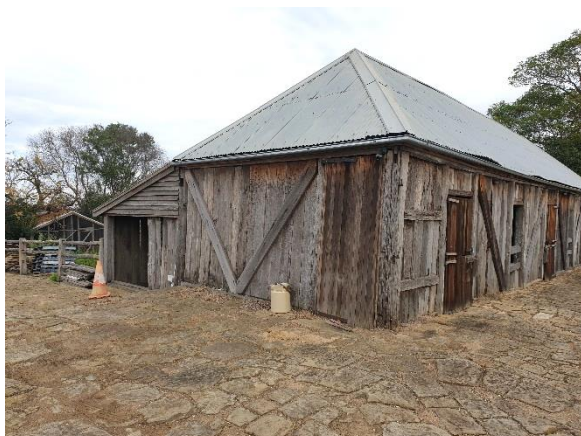
Figure 2.9: The stables (the timber slab 'milking shed', c.1820s/30s). View to west. Casey & Lowe 2020.

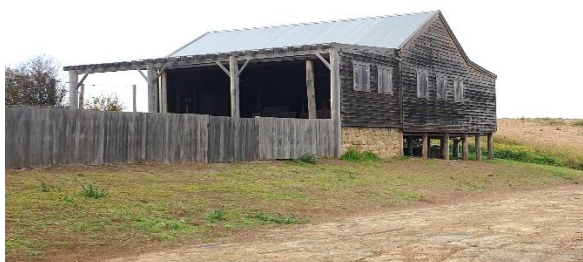
Figure 2.11: The new outbuilding erected in 2011 after the original farm building (possibly a woolshed) was destroyed in a fire in c.2009. View to south. Casey & Lowe 2020.

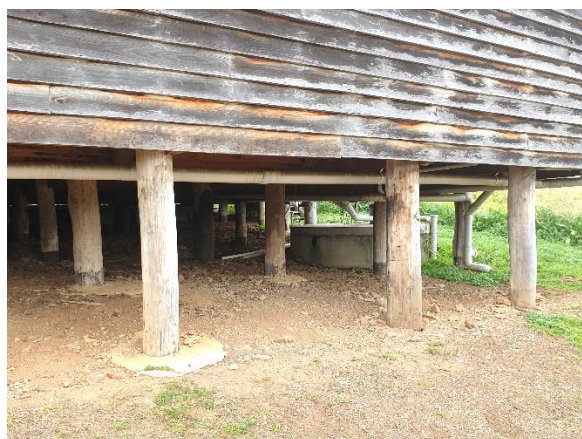
Figure 2.12: View under the new (2011) outbuilding, built on the site of the earlier farm building. View to east. Casey & Lowe 2020.

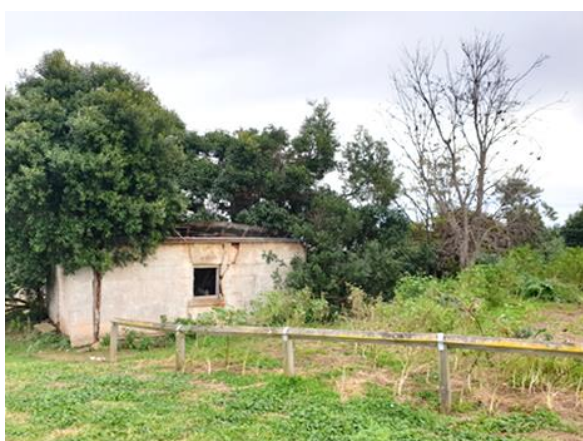
Figure 2.13: The former gatehouse (c.1830s). Note the tree that has grown through the east wall. View to west. Casey & Lowe 2020.

The dense ground cover within the paddocks prevented any close inspection of much of these areas during the 2017 or 2020 site visits (Figure 2.18, Figure 2.13). Nonetheless, the changing uses of the surrounding land on the property for crop growing, pasture and cattle grazing and more recently as an olive grove (1999-2014) is likely to have impacted on more ephemeral remains in those areas over time. The land preparation for the olive grove involved deep ploughing and further extensive disturbance when the grove and root systems were removed. Figure 2.4 above indicates some of the modifications throughout the 20th century, where structures and landscape elements have been removed or replaced since the mid-1800s.

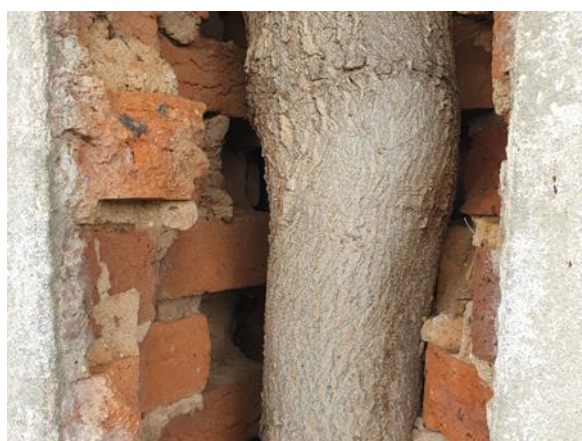
Figure 2.14: View of brickwork of the former gatehouse where a tree has grown through the east wall. Casey & Lowe 2020.

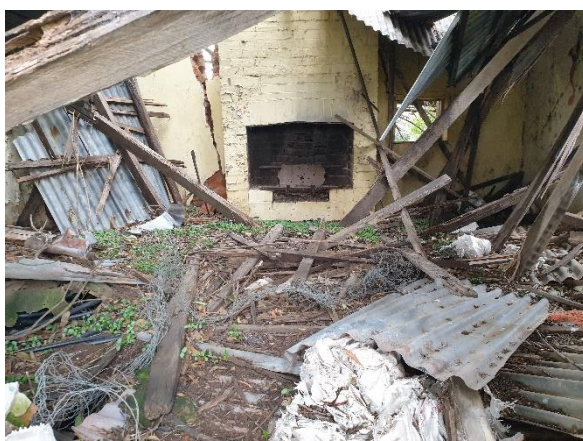
Figure 2.15: Interior of the former gatehouse showing the collapsed roof. View to north. Casey & Lowe 2020.

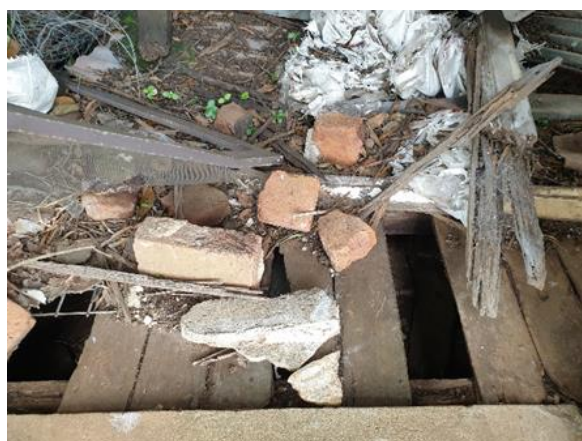
Figure 2.16: Interior of the former gatehouse, showing exposed floorboards. Casey & Lowe 2020.

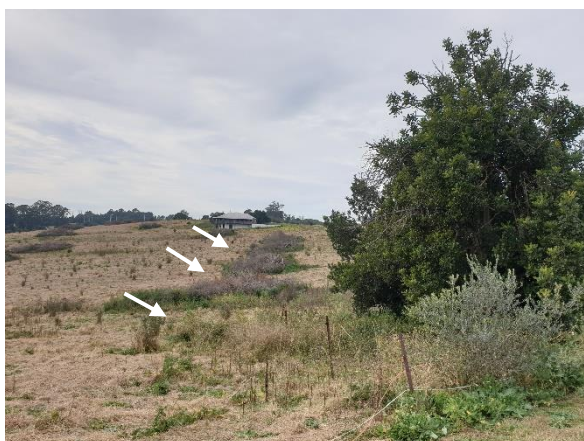
Figure 2.17: View from the homestead to the gatehouse, showing the approximate line of the early carriageway (arrowed). View to east. Casey & Lowe 2020.

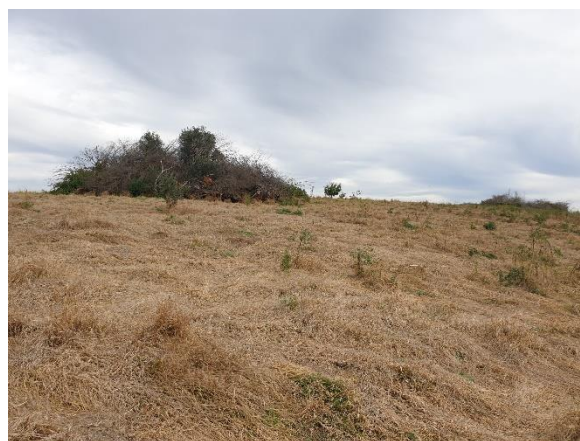
Figure 2.18: View of the modern fields and the approximate location of the former farm outbuilding (barn) demolished by 1971. View to south. Casey & Lowe 2020.

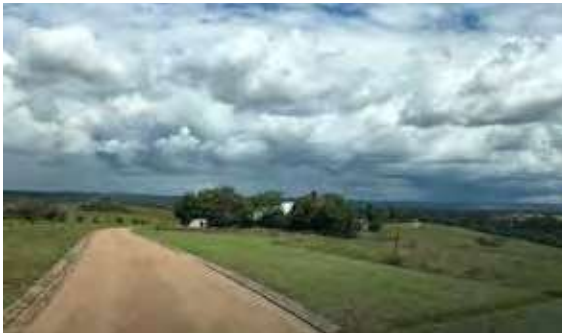
3. Gatehouse and Olive Processing building. Continue landscape screen olive processing plant, extend planting at lower level to screen new first storey development while allowing distant views.

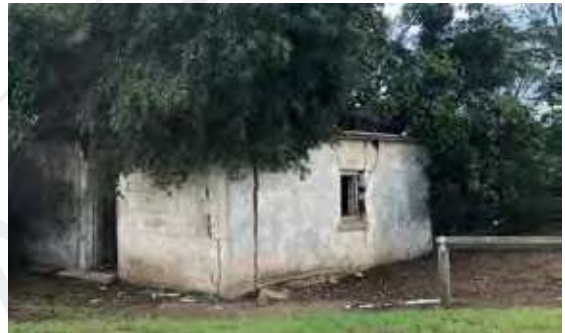
4. Restore and reveal gatehouse, consider reinstating carriage loop

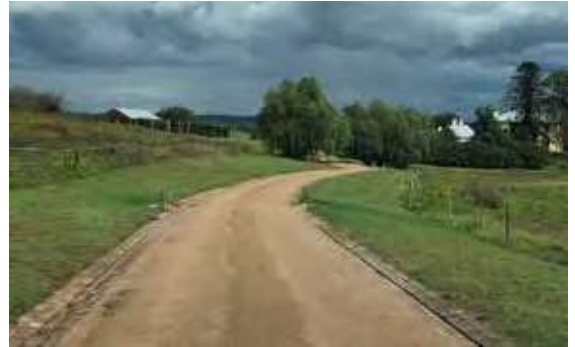
8. Topography starts to screen 2011 outbuilding and new development in that area

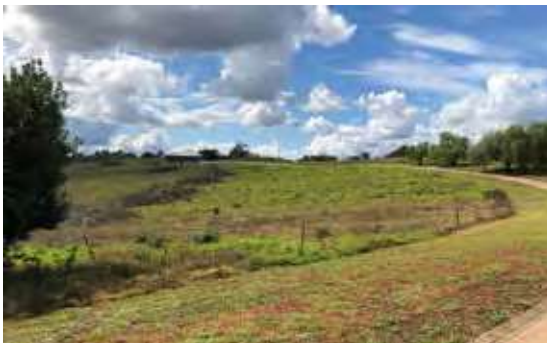
9. Definition of parish boundary with landscape will allow a sense of openness either side of road

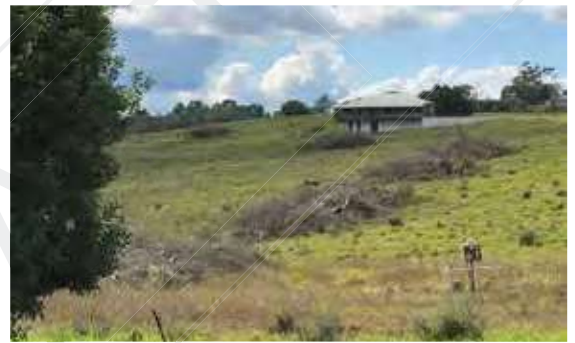
10. Screen Olive Processing shed by extending cluster planting around the building

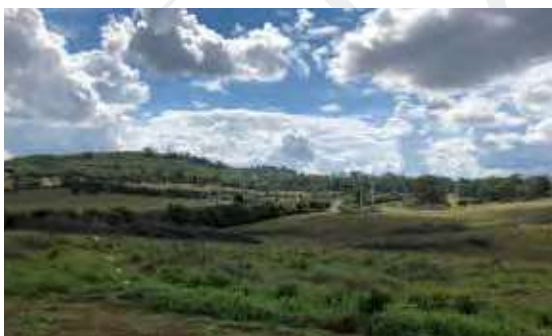
11. View to Mt Annan from driveway. Location of 1 storey buildings at low RL and new screen hedge planting following contours allows for distant views to be maintained

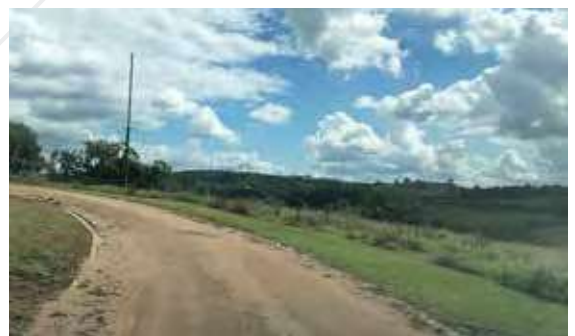
12. Distant views maintained with low hedge planting to mark parish boundary and land holding associated with house

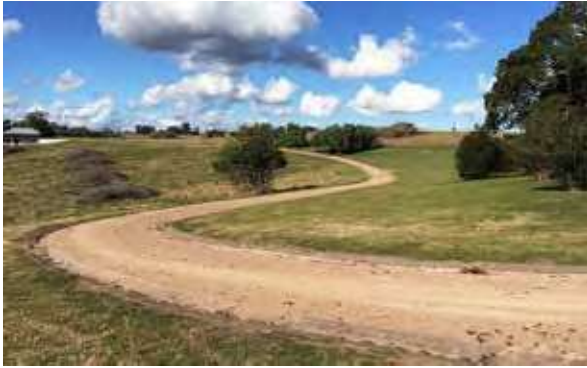
13. Views along driveway departing Glenlee homestead. Maintain rural quality and openness

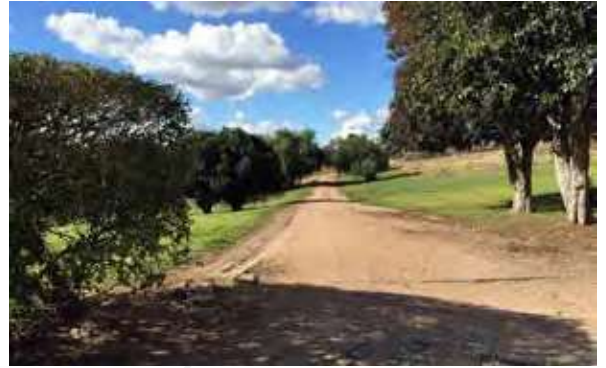
14. Clusters of trees along driveway exiting Glenlee

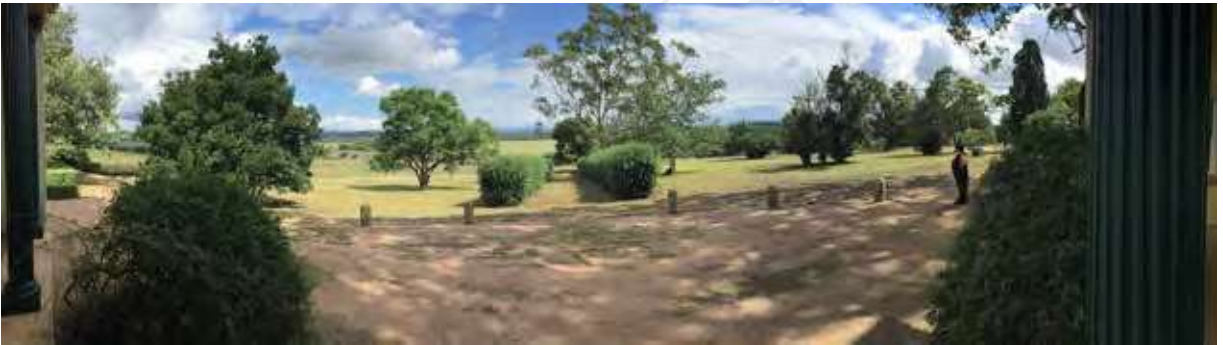
15. View from Glenlee homestead. Existing landscape restricts expansive views and view to Camden Park ridge

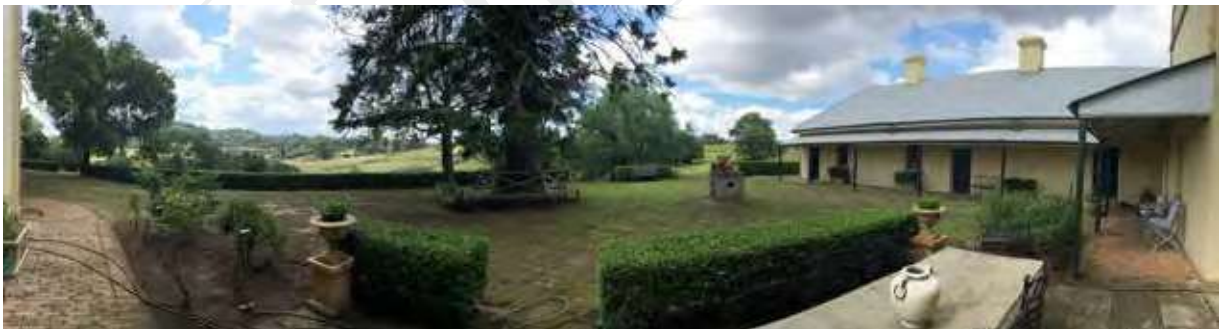
16. View from rear courtyard. 1 storey Development area on low RL to be screened by vegetation allowing distant views over

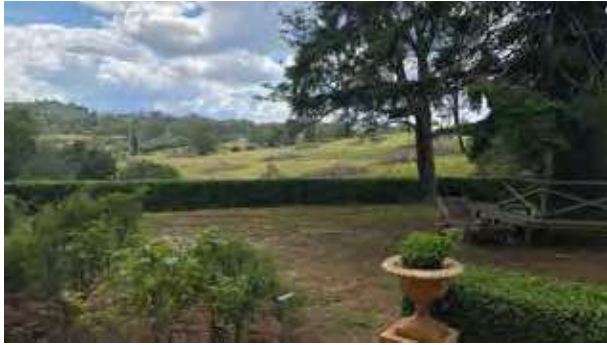
17. View to development area from historic garden

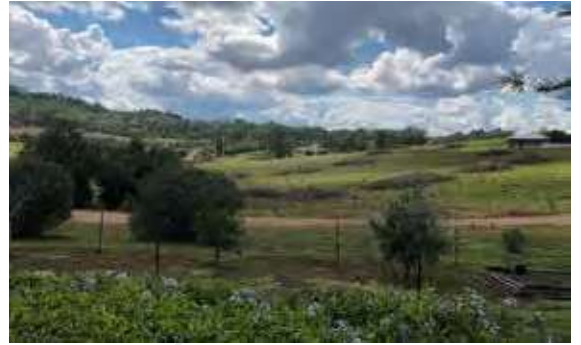
18. Hedge screening of parish boundary and additional cluster planting, to mitigate impact

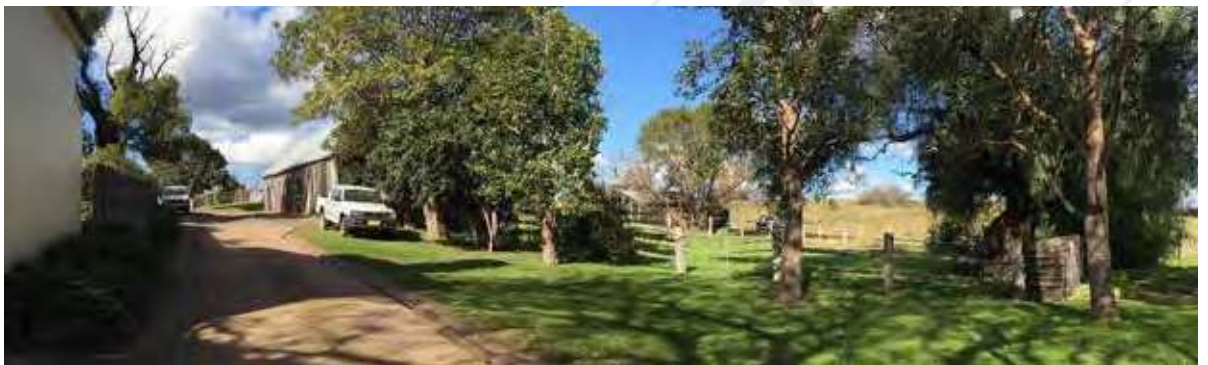
19. View from driveway to area of potential development. Potential to screen with vegetation beyond fenced yard

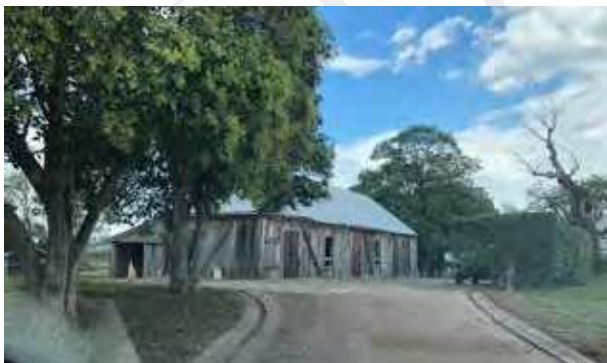
20. Outbuildings- former stables/milking shed. Protect setting

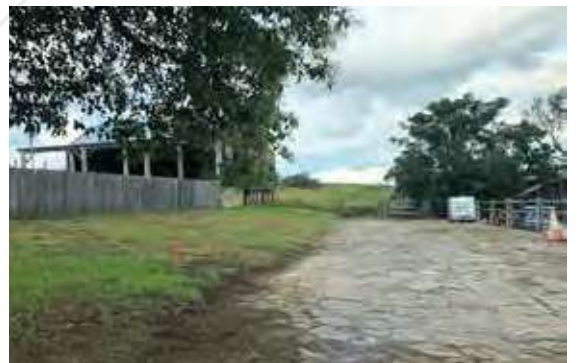
21. 2011 farm building, potential to provide additional screening, by extending landscape setting of group

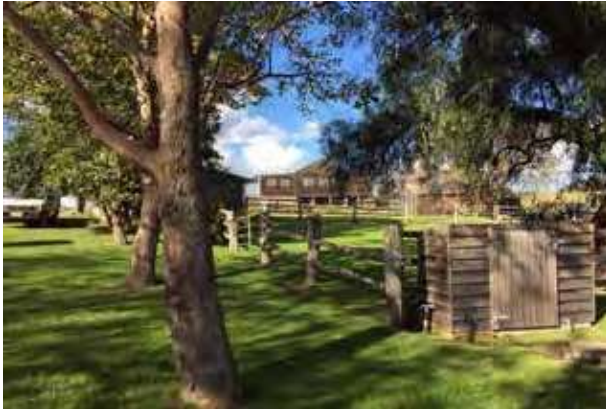
22. View across yard to 2011 farm building to be protected

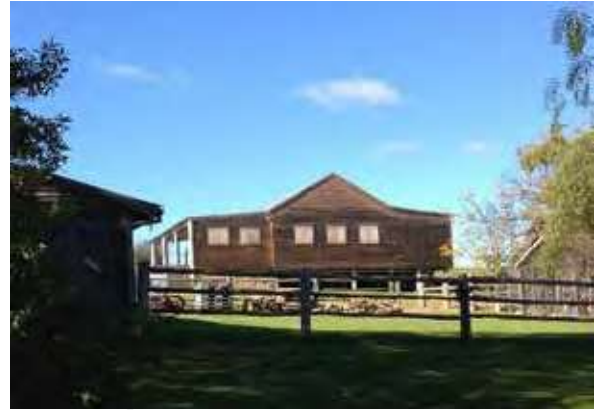
23. 2011 farm building has little value modify to reduce impact

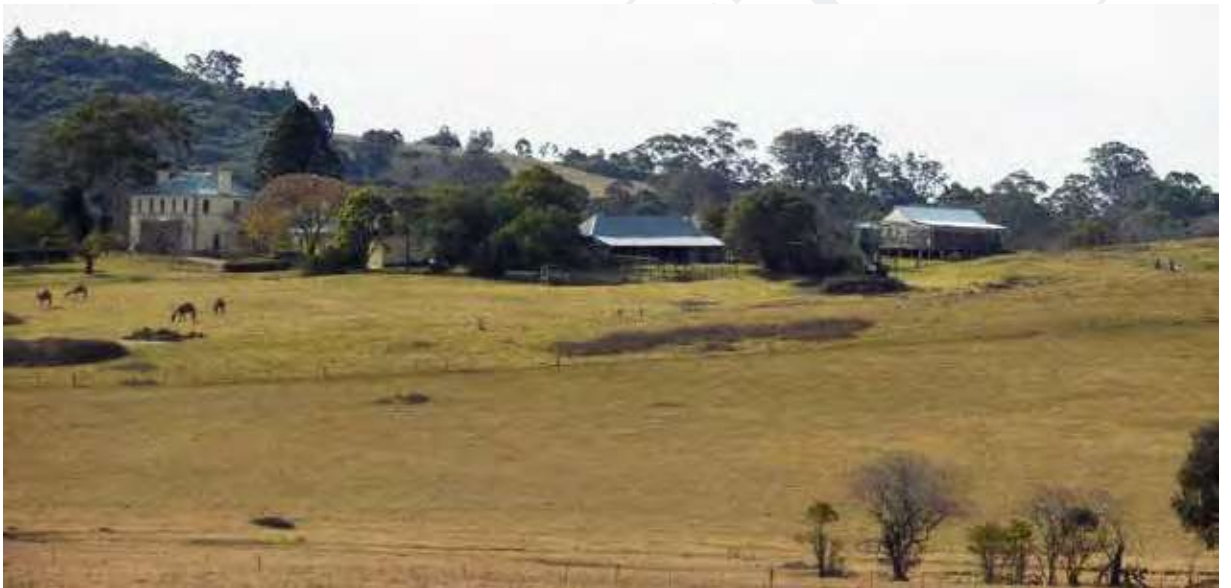
24. View from Menangle Park. Potential screening of 2011 farm building and new development
